# CSO Annual Report for Calendar Year 2023

March 29, 2024

CITY OF PEORIA  
3505 N DRIES LN, PEORIA, IL 61604  
PHONE: (309) 494-8800 | [PUBLICWORKS@PEORIAGOV.ORG](mailto:PUBLICWORKS@PEORIAGOV.ORG)

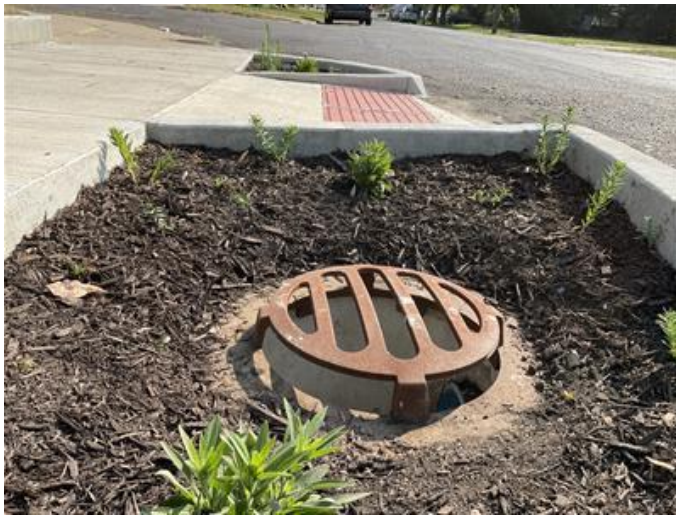
**Figure 6 | Showing Inlets in Stormwater Bump Outs in Year 1 Project Area. Photos taken August 29, 2023.**

- The stormwater bump-outs utilize curb cuts and inlets to capture stormwater and use pipes to convey the stormwater to the aggregate storage underlying the permeable pavers. Mulch that was used for weed suppression and erosion control in the bump-outs was identified as a clogging risk. Peoria plans to remove the mulch and replace it with turf grass or native plantings.

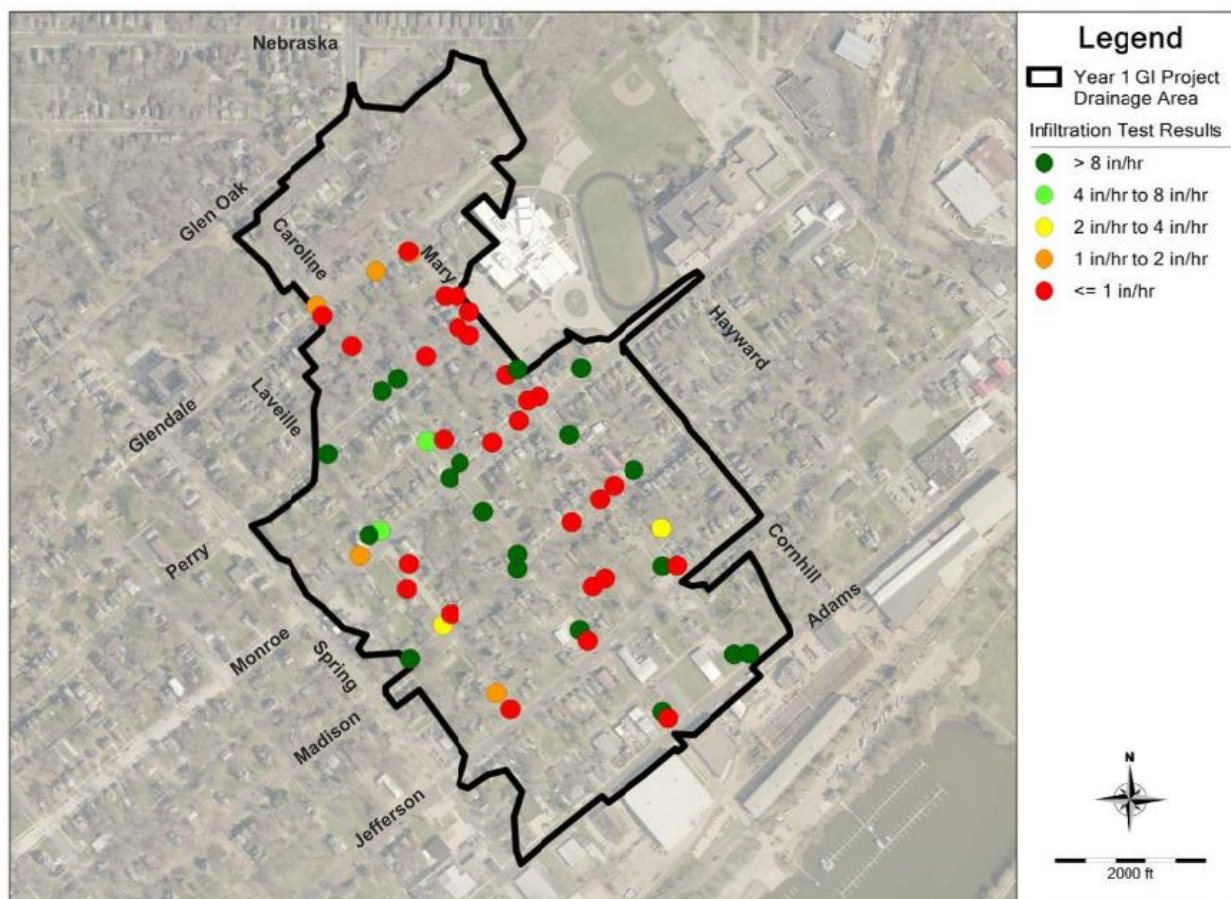
**Figure 8 | Year 1 CSO Control Project Pre-Construction Infiltration Tests**

Pre-construction performance testing is completed at or just below the native soil interface to determine the infiltration capacity for each green infrastructure facility. Pre-construction performance testing was completed for the Year 1 CSO Control Project using either a Guelph Permeameter, Compact Constant Head Permeameter, or lab permeameter. Figure 8 shows the pre-construction infiltration tests for the Year 1 CSO Control Project. The Year 1 project pre-construction infiltration test results are included in Appendix B.

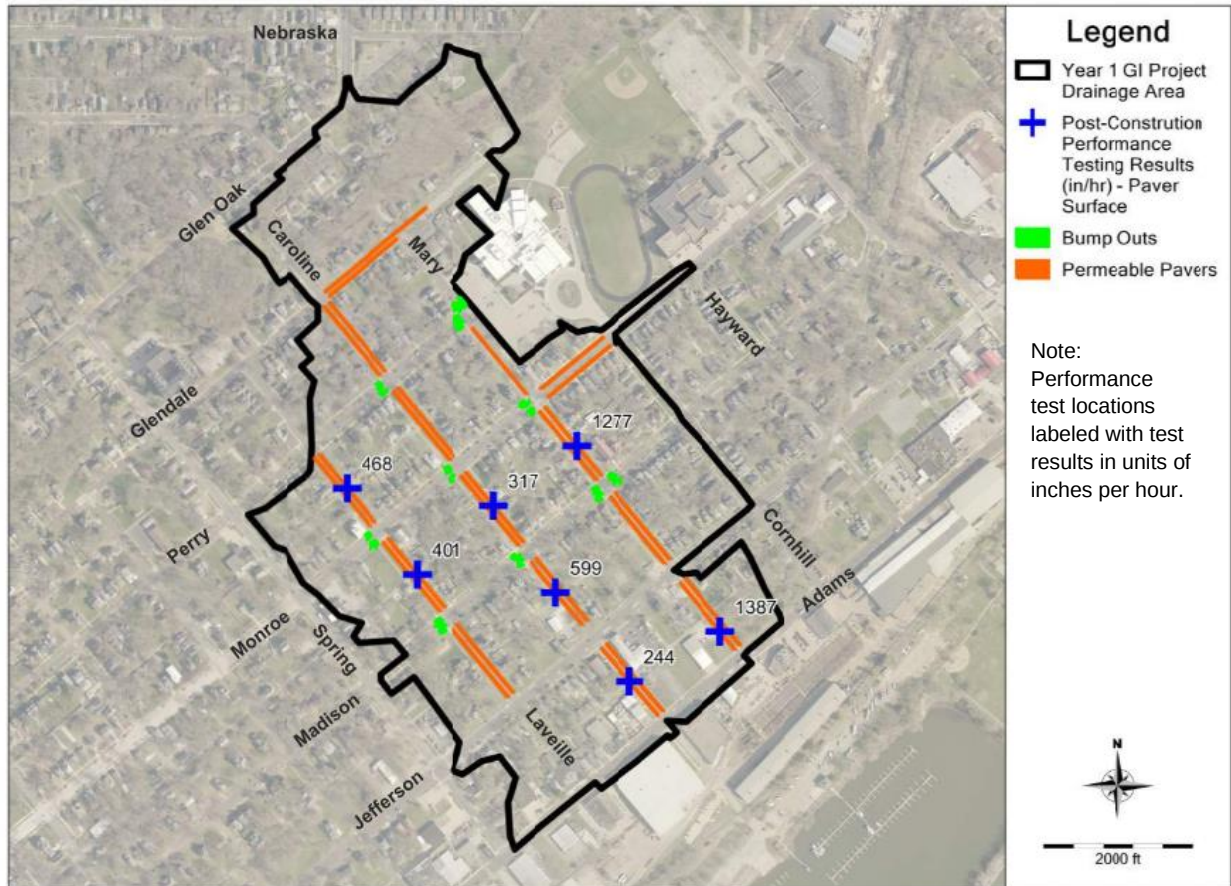
Figure 9 | Post-Construction Performance Test Results of Permeable Paver Surface

Seven permeable paver surface infiltration tests were completed using two different testing methods, ASTM C1781 and hydrant testing; the results are shown in Figure 9 and Table 3. The ASTM C1781 test is a standardized single ring infiltration test. The single ring test isolates the pavement test section creating uniform infiltration over the test area. Hydrant testing the pavement surface is

completed in combination with hydrant testing the native soil interface. The permeable pavement wetted area is measured following the test, and the surface infiltration rate is calculated by dividing the hydrant flow rate by the wetted area. The surface infiltration rate calculated from hydrant testing is conservative since it assumes uniform infiltration over the wetted surface area, whereas the field surface infiltration varies with distance from the hose. The ASTM C1781 tests are therefore considered to be more accurate and, as such, will typically be used in the future to evaluate permeable pavement pavers surface infiltration rates.

<sup>2</sup> The surface infiltration rate calculated from hydrant testing is conservative since it assumes uniform infiltration over the wetted surface area, whereas the field surface infiltration varies with distance from the hose. ASTM C1781 test is a standardized single ring infiltration test that isolates the pavement test section creating uniform infiltration over the test area and therefore provides a more accurate measurement of surface infiltration rates than hydrant testing.

- Thorough cleaning the permeable paver surface is key to maintaining the surface infiltration capacity. Permeable pavers are subject to clogging from leaves and other debris. Peoria

performed maintenance, which restored the surface infiltration capacity to like new conditions. Peoria continues to monitor the permeable paver surface infiltration rate via periodic infiltration testing and is using the data to inform and optimize maintenance activities.

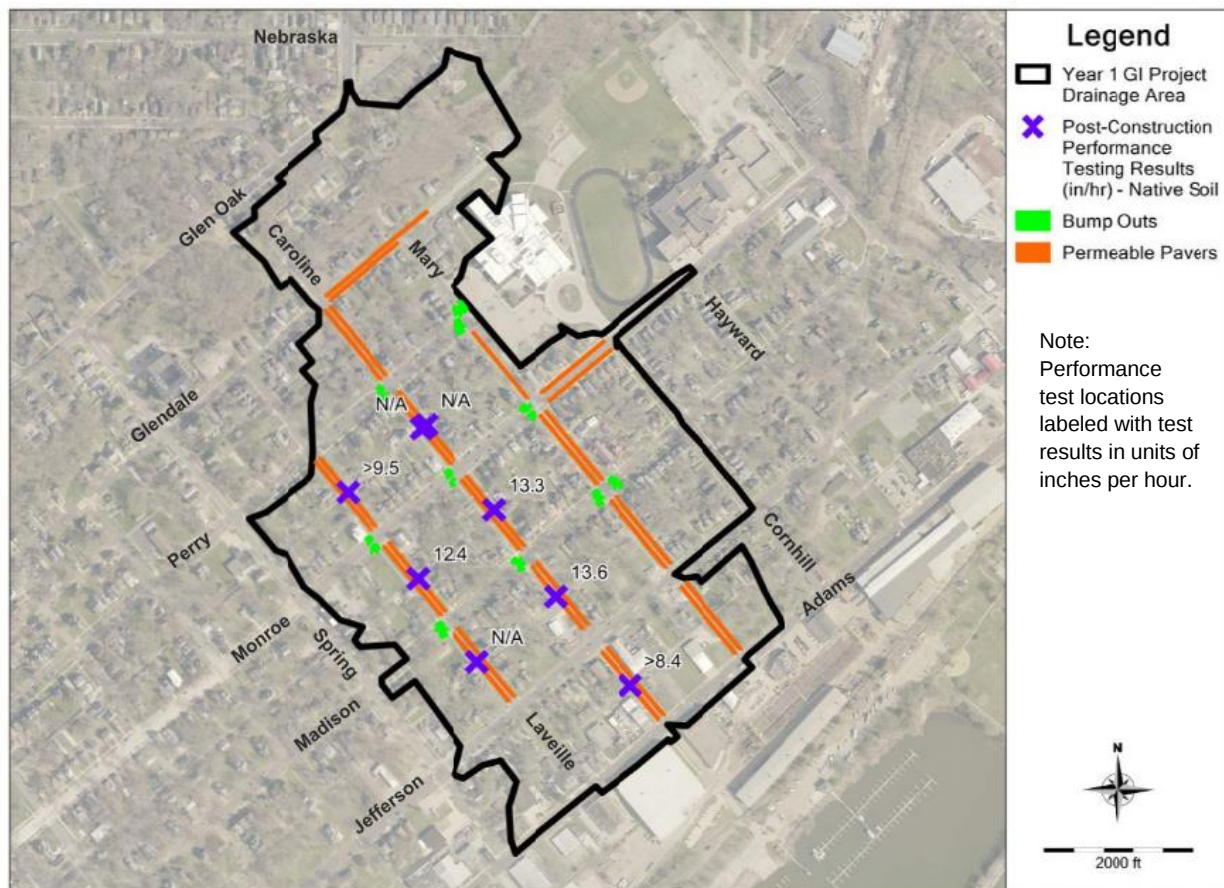
**Figure 10 | Post-Construction Performance Test Results of Native Soil Below GI Storage**

Eight hydrant tests were performed to measure the infiltration rate of the soil below the GI storage, the results are shown in Table 4 and Figure 10. Five of the subsurface infiltration tests were performed as hydrant tests where the flow was directed to the permeable paver surface. For these tests, the native soil infiltration rate was calculated following procedures in the CSO Remedial Measures Operation & Maintenance and GI Performance Testing Plan. When an inlet or cleanout was available to observe the water level in the subsurface, the native soil infiltration rate was calculated from either the observed drawdown rate after the hydrant test ended or, if applicable, the steady state rate during the test. When an inlet or cleanout is not available for observation of the subsurface water level, the native soil infiltration rate was conservatively calculated from a mass balance and reported as greater than the calculated value.

Three of the subsurface aggregate storage tests were performed as hydrant tests where the flow was directed through a connected bump-out or inlet, to verify that water flows through the project as designed following procedures in the O&M and Performance Testing Plan. During the testing, a flow restriction was identified that prevented the completion of these subsurface infiltration tests. The flow restriction was identified when water was observed coming out of all connected inlets and cleanouts upstream of the subsurface storage within minutes of starting the hydrant test, well before the subsurface storage would have filled. The flow restriction is expected to be the storm chamber that is used to distribute flow into the subsurface storage since overflow was observed nearly simultaneously at all connected structures upstream of the storm chamber, but no overflow was observed from the subsurface storage downstream of the storm chamber. Storm chambers Y1\_P-22A, Y1\_P-32A, and Y1-P43, which were evaluated during the post-construction performance testing, were televised to help evaluate the issue. Additional investigation and corrective actions for the storm chambers are planned for 2024. Follow up performance testing will be completed after the corrective action is completed.

<sup>1</sup> The subsurface infiltration rate was not evaluated due to a flow restriction in the system, preventing flow from stormwater bump-outs from getting into the subsurface storage below permeable pavers.

| Test Method | Facility ID | Design Rate | Test Date | Test Result | Exceeding Design Rate? | Follow-up Actions |
|---|---|---|---|---|---|---|
| | Y1_PP-15 | 6 in/hr | 7/21/2023 | N/A <sup>1</sup> | Unknown | Perform corrective action and re-test |
