# CSO Annual Report for Calendar Year 2024

March 31, 2025

CITY OF PEORIA  
3505 N DRIES LN, PEORIA, IL 61604  
PHONE: (309) 494-8800 | [PUBICWORKS@PEORIAGOV.ORG](mailto:PUBICWORKS@PEORIAGOV.ORG)

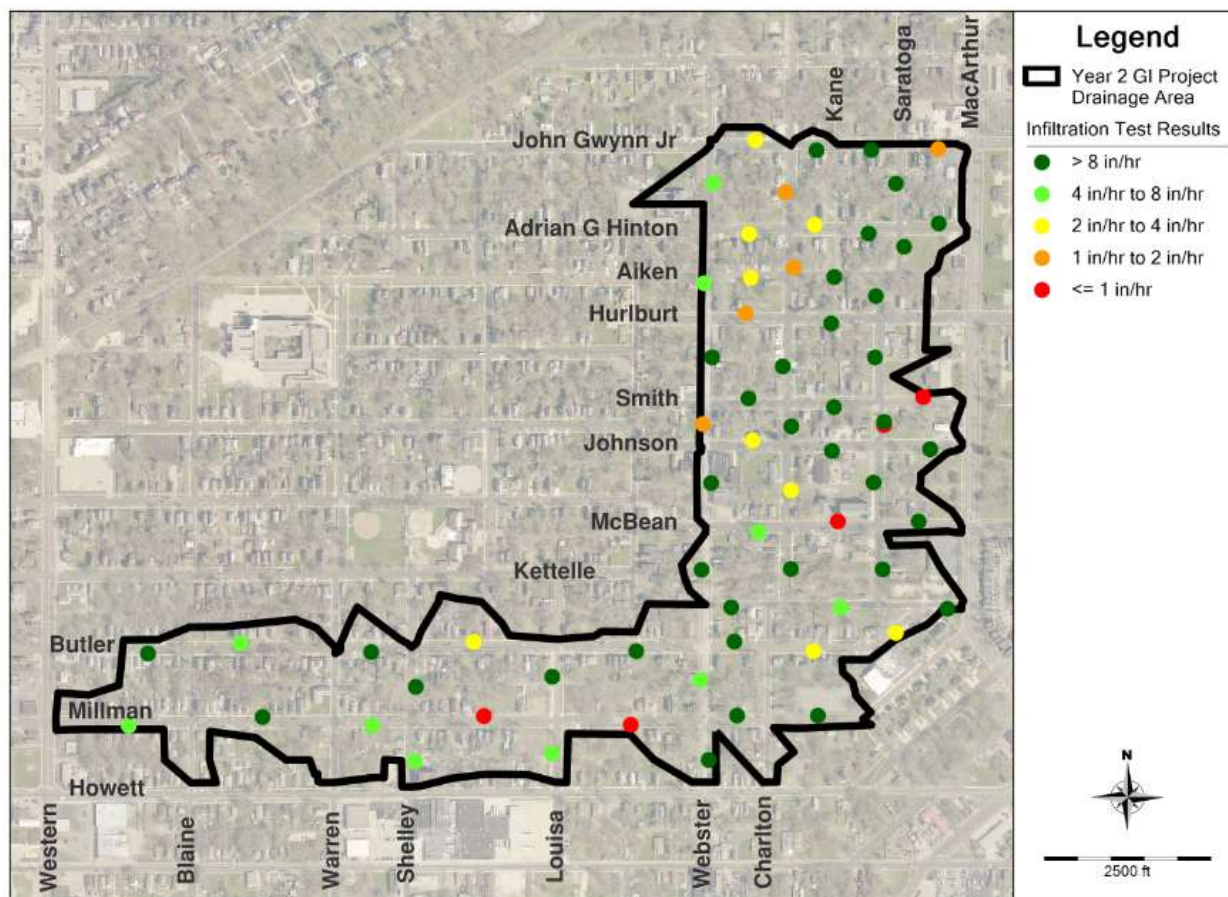
Figure 8 | Year 2 CSO Control Project Pre-Construction Infiltration Tests

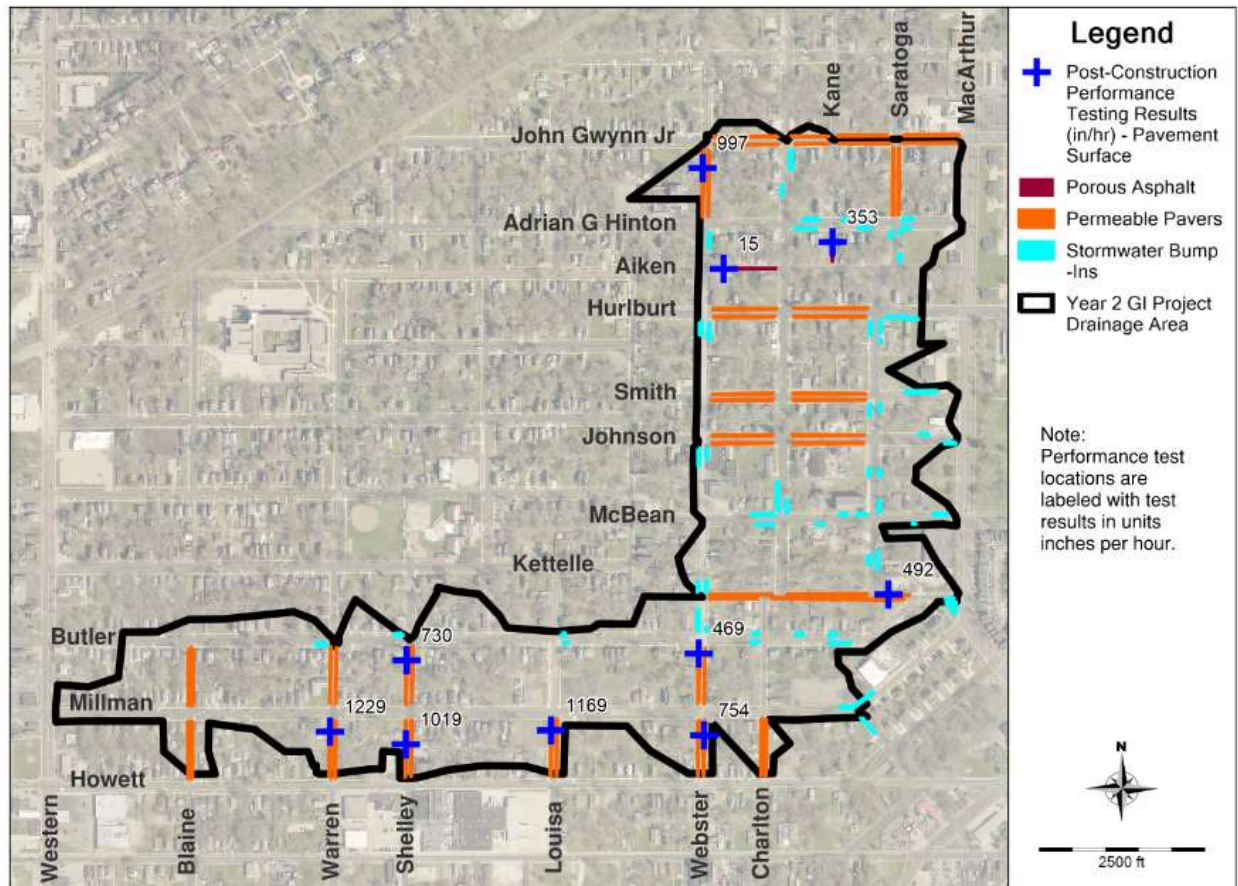
**Figure 9 | Post-Construction Surface Infiltration Tests Completed for Permeable Pavers and Porous Asphalt in the Year 2 CSO Control Project**

| GI Type | Facility ID | Design Infiltration Rate <sup>1</sup> (in/hr) | Test Date | Test Result (in/hr) | Does Test Result Exceed Design Rate? | Follow-up Actions |
|---|---|---|---|---|---|---|
| Porous Asphalt | Y2_PA-01 | 25 | 9/5/2024 | 15 | No | Investigate cause of low infiltration rate and consider implications for future use of porous asphalt |

- Permeable pavement is subject to clogging and thorough cleaning of the permeable pavement surface is key to maintaining the surface infiltration capacity. Peoria performed maintenance, which restored the permeable paver surface infiltration capacity to like new conditions. Peoria is working to identify an effective method to restore the surface infiltration capacity of the porous asphalt. Peoria continues to monitor the permeable pavement surface infiltration rate via periodic surface infiltration testing and is using the data to inform and optimize maintenance activities.

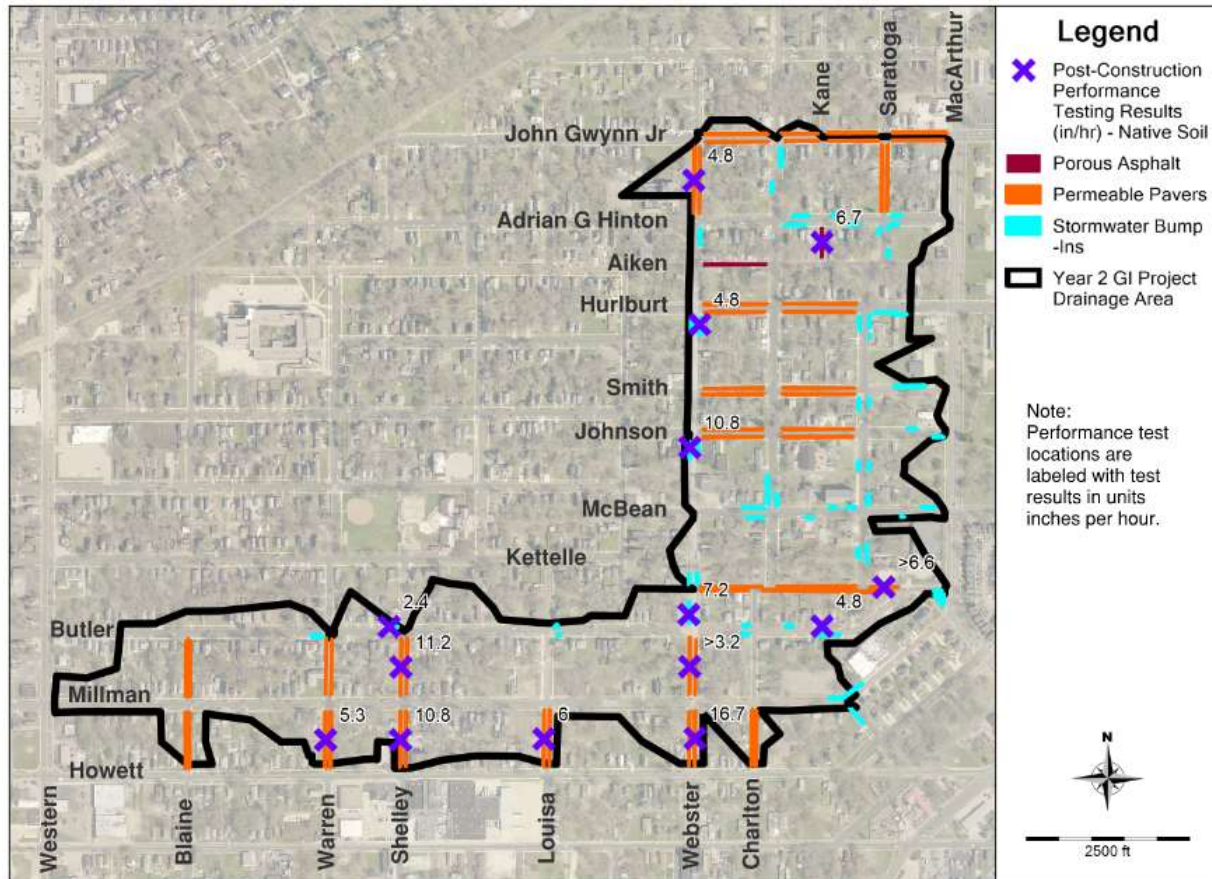
Figure 10 | Post-Construction Subsurface Infiltration Tests Completed for Permeable Pavers, Porous Asphalt, and Stormwater Bump-Ins in the Year 2 CSO Control Project

| GI Type | Facility ID <sup>1</sup> | Design Rate (in/hr) | Test Date | Test Result (in/hr) | Does Test Result Exceed Design Rate? | Follow-up Actions |
|---|---|---|---|---|---|---|
| Porous Asphalt | Y2_PA-02 | 5 | 12/17/24 | 6.7 | Yes | Update the modeled native soil infiltration rate to represent the measured performance test results. Continue following O&M & Performance Testing Plan |

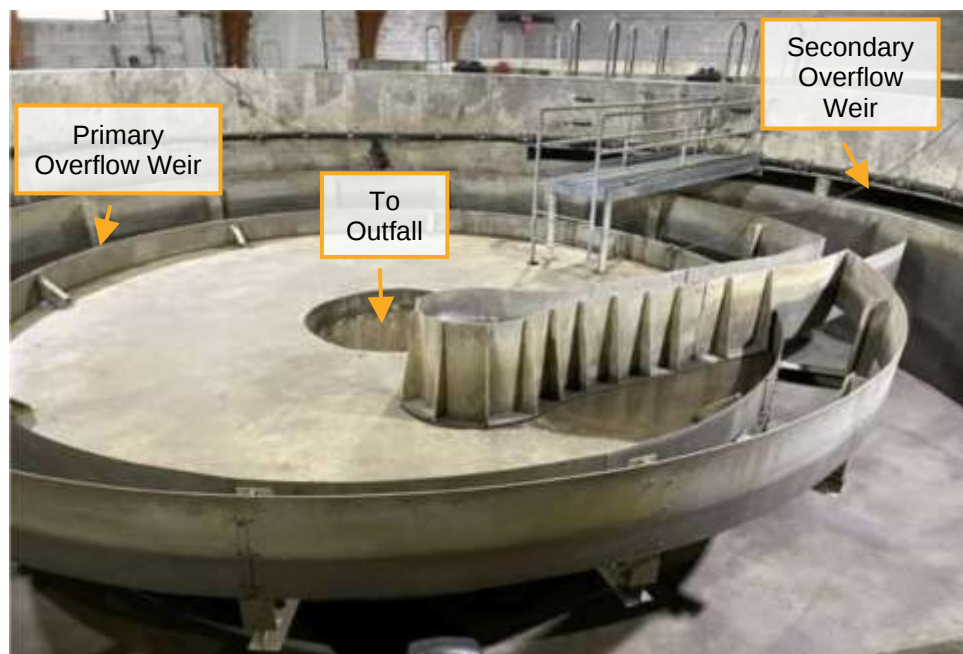
The secondary weir in the swirl concentrators consists of multiple 1-foot high rectangular openings along the outer wall of the structure. Two observations were made relating to the geometry of the

Figure 17 | Swirl Concentrator During Dry Weather Flow

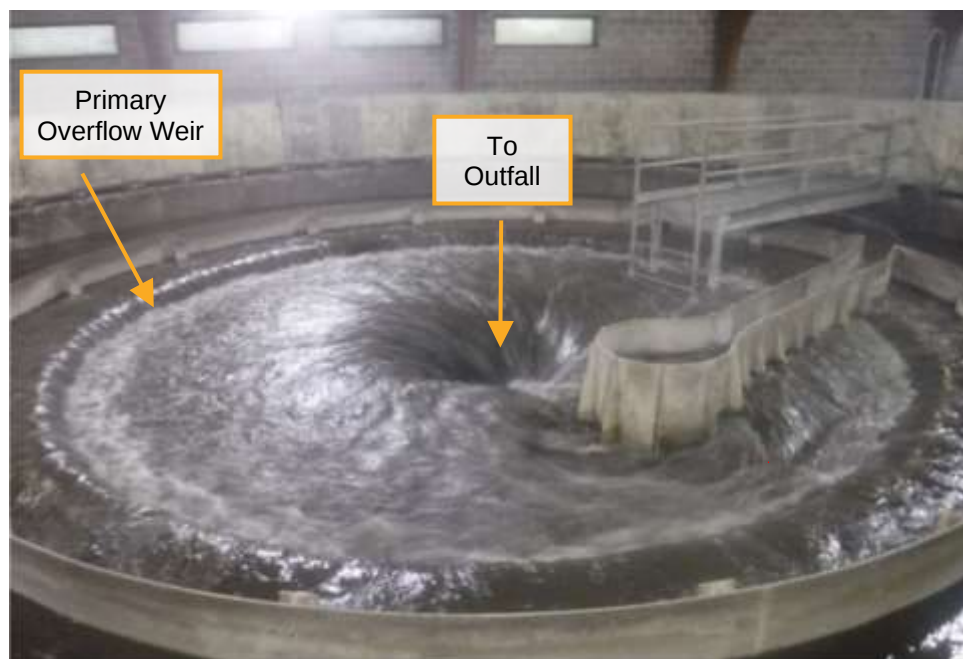
secondary weir, indicating the original level-flow relationship should be updated. First, the secondary weir will function as a sideflow weir, not a transverse weir, as the flow travels in a circular motion around the wall. Second, when the rectangular openings are fully submerged, they function as side orifices. Based on these observations, the level-flow relationship for the secondary weir was updated from a transverse weir equation to a sideflow weir equation, transitioning to orifice flow when the openings are submerged.

Figure 18 | Swirl Concentrator During Active CSO Event

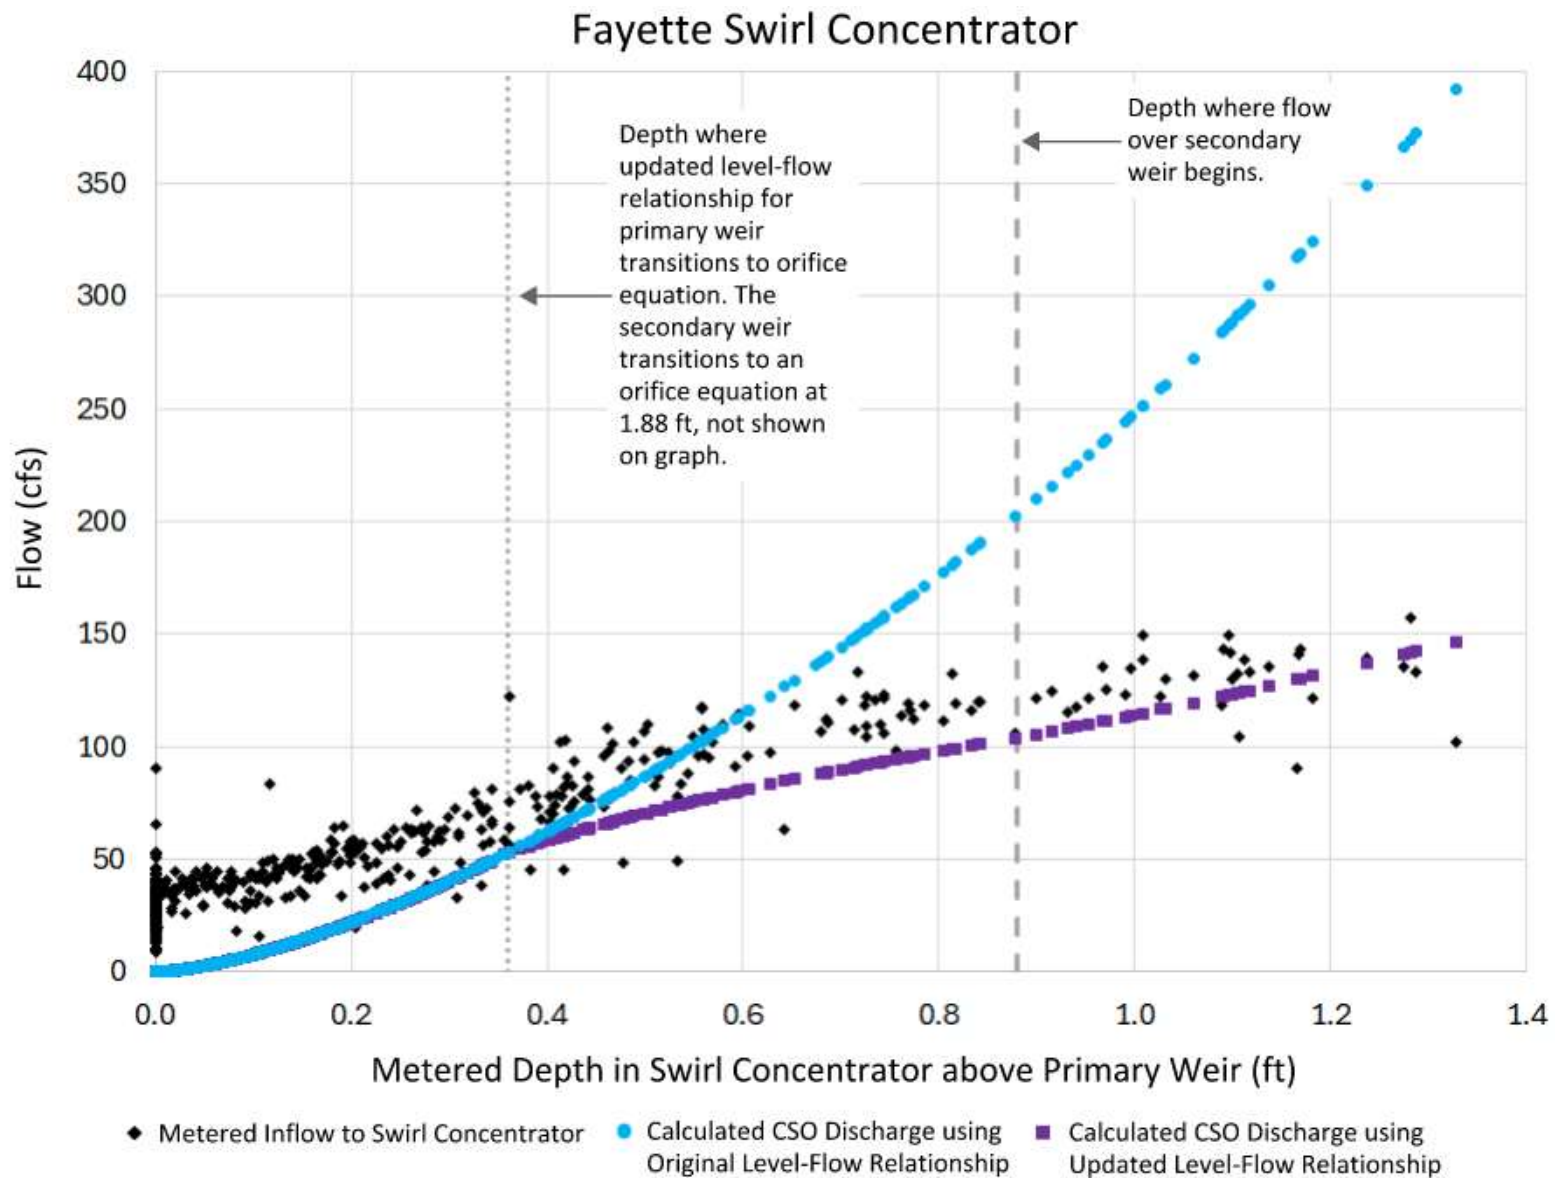
Figure 19 and Figure 20, below, show the original and updated level-flow relationships and the metered regulator inflow data for the Fayette and Eaton swirl concentrators. The graphed level-flow relationships use the metered depth in the structure. The flows are graphed versus the metered depth above the primary weir, where CSO discharges begin.

The transition from transverse weir flow to orifice flow for the primary weirs in the Fayette and Eaton swirl concentrators occurs at the depth where the CSO discharge flow, calculated using original level-flow relationship, starts consistently exceeding the metered regulator inflow. The transition depth is indicated by the dotted lines on Figure 19 and Figure 20 below.

Figure 19 | Graph showing Fayette Swirl Concentrator Original and Updated Level-Flow Relationships and 2023-2024 Meter Data

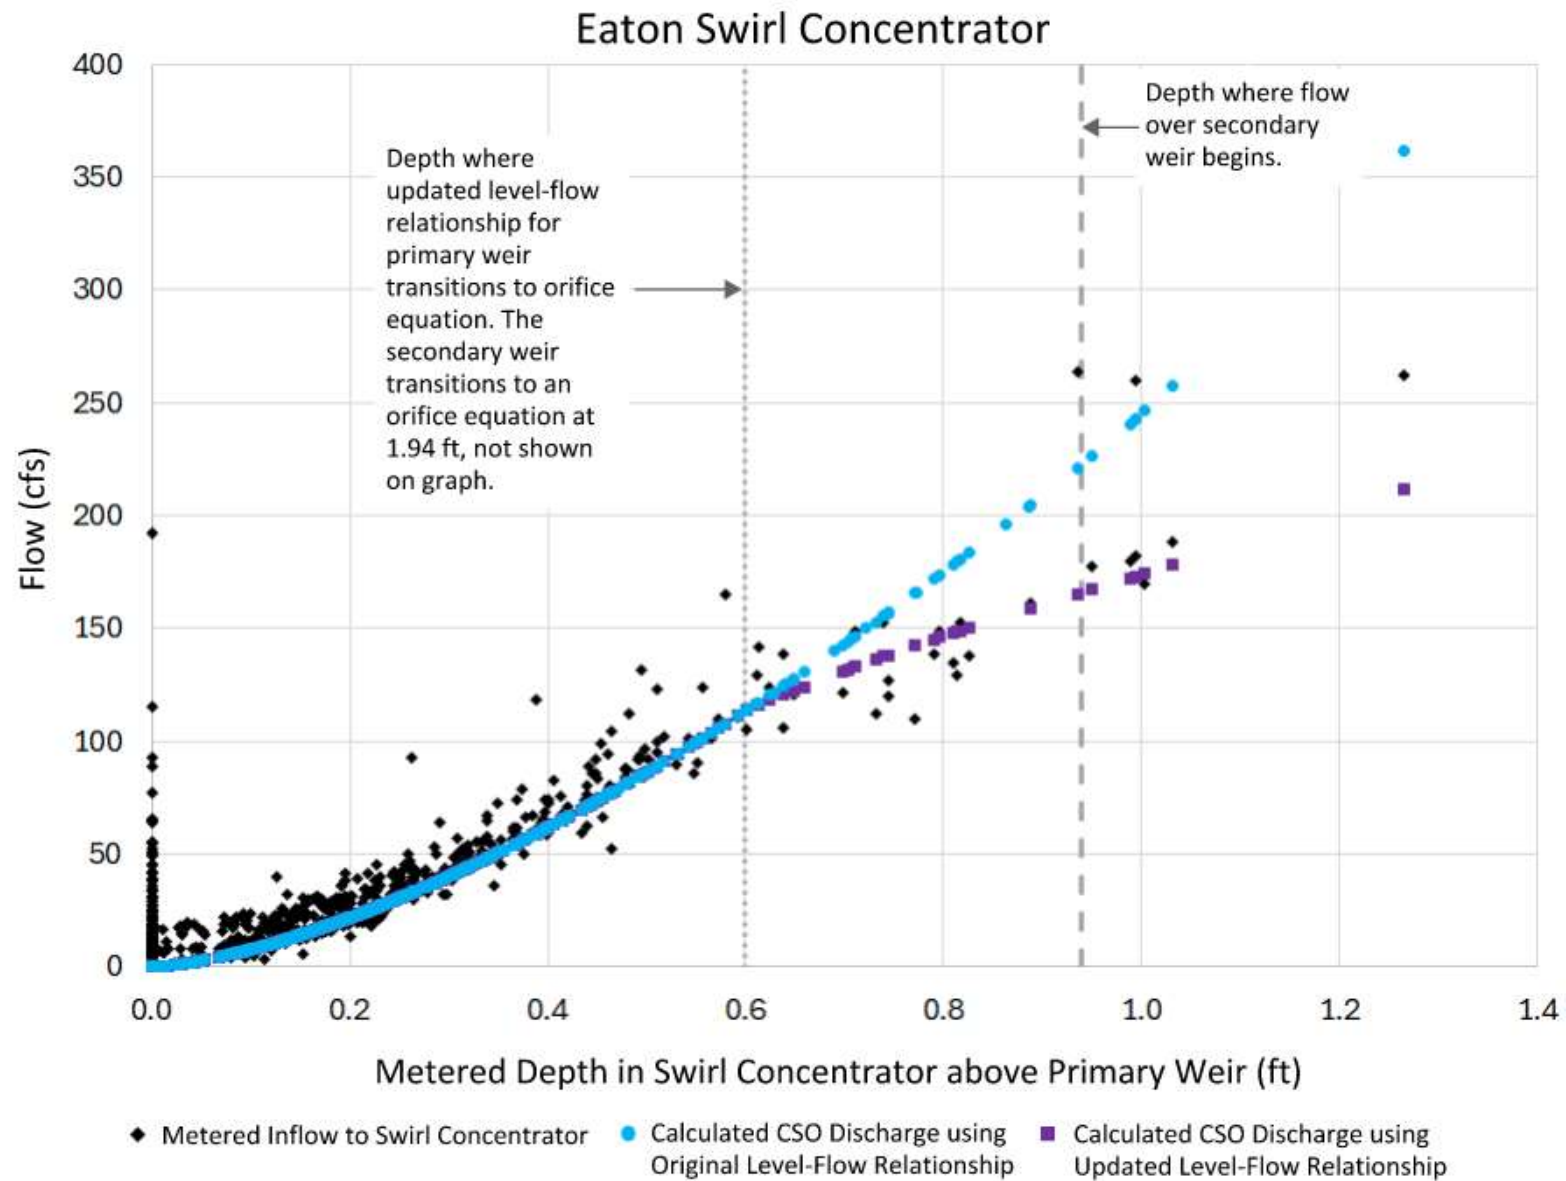
Figure 20 | Graph showing Eaton Swirl Concentrator Original and Updated Level-Flow Relationships and 2023-2024 Meter Data
