APPENDIX D

**ENVIRONMENTAL  
CONSEQUENCES**

# **Aviation Emissions and Air Quality and Noise Technical Report**

## **Birmingham-Shuttlesworth International Airport Taxiway A Relocation Project Environmental Assessment**

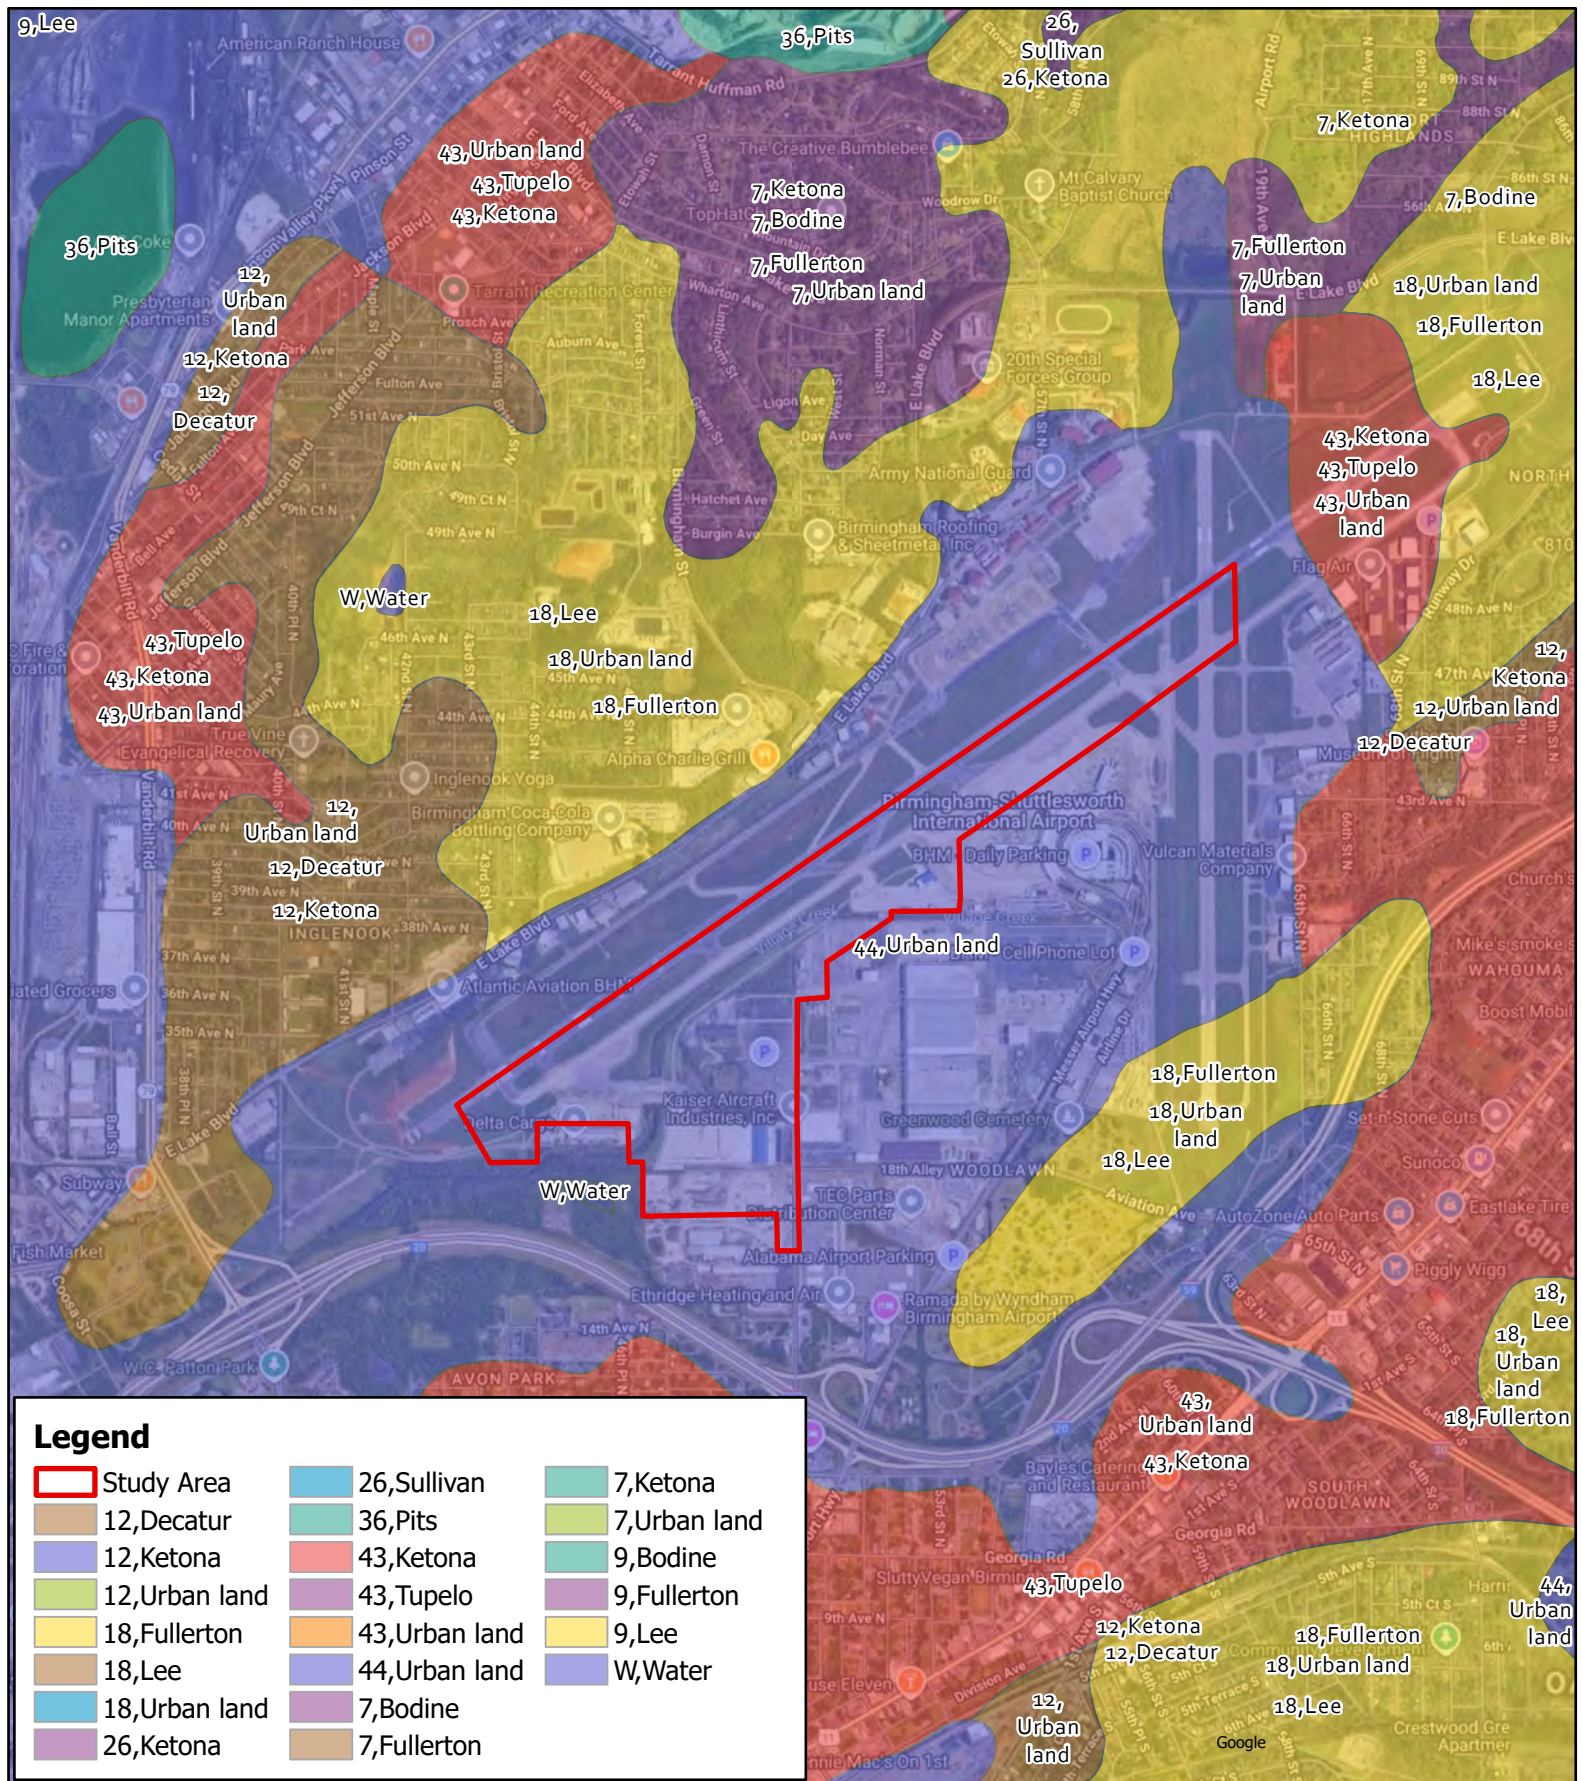
**Figure 4: NRCS Web Soil Survey  
BAA Taxiway A Relocation  
Birmingham, Jefferson County, Alabama**

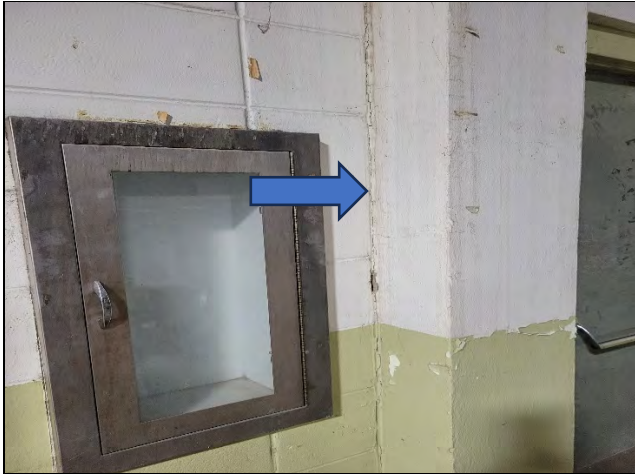
Asbestos Caulking at Joint between Column and Wall, NW Corner

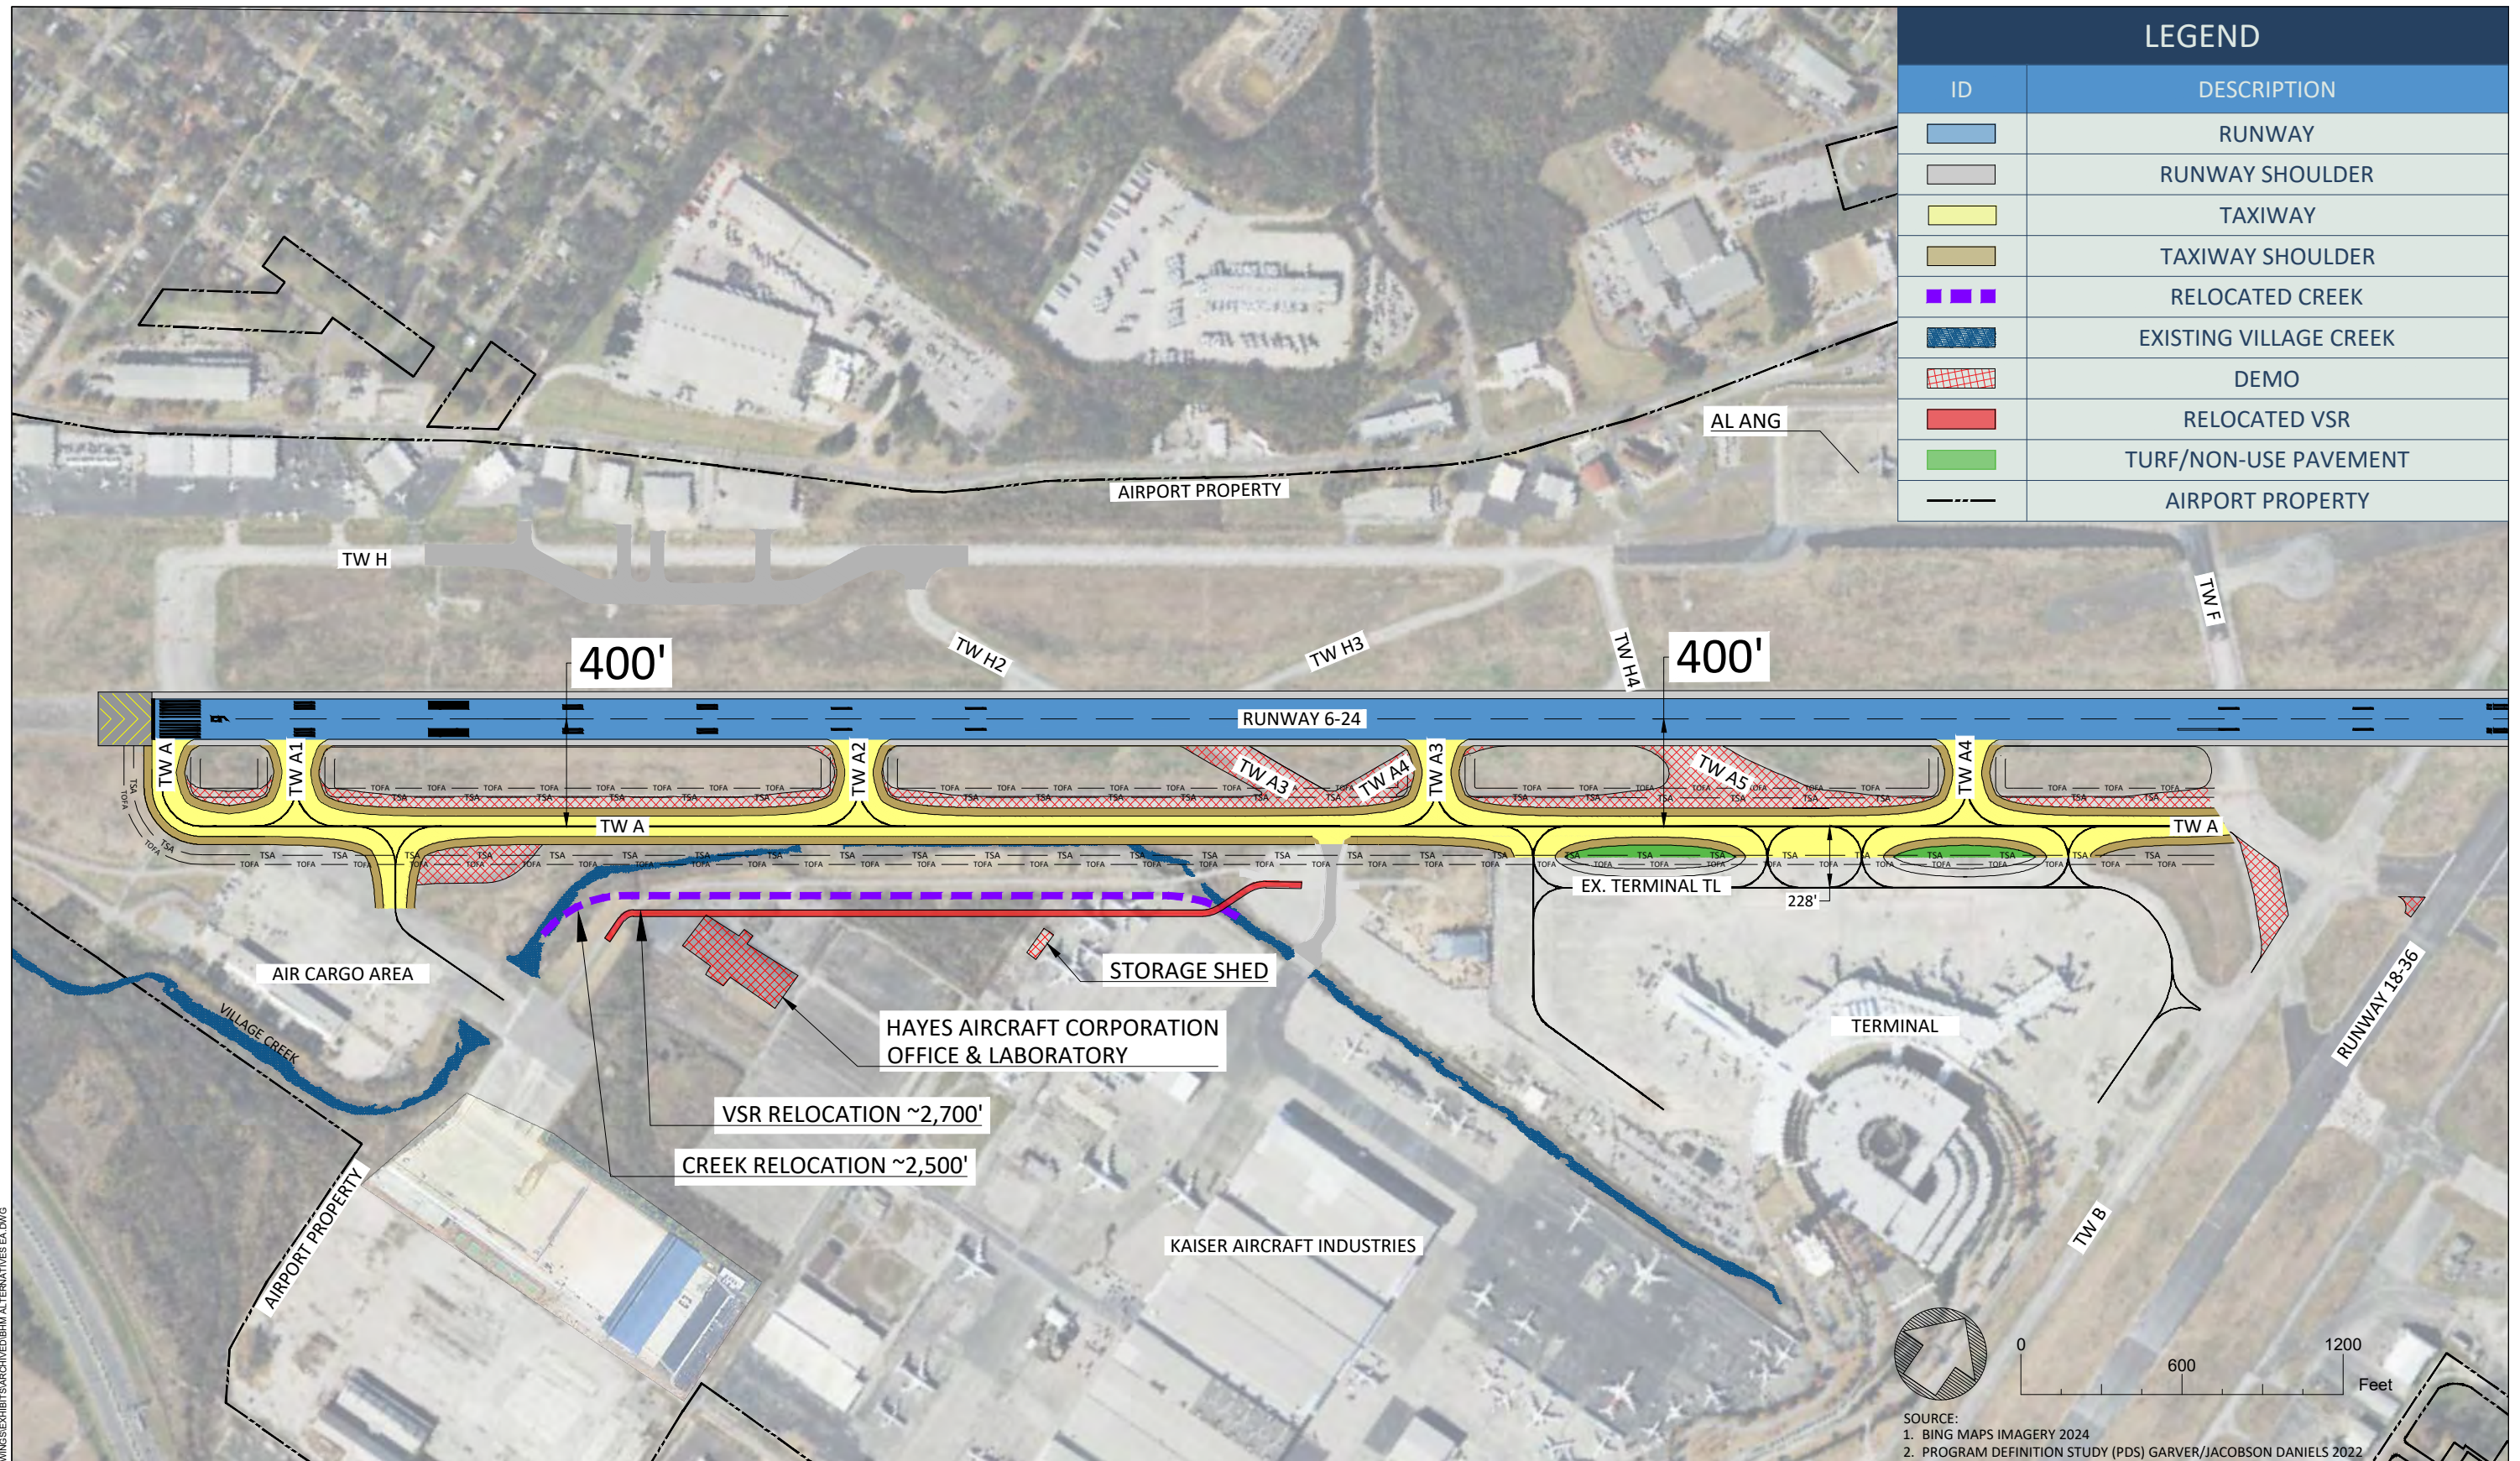
**FIGURE B2** ALTERNATIVE 2: VILLAGE CREEK RELOCATION  
AND TAXIWAY A RELOCATION TO 400 FEET

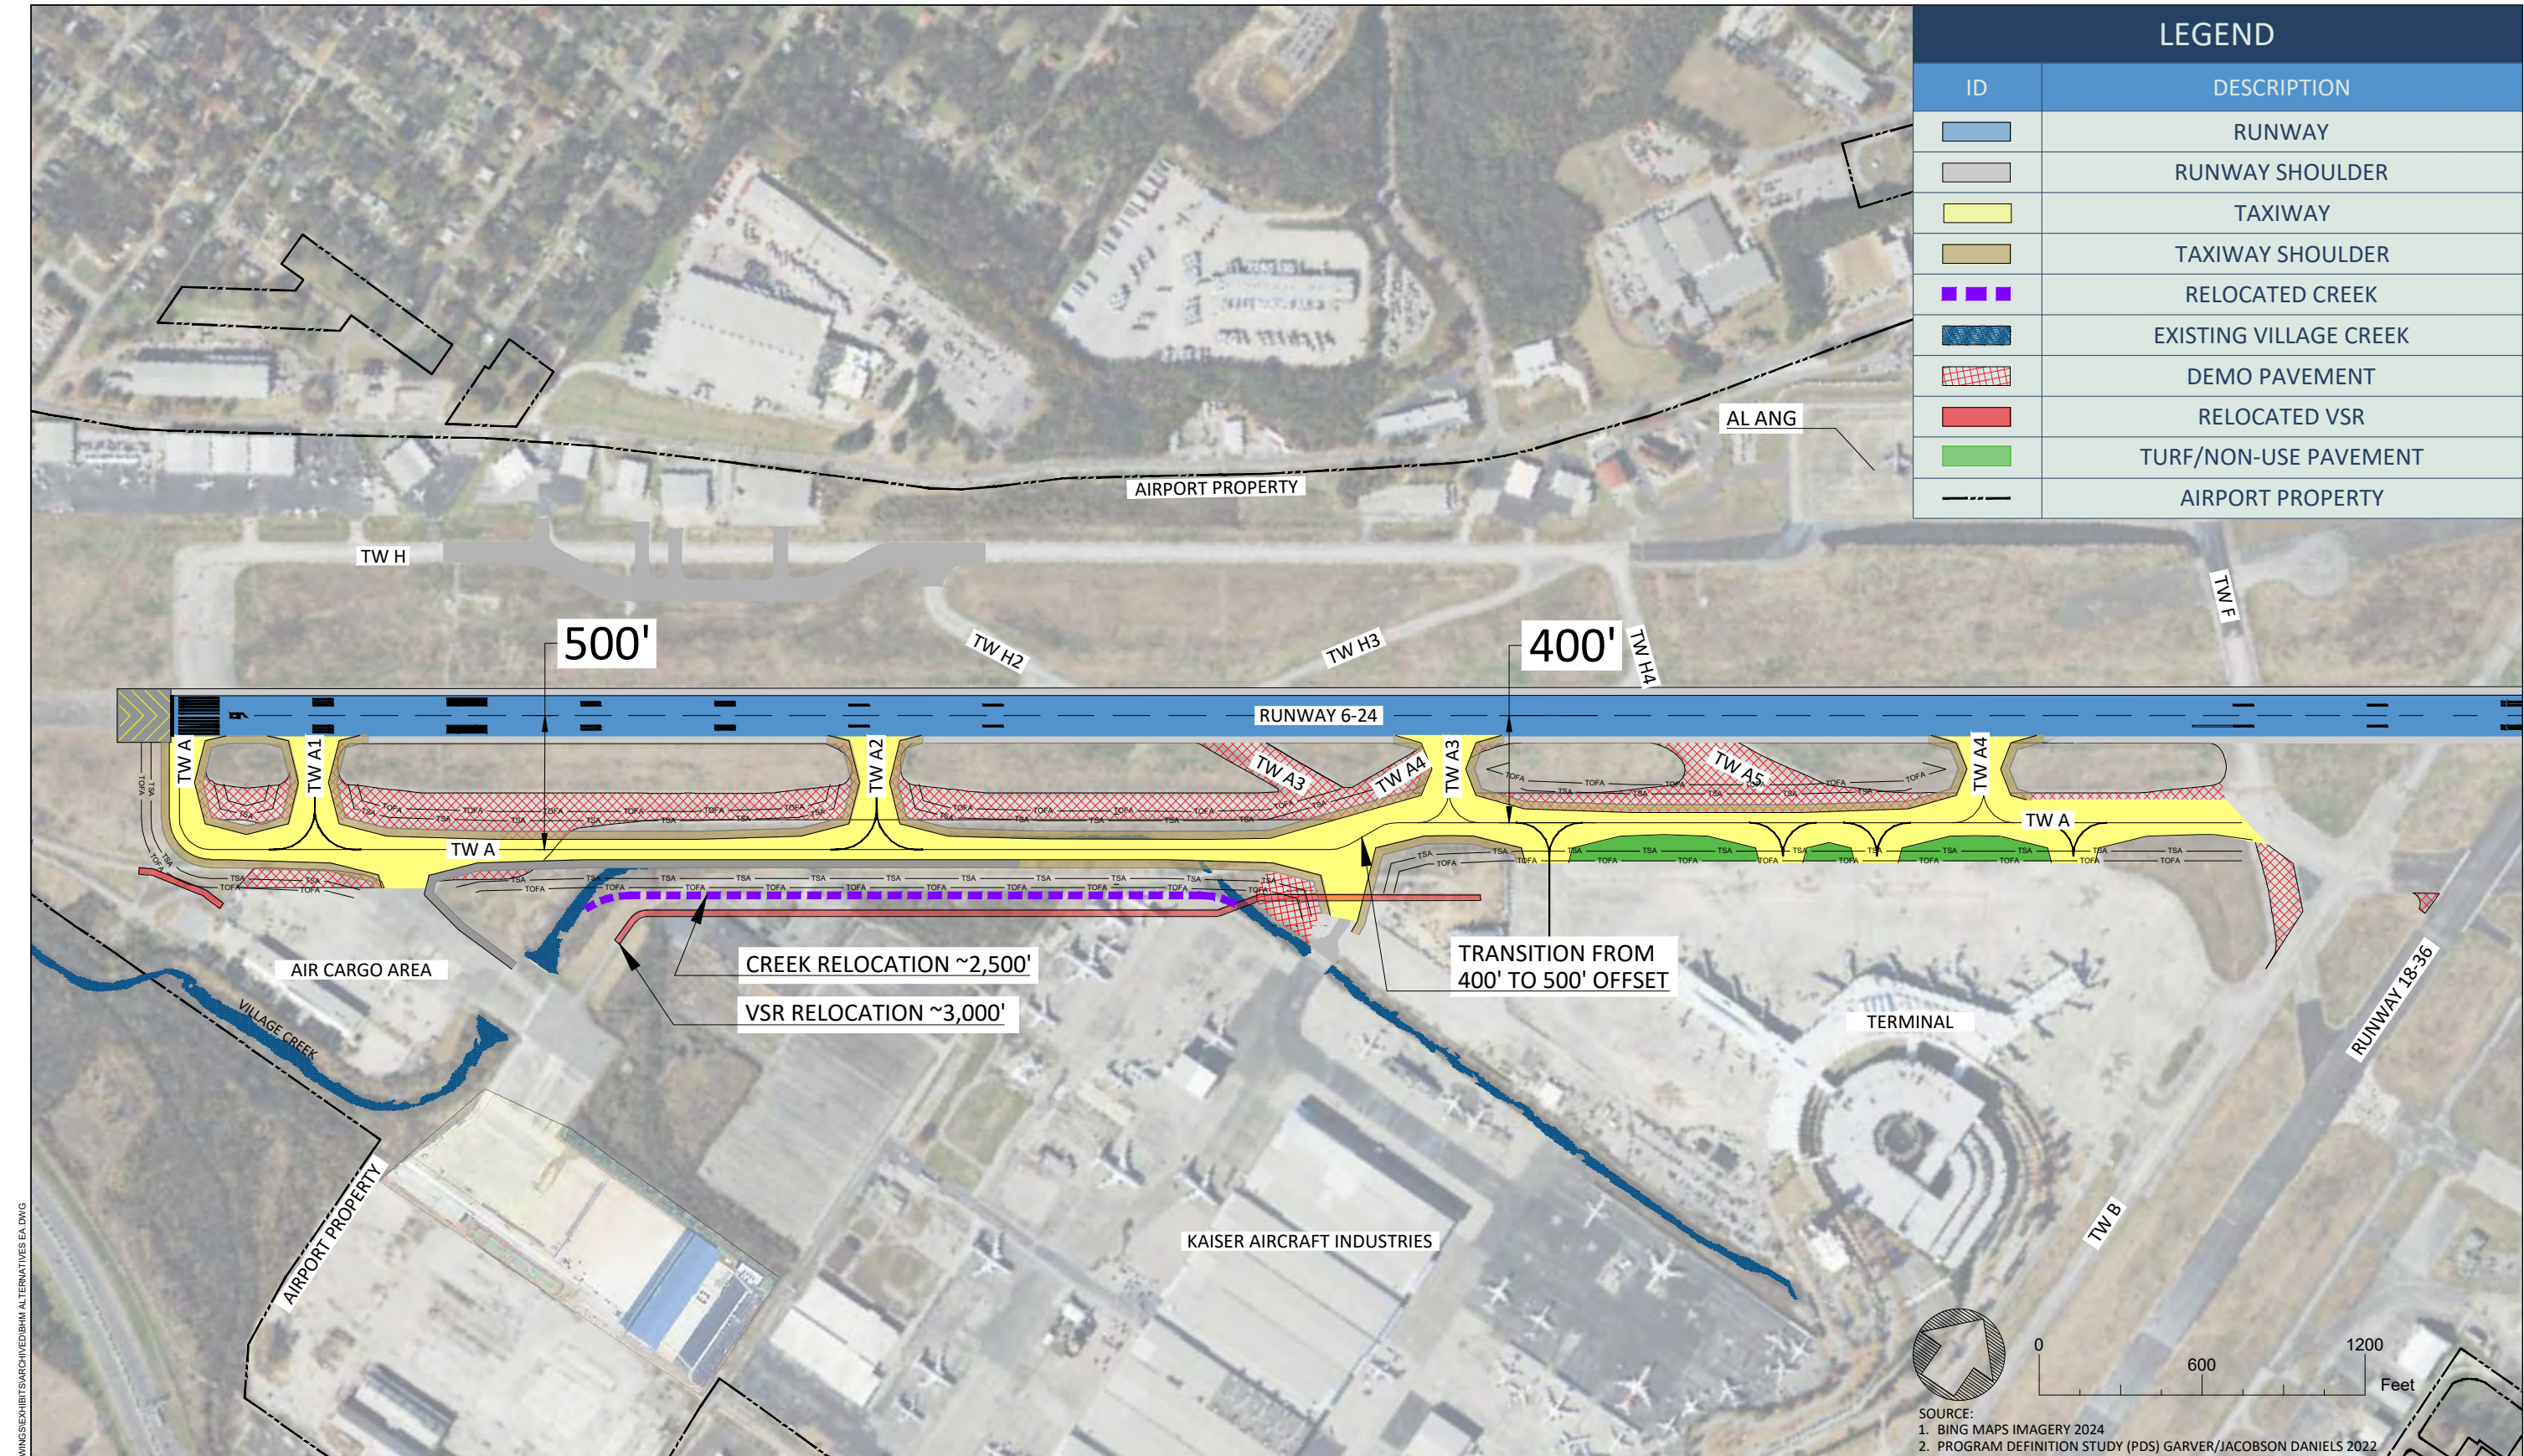
**FIGURE B6** ALTERNATIVE 5: VILLAGE CREEK RELOCATION  
AND HYBRID 400'/500' TAXIWAY A RELOCATION

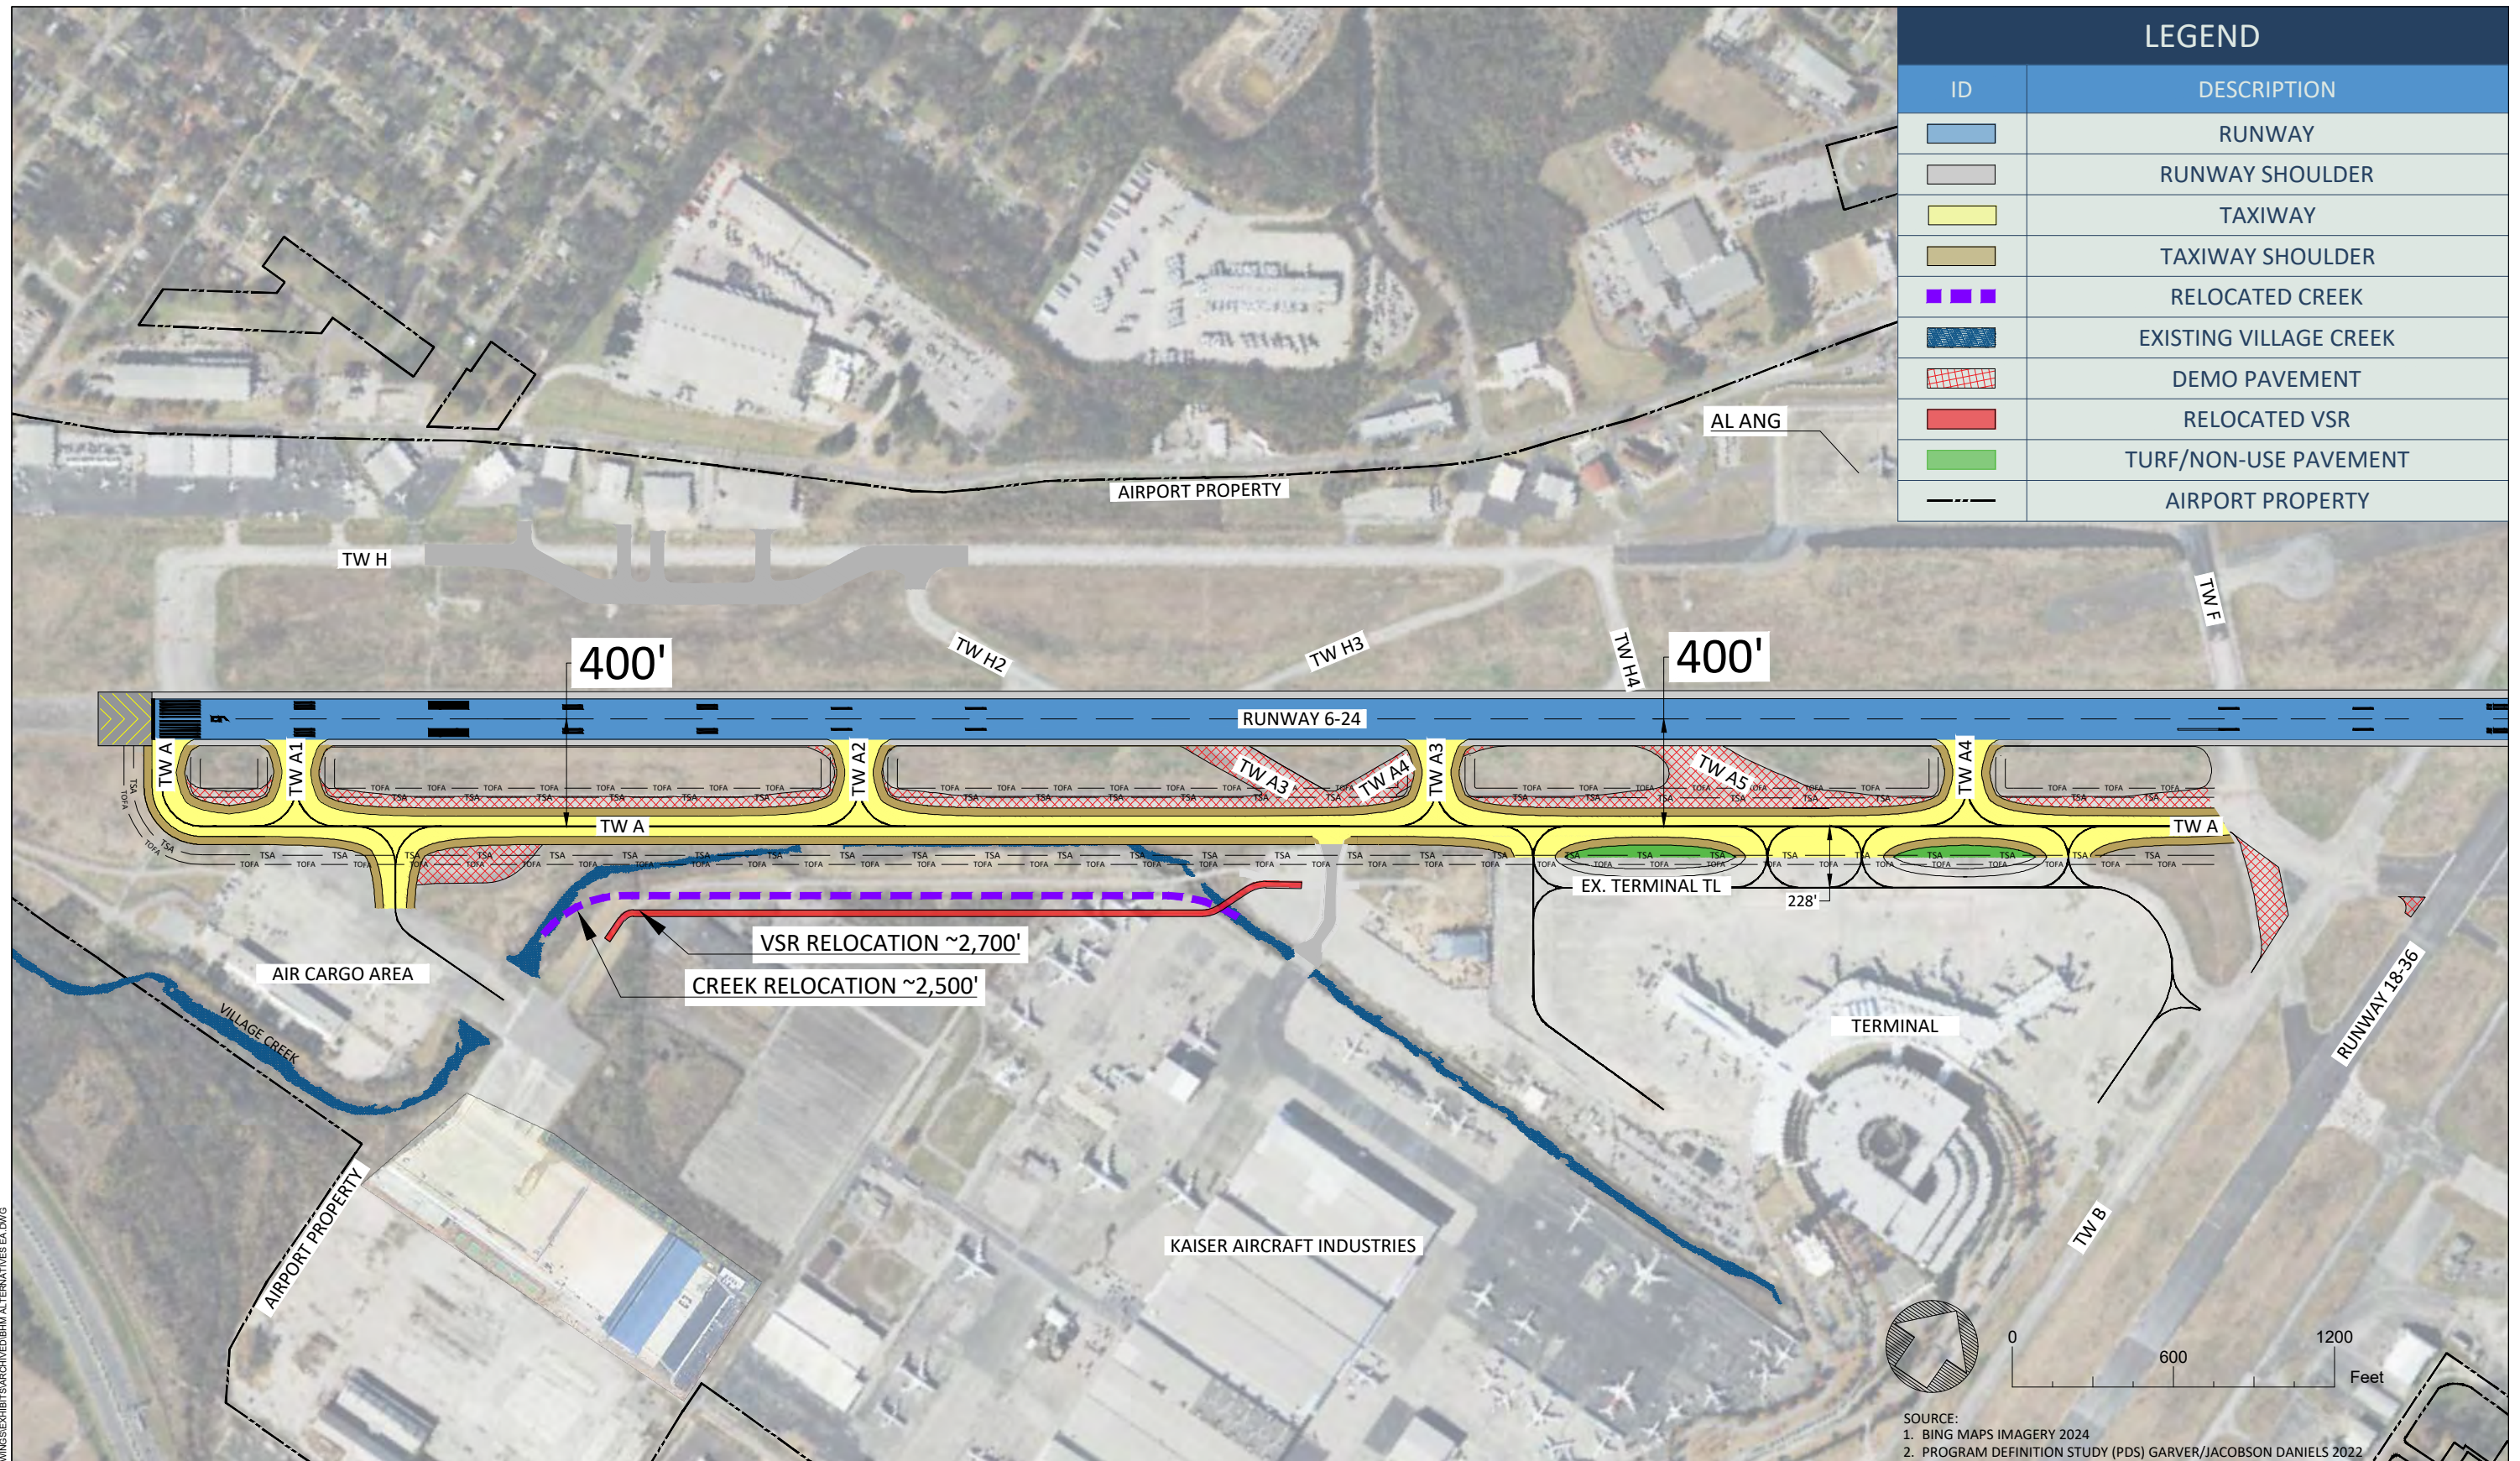
**FIGURE B2** ALTERNATIVE 2: VILLAGE CREEK RELOCATION  
AND TAXIWAY A RELOCATION TO 400 FEET

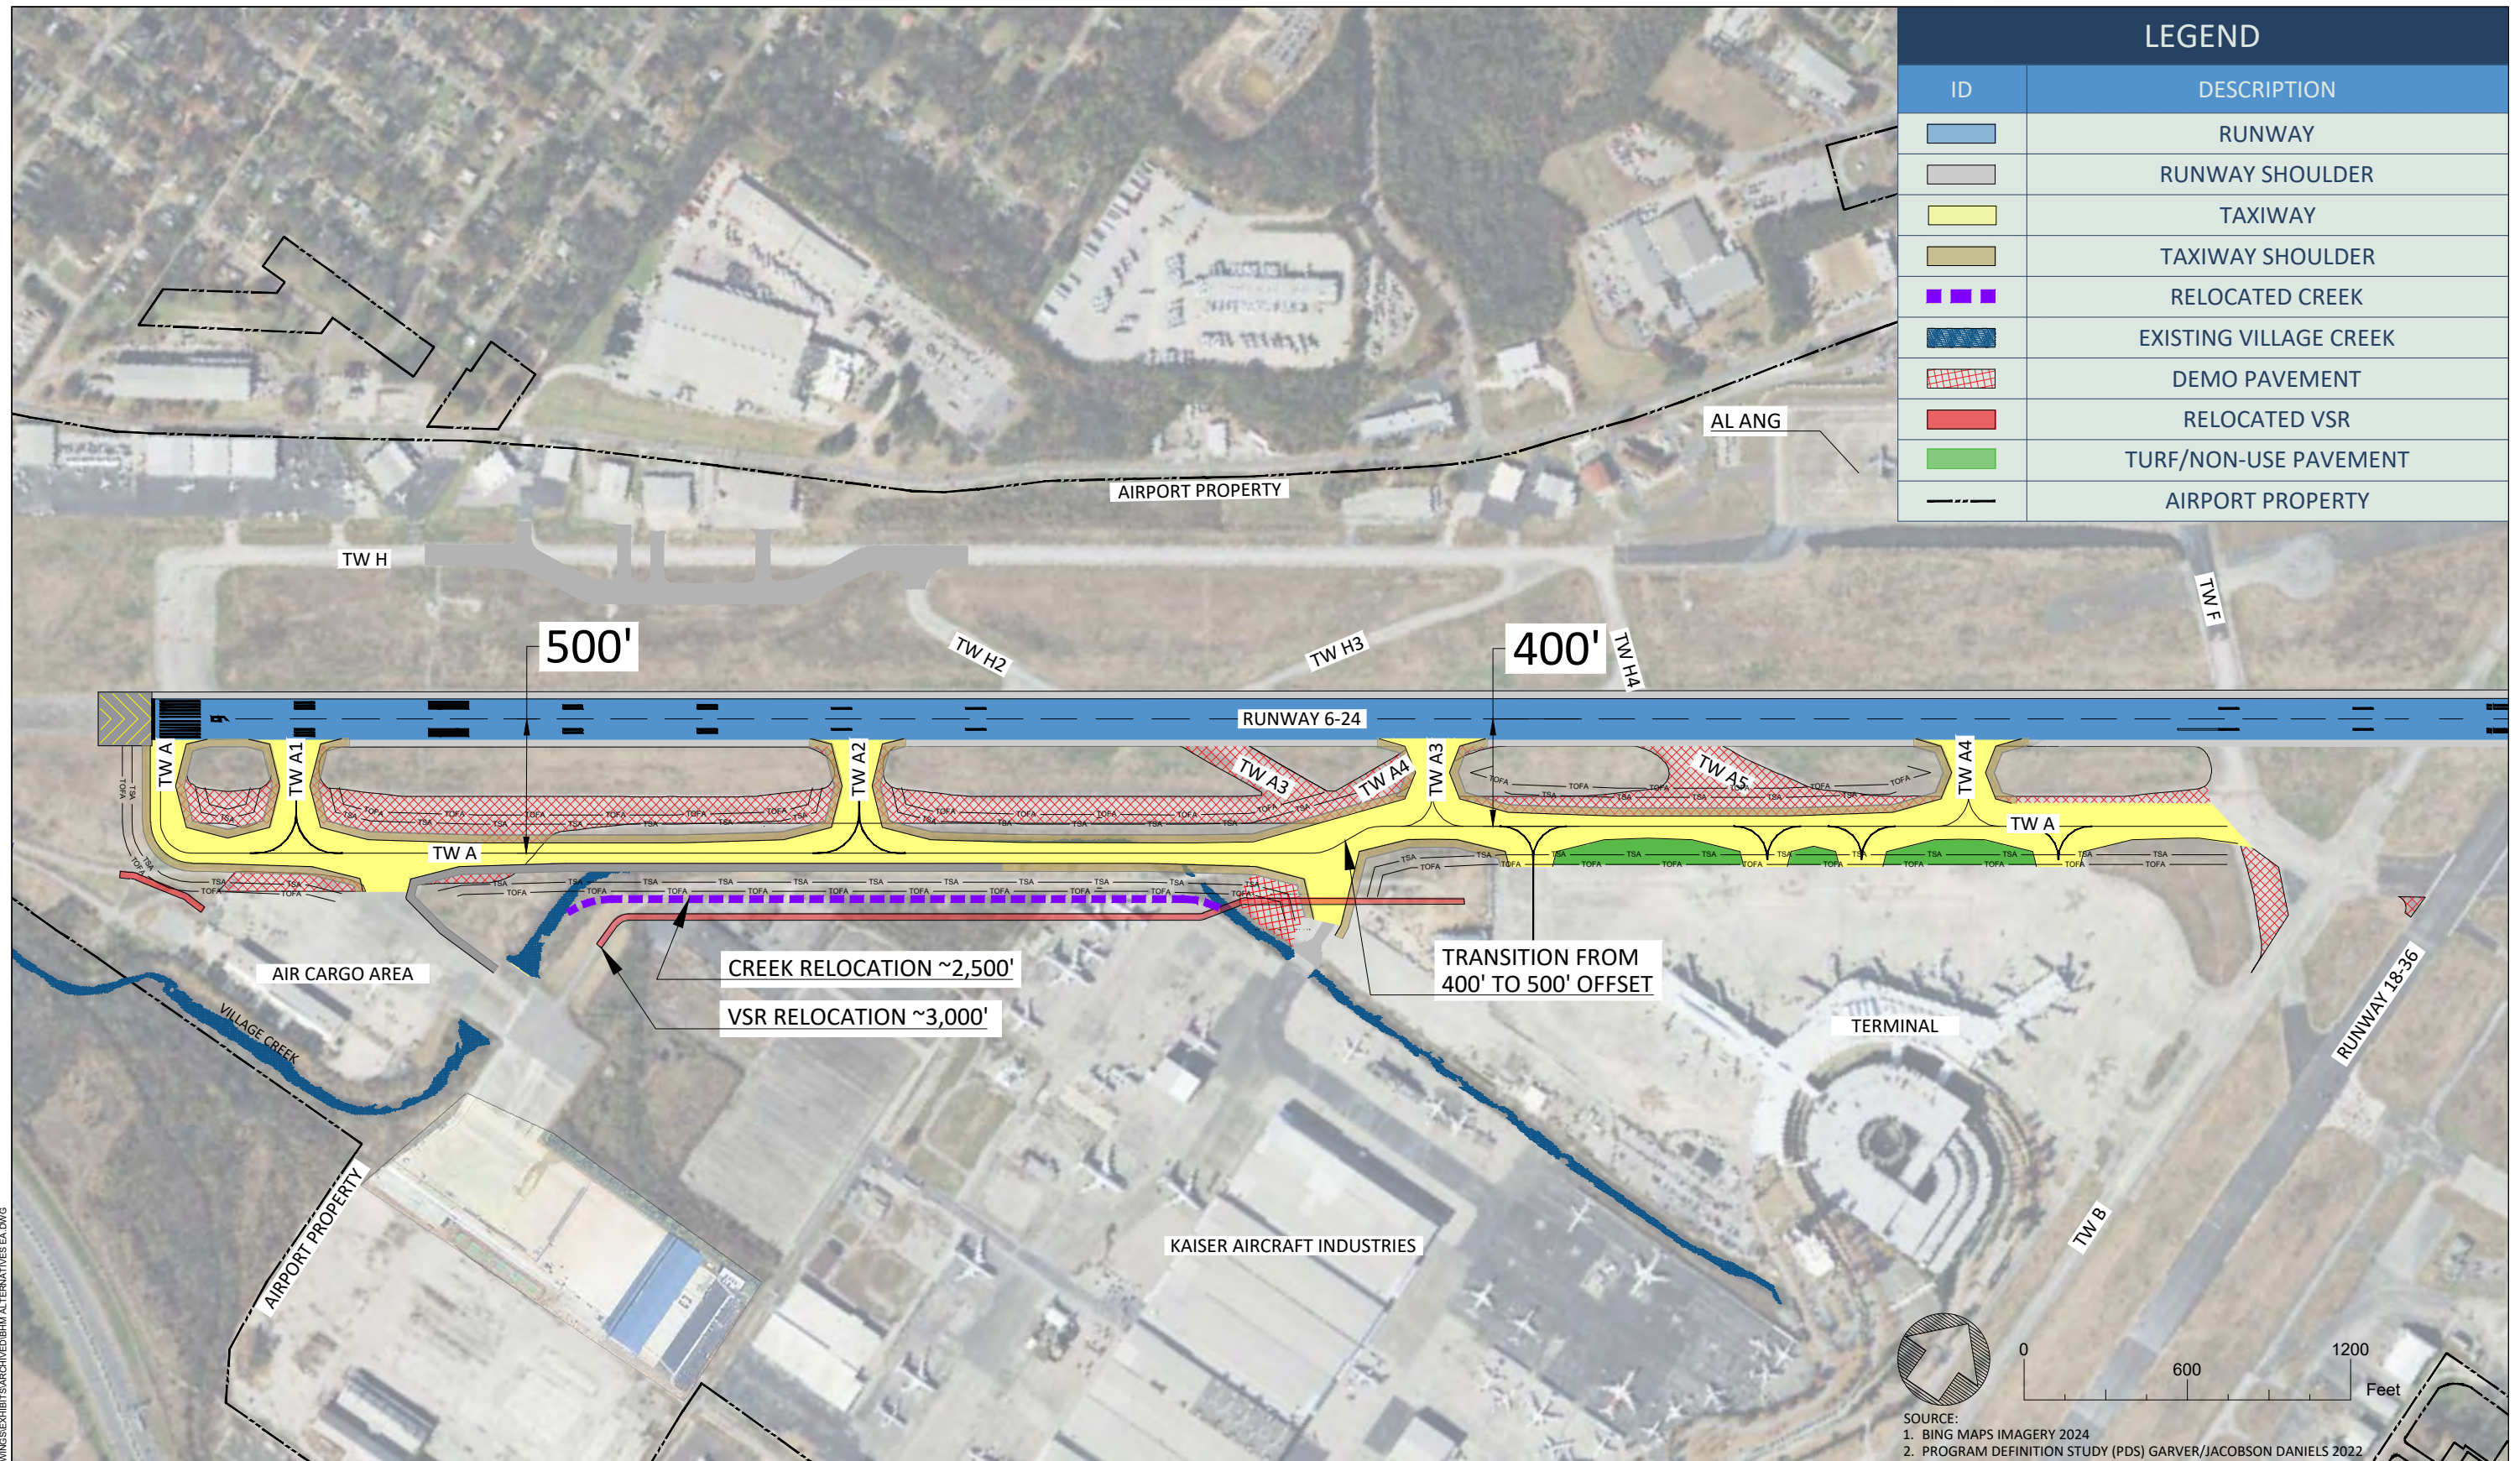
**FIGURE B6** ALTERNATIVE 5: VILLAGE CREEK RELOCATION  
AND HYBRID 400'/500' TAXIWAY A RELOCATION

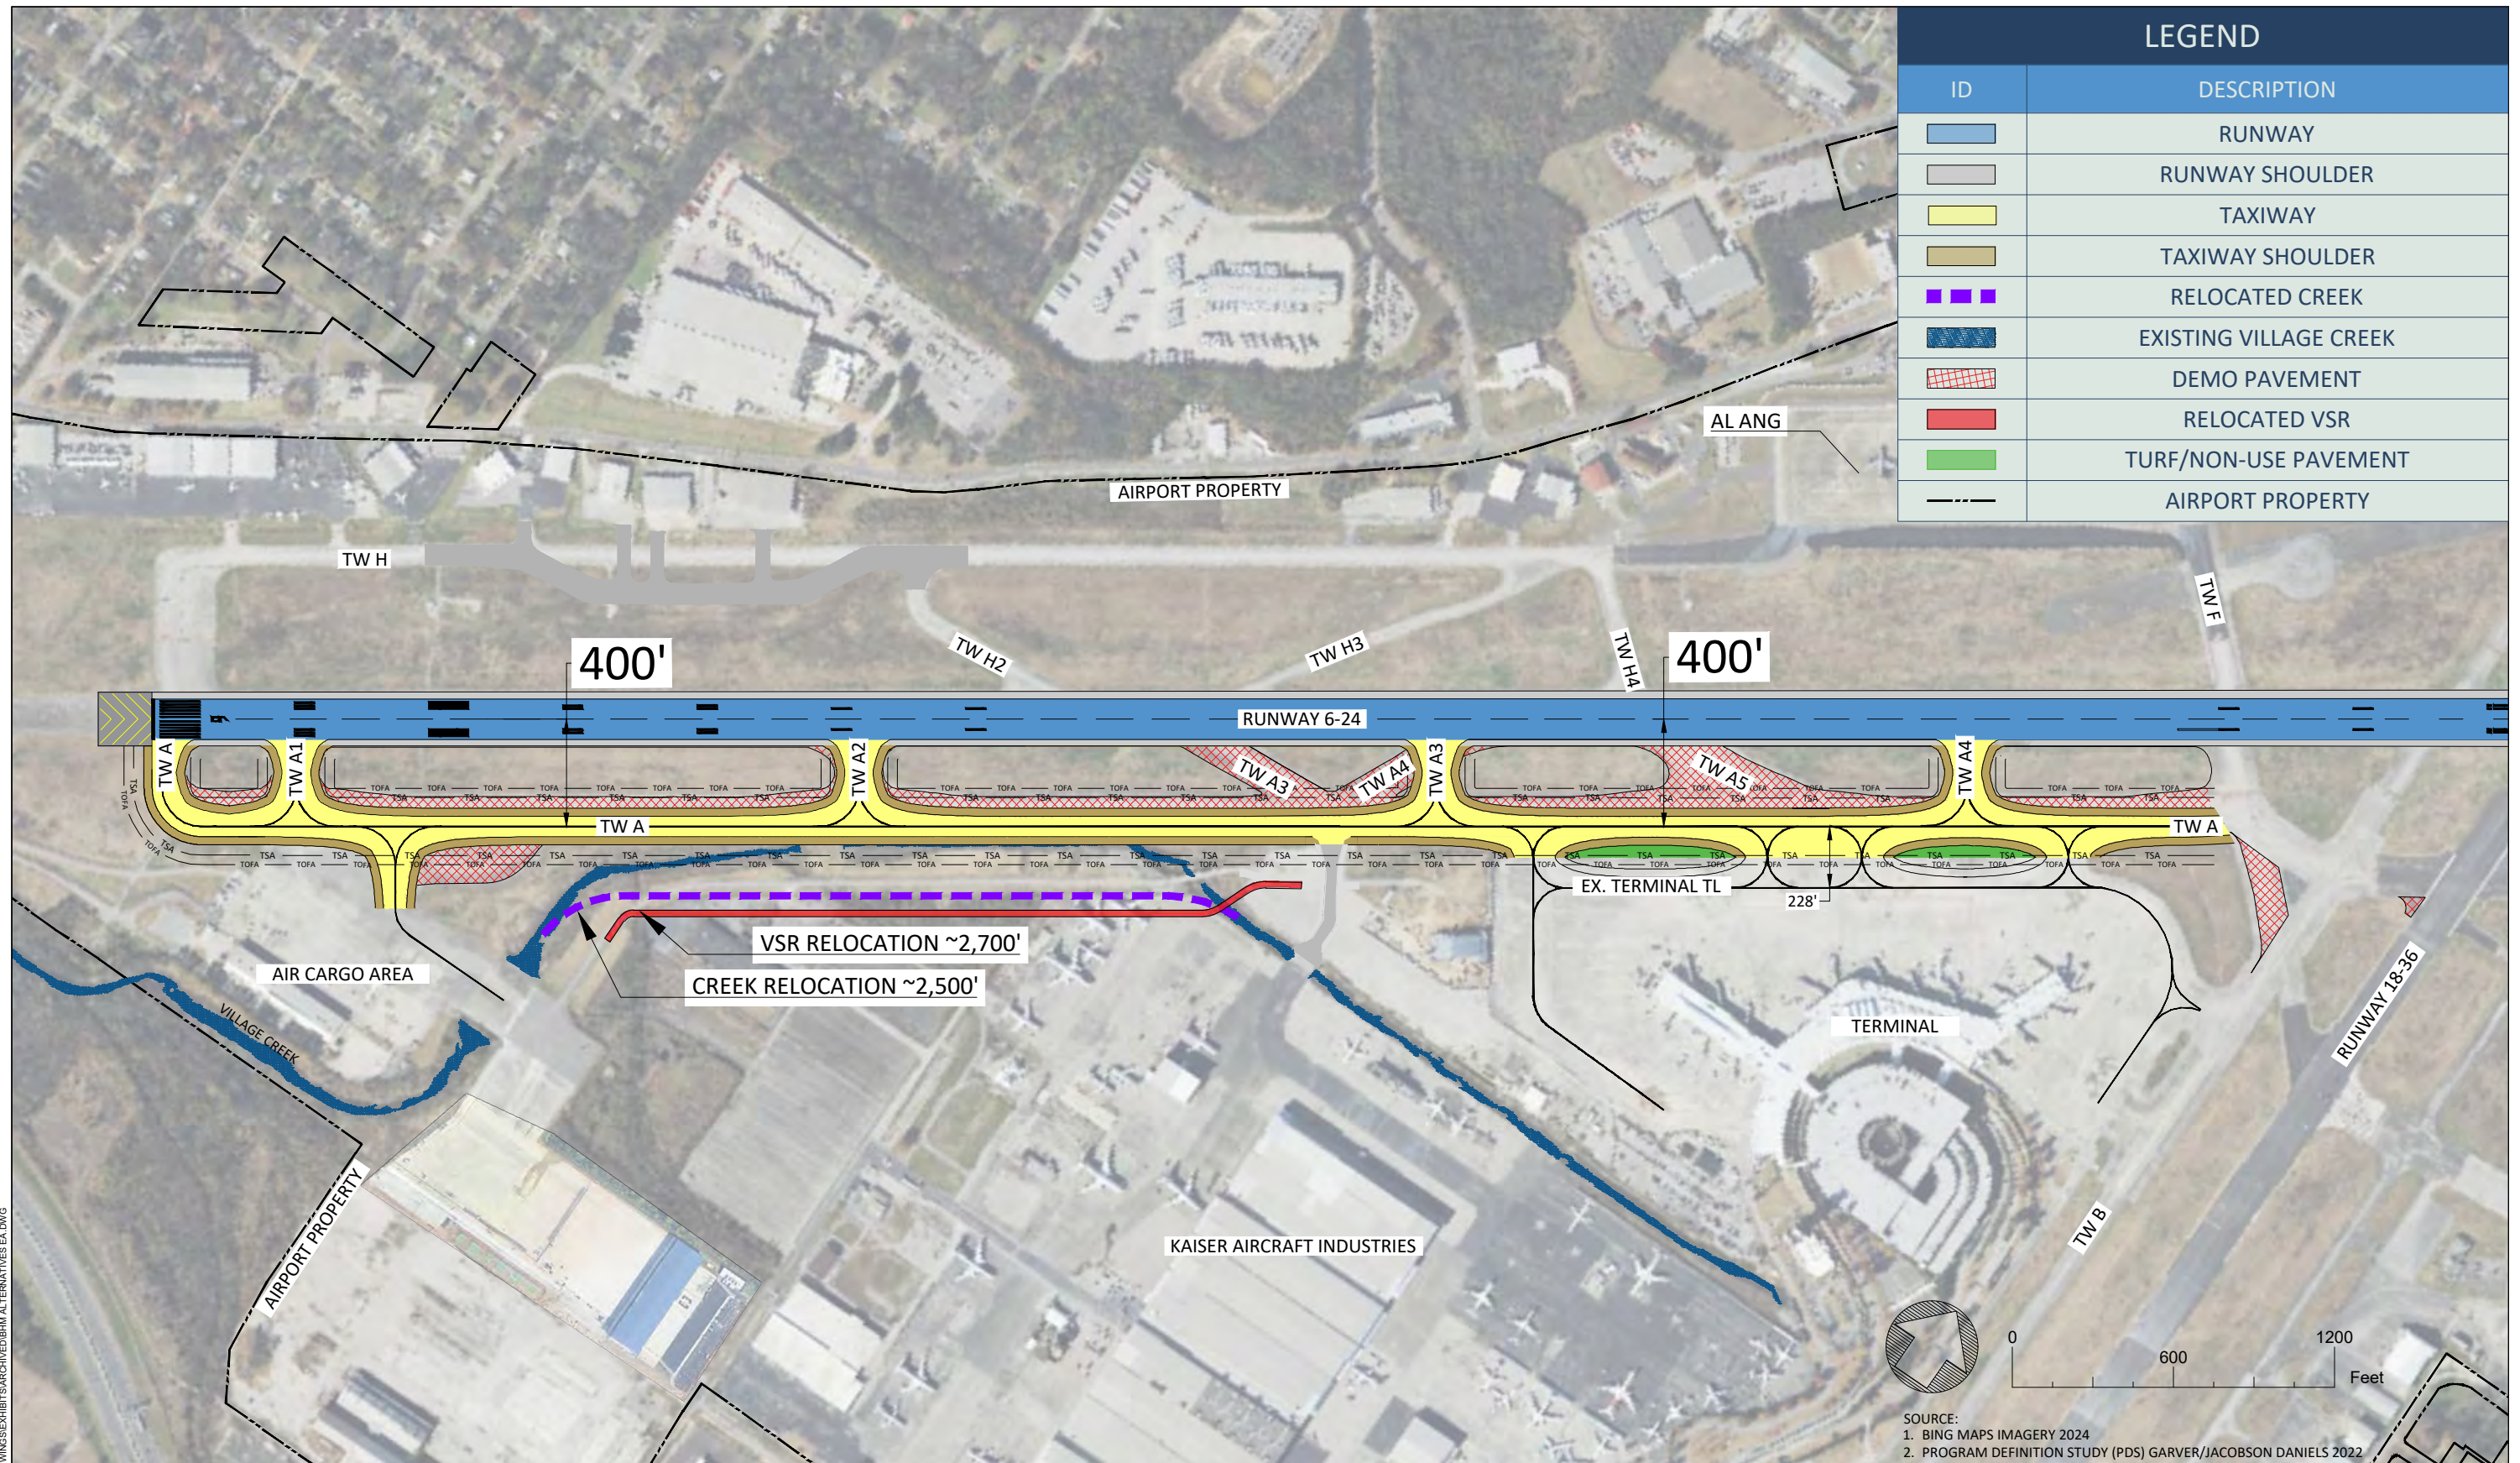
**FIGURE B2** ALTERNATIVE 2: VILLAGE CREEK RELOCATION  
AND TAXIWAY A RELOCATION TO 400 FEET
