APPENDIX D

**ENVIRONMENTAL  
CONSEQUENCES**

# **Aviation Emissions and Air Quality and Noise Technical Report**

## **Birmingham-Shuttlesworth International Airport Taxiway A Relocation Project Environmental Assessment**

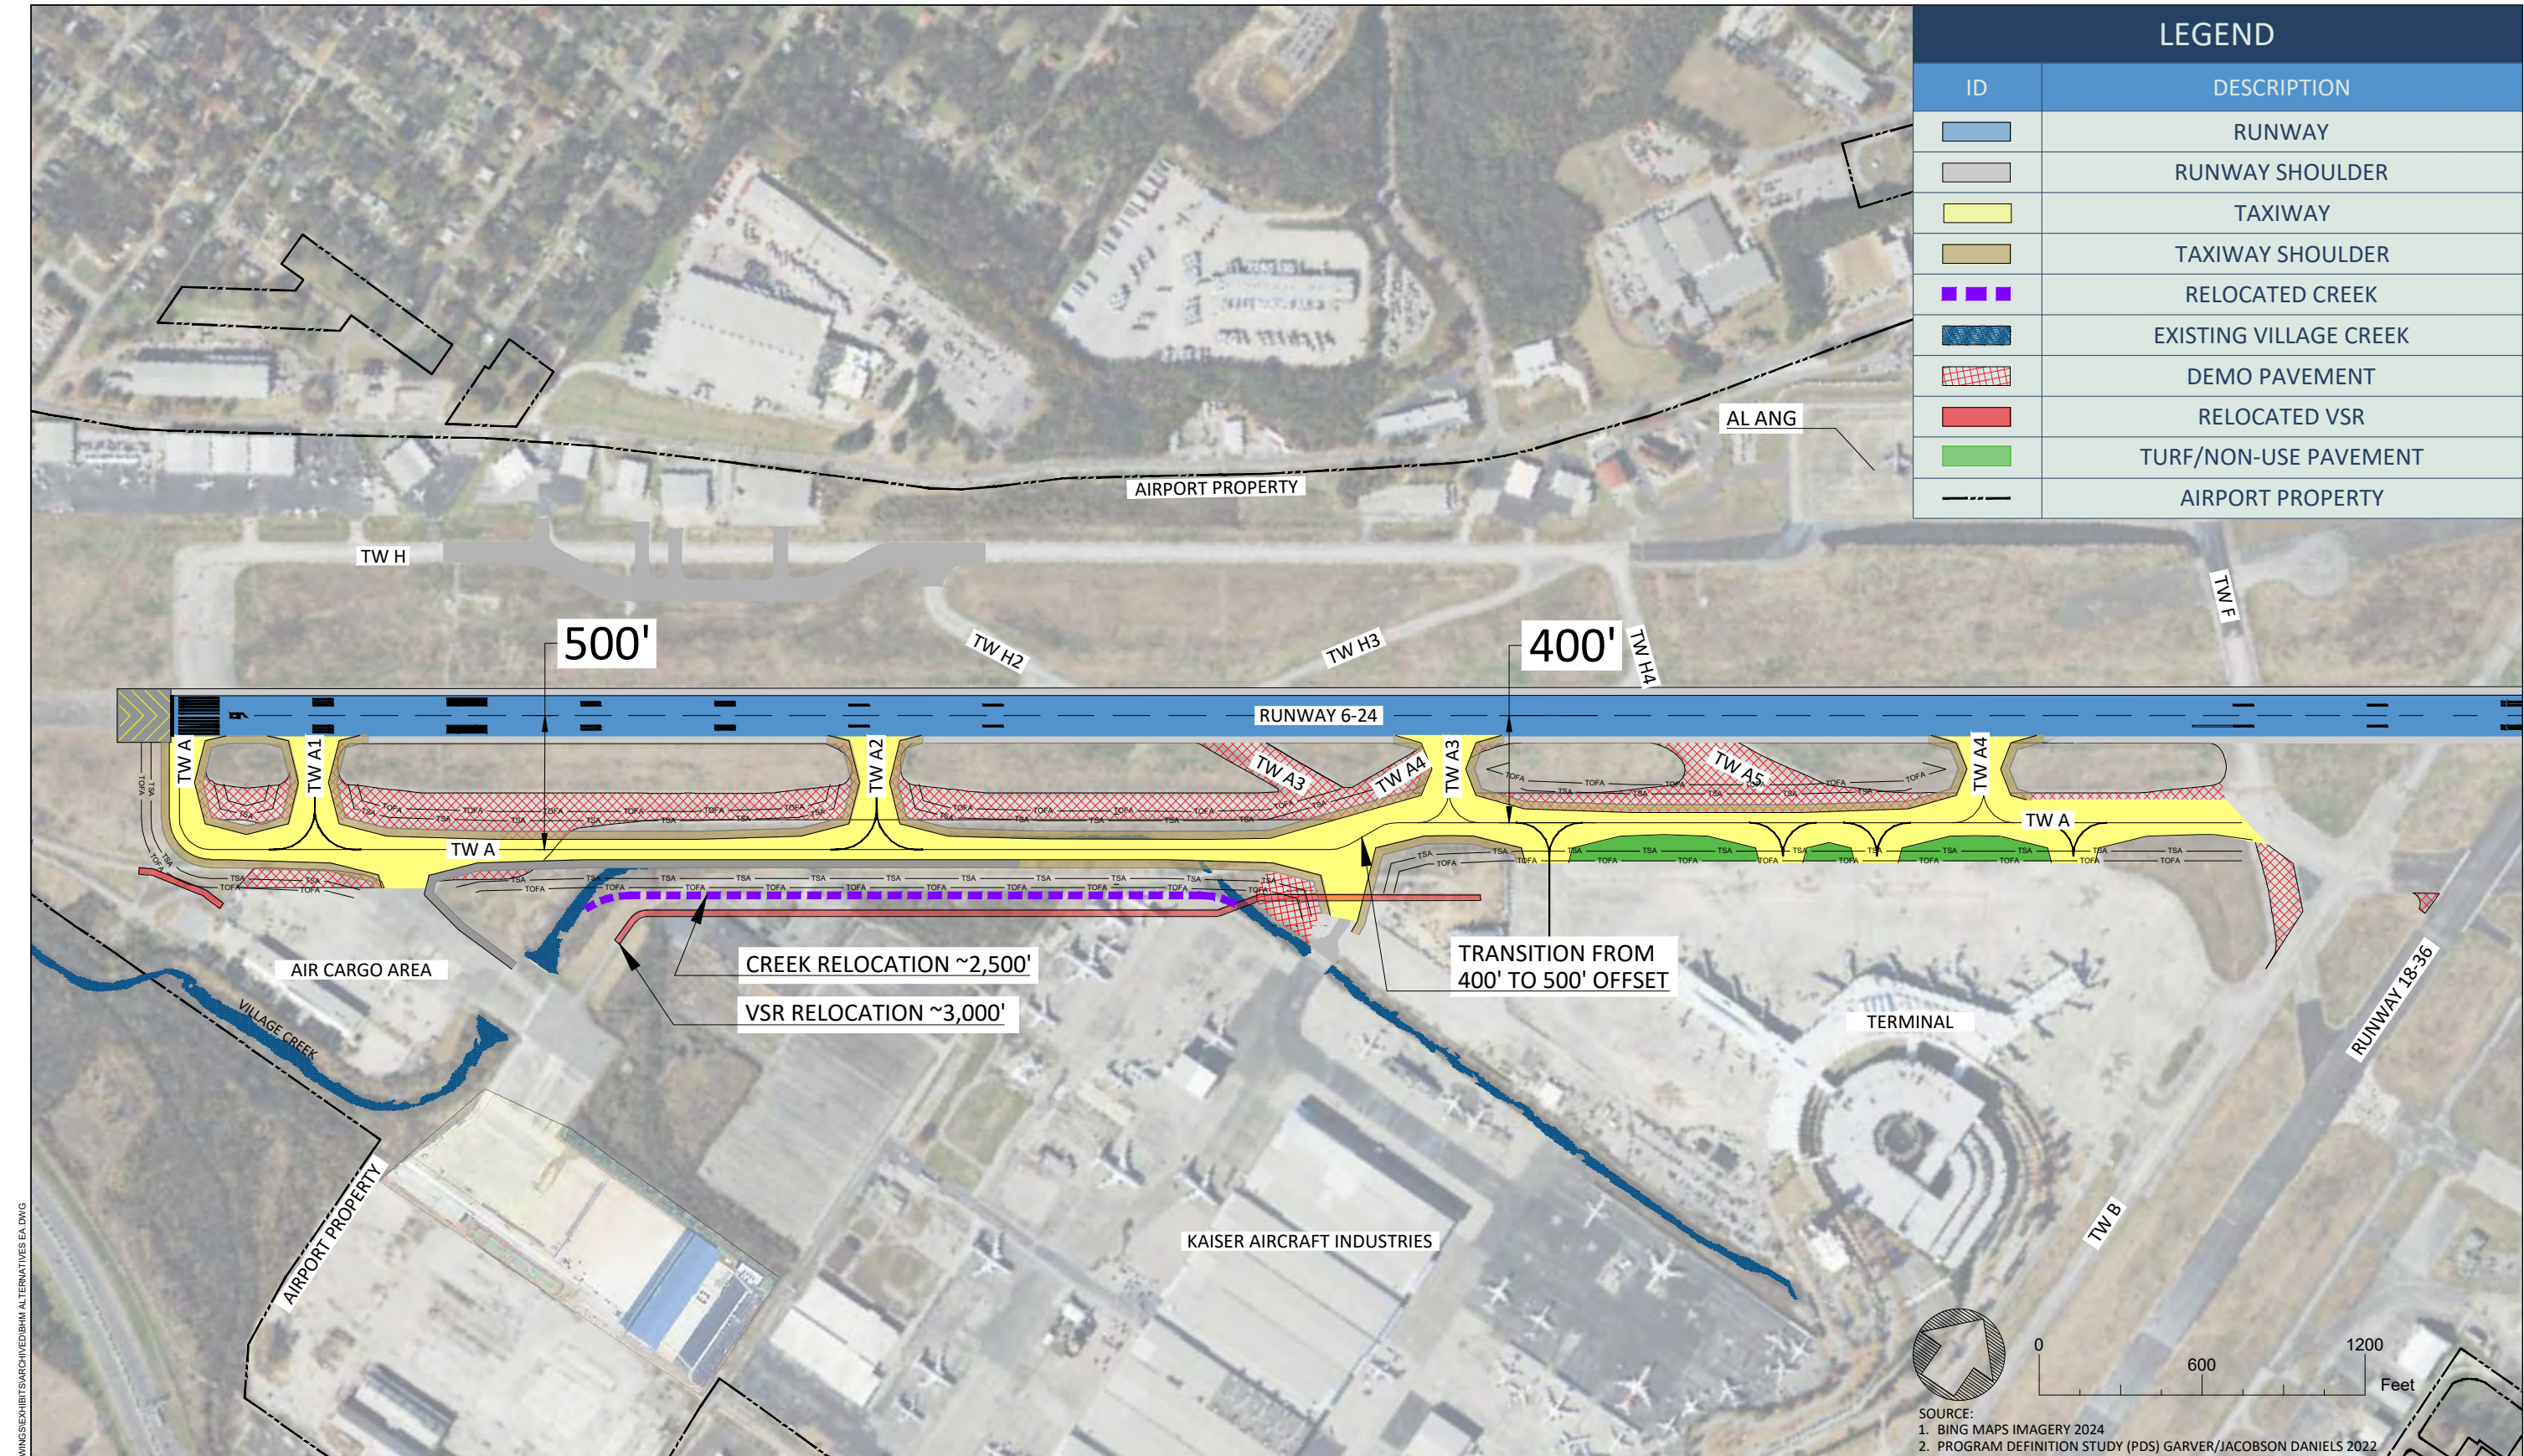
**FIGURE B6** ALTERNATIVE 5: VILLAGE CREEK RELOCATION  
AND HYBRID 400'/500' TAXIWAY A RELOCATION

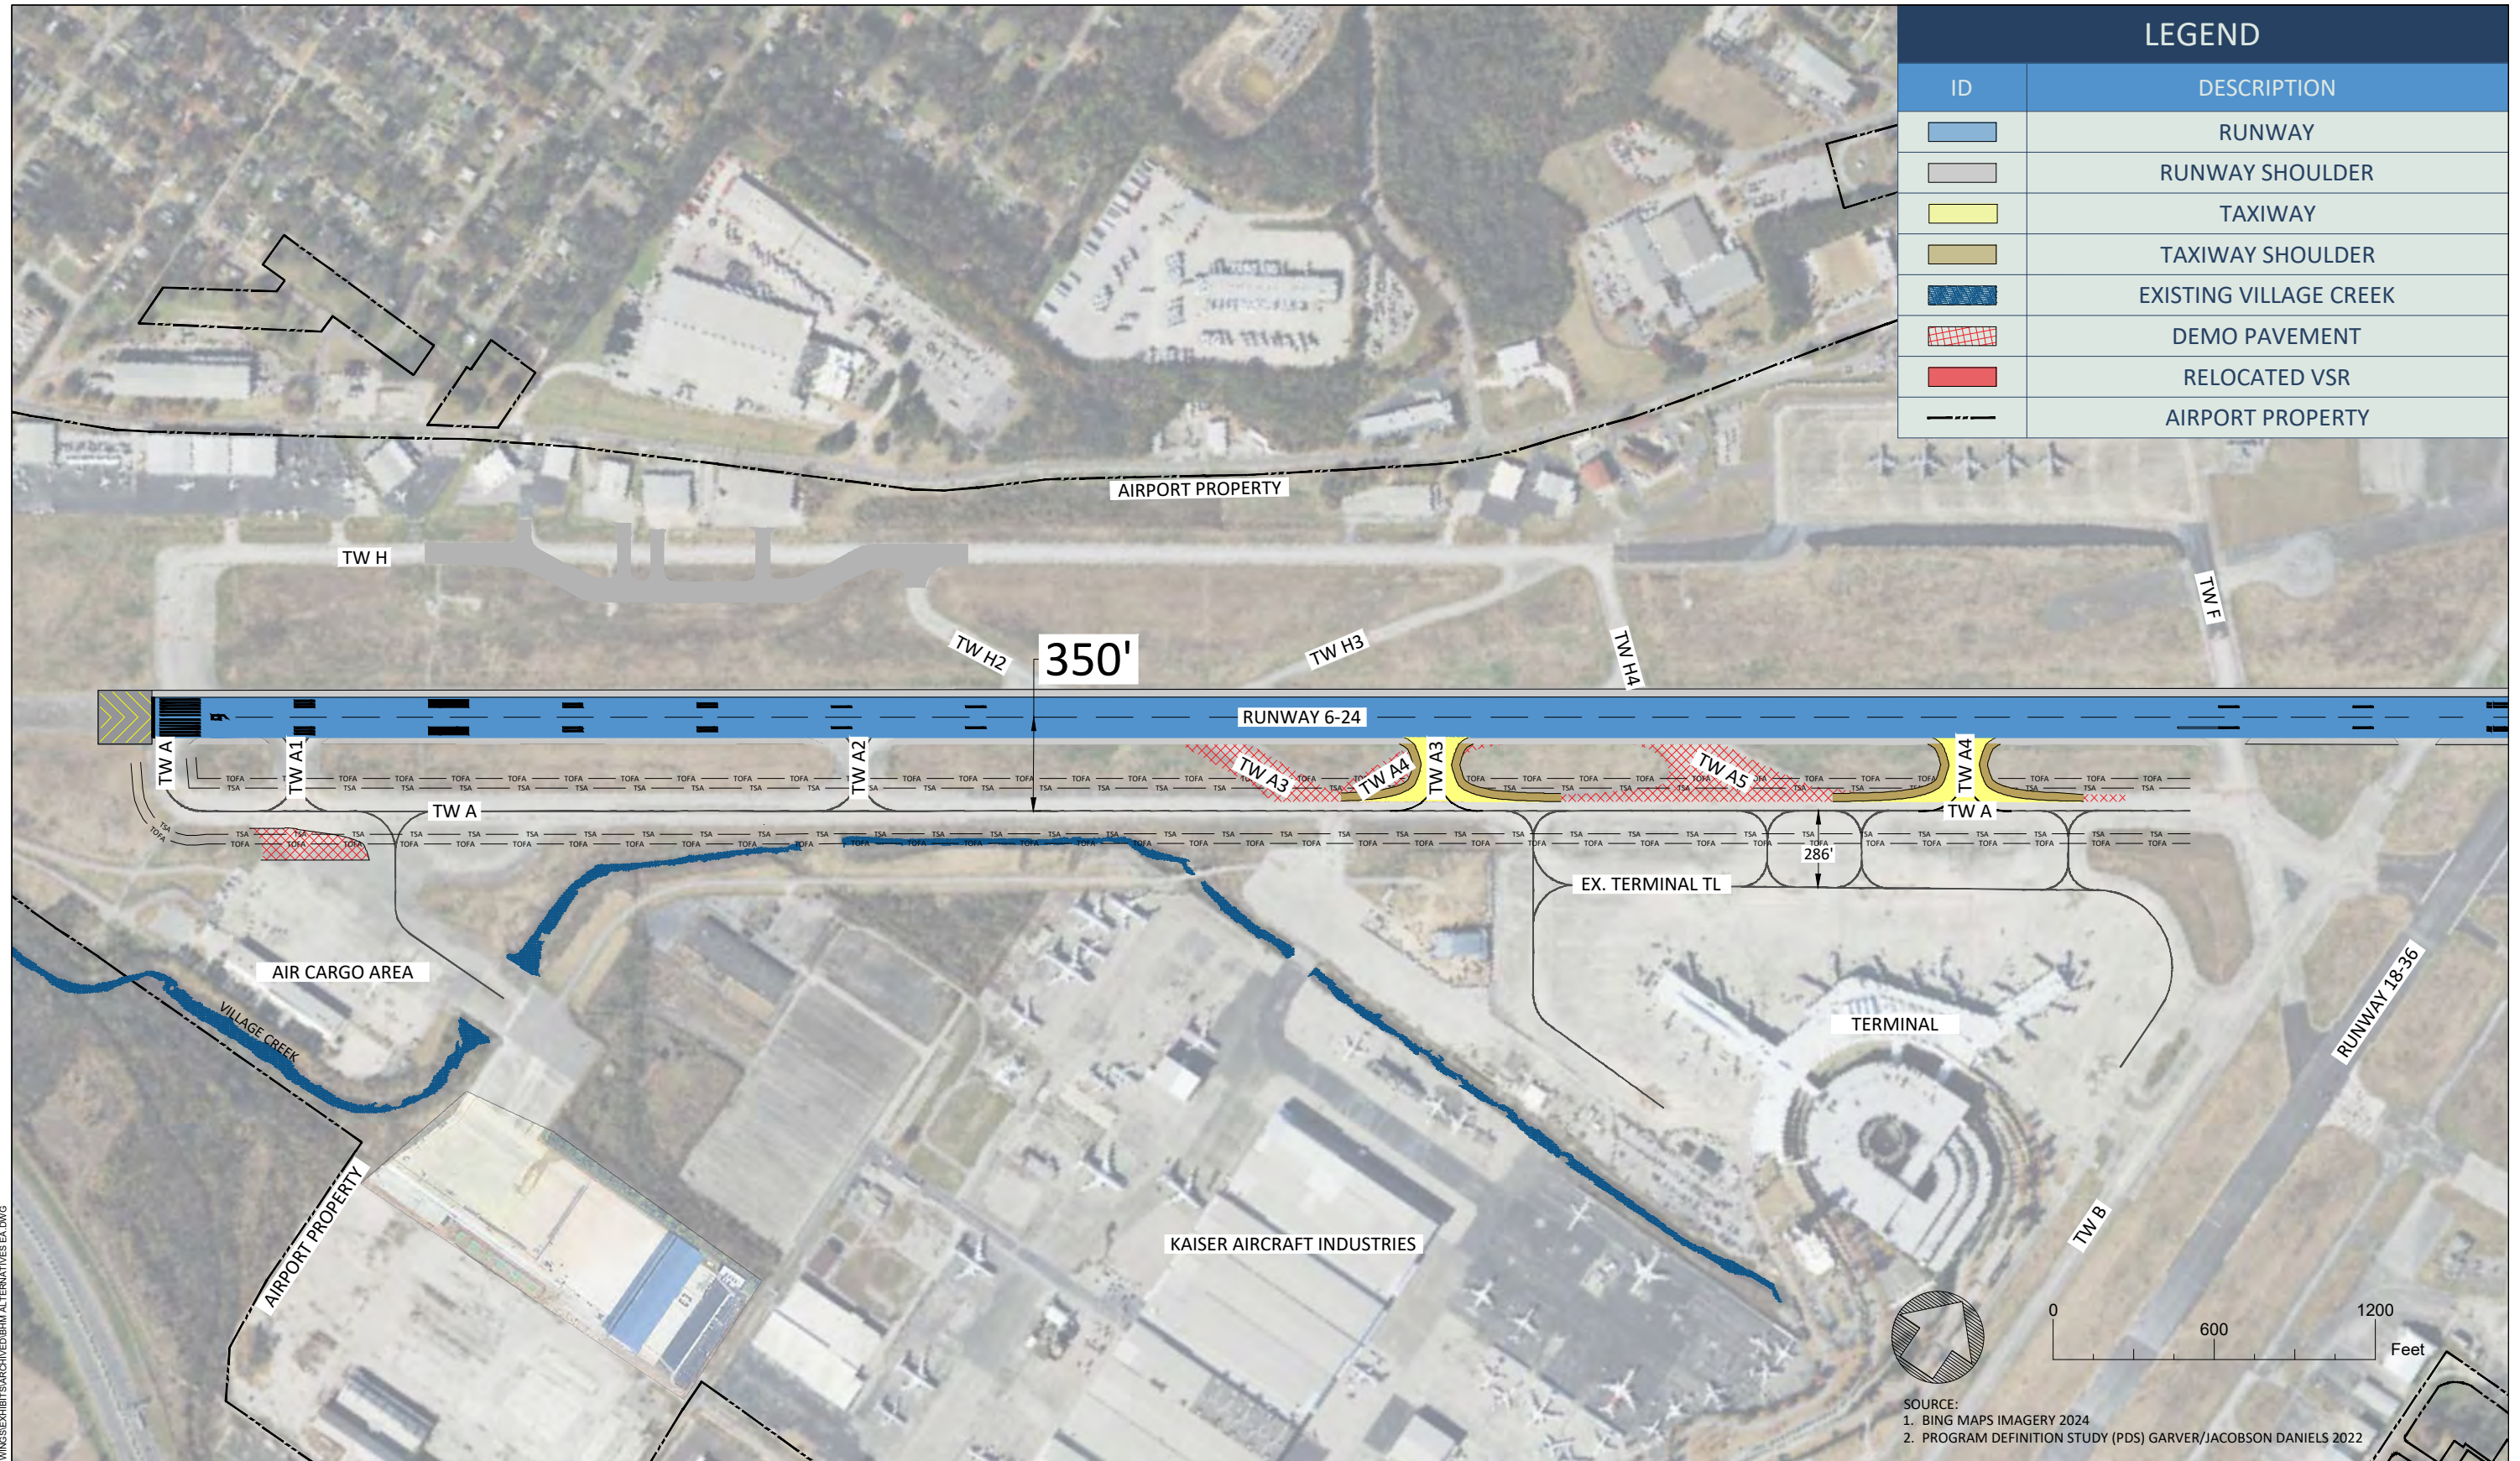
FIGURE B7 NO ACTION - REHAB AND RECONSTRUCT IN CURRENT LOCATION

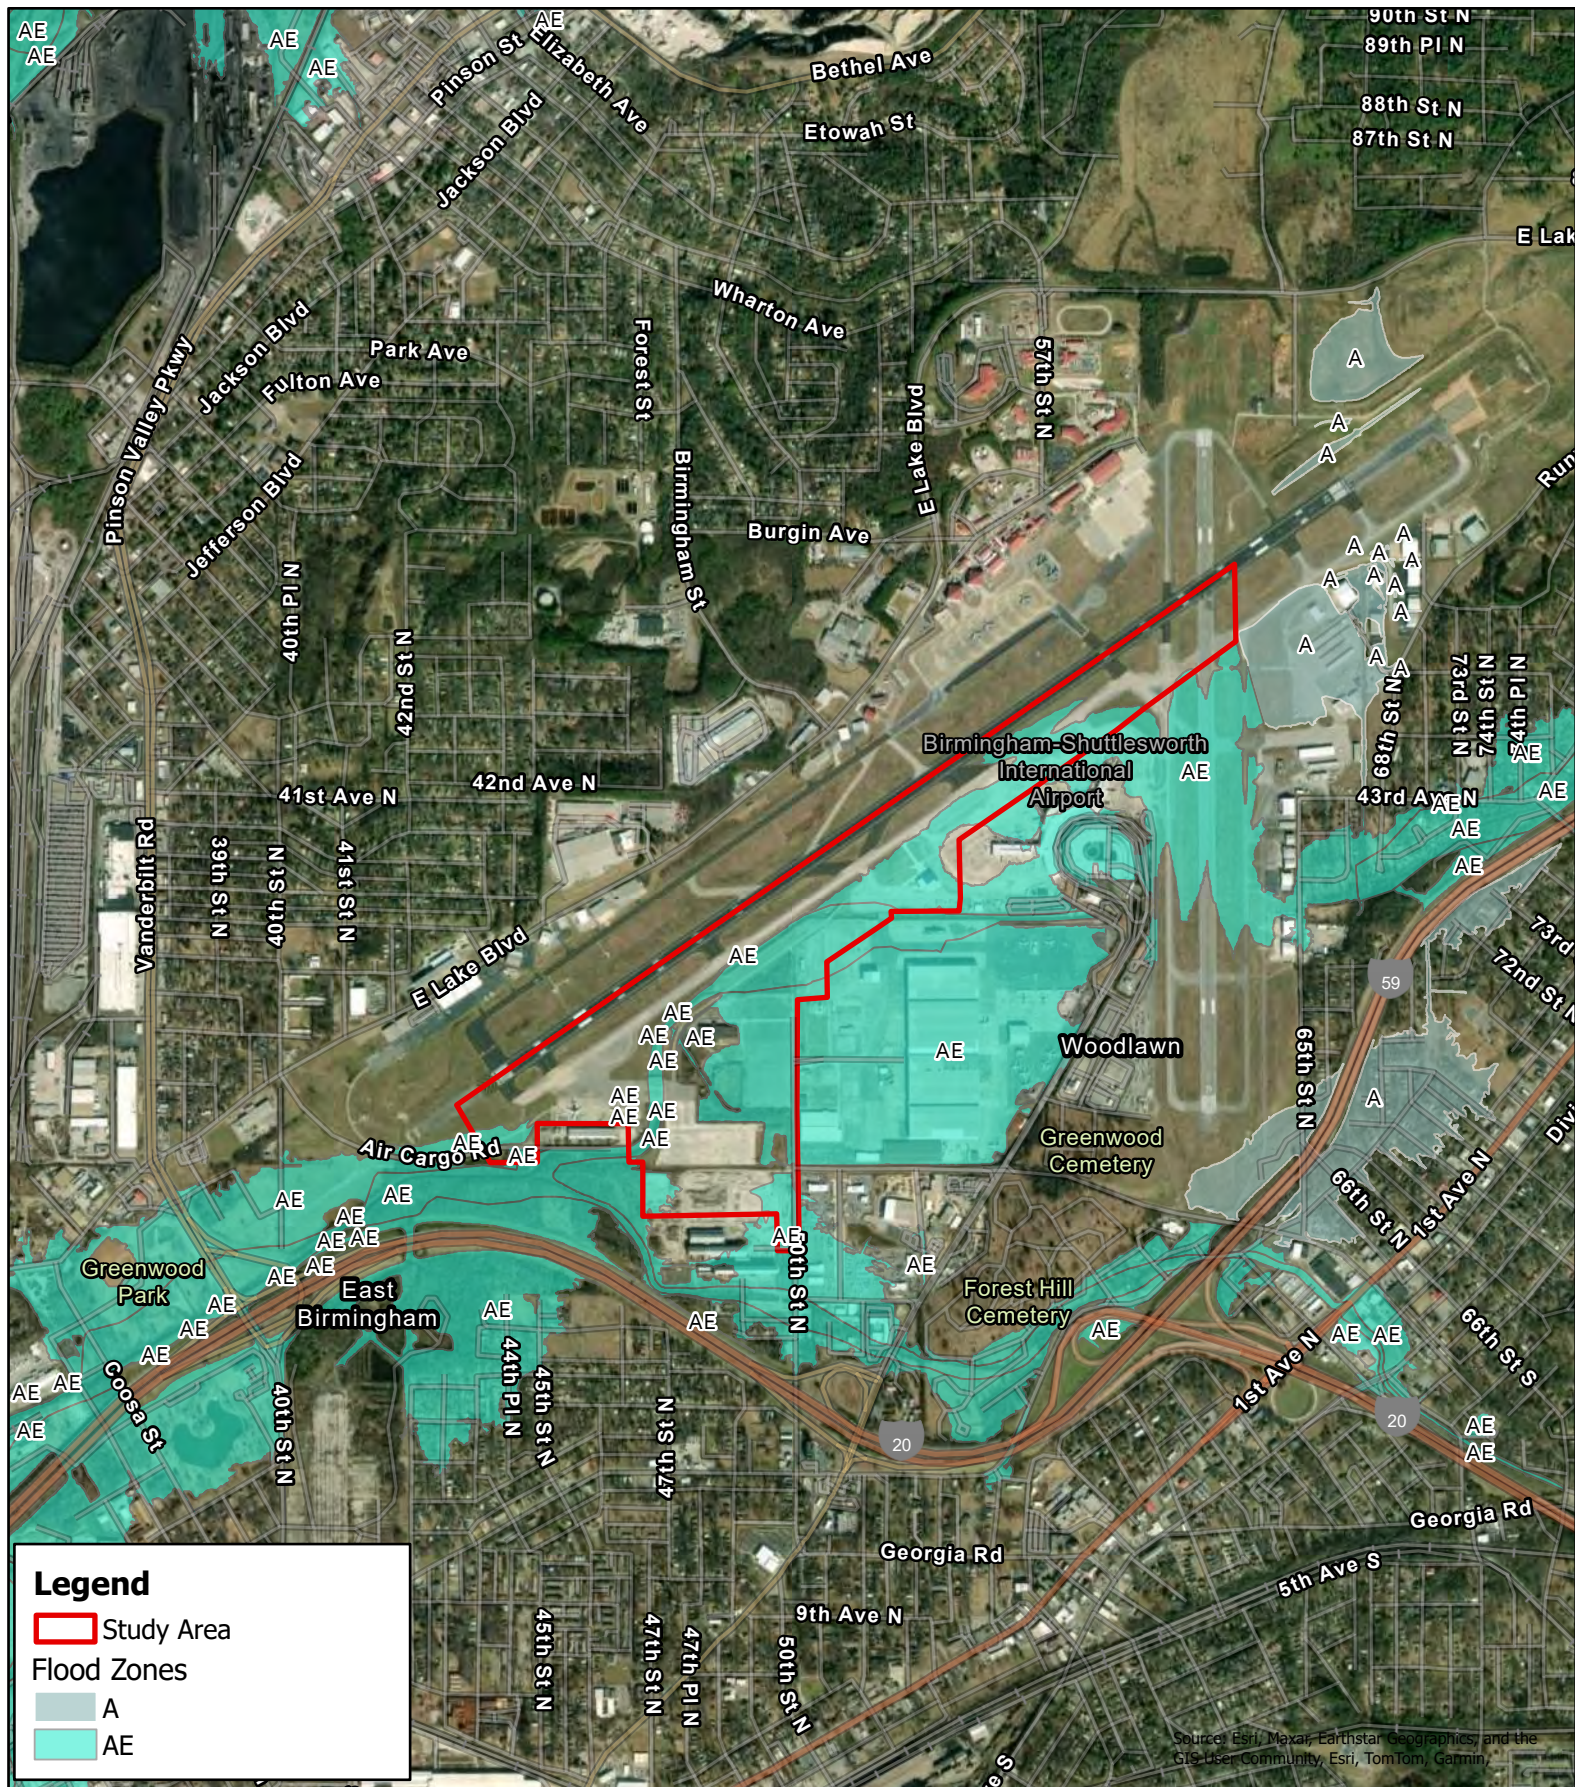
**Figure 3: FEMA Flood Zone  
BAA Taxiway A Relocation  
Birmingham, Alabama  
Jefferson County**

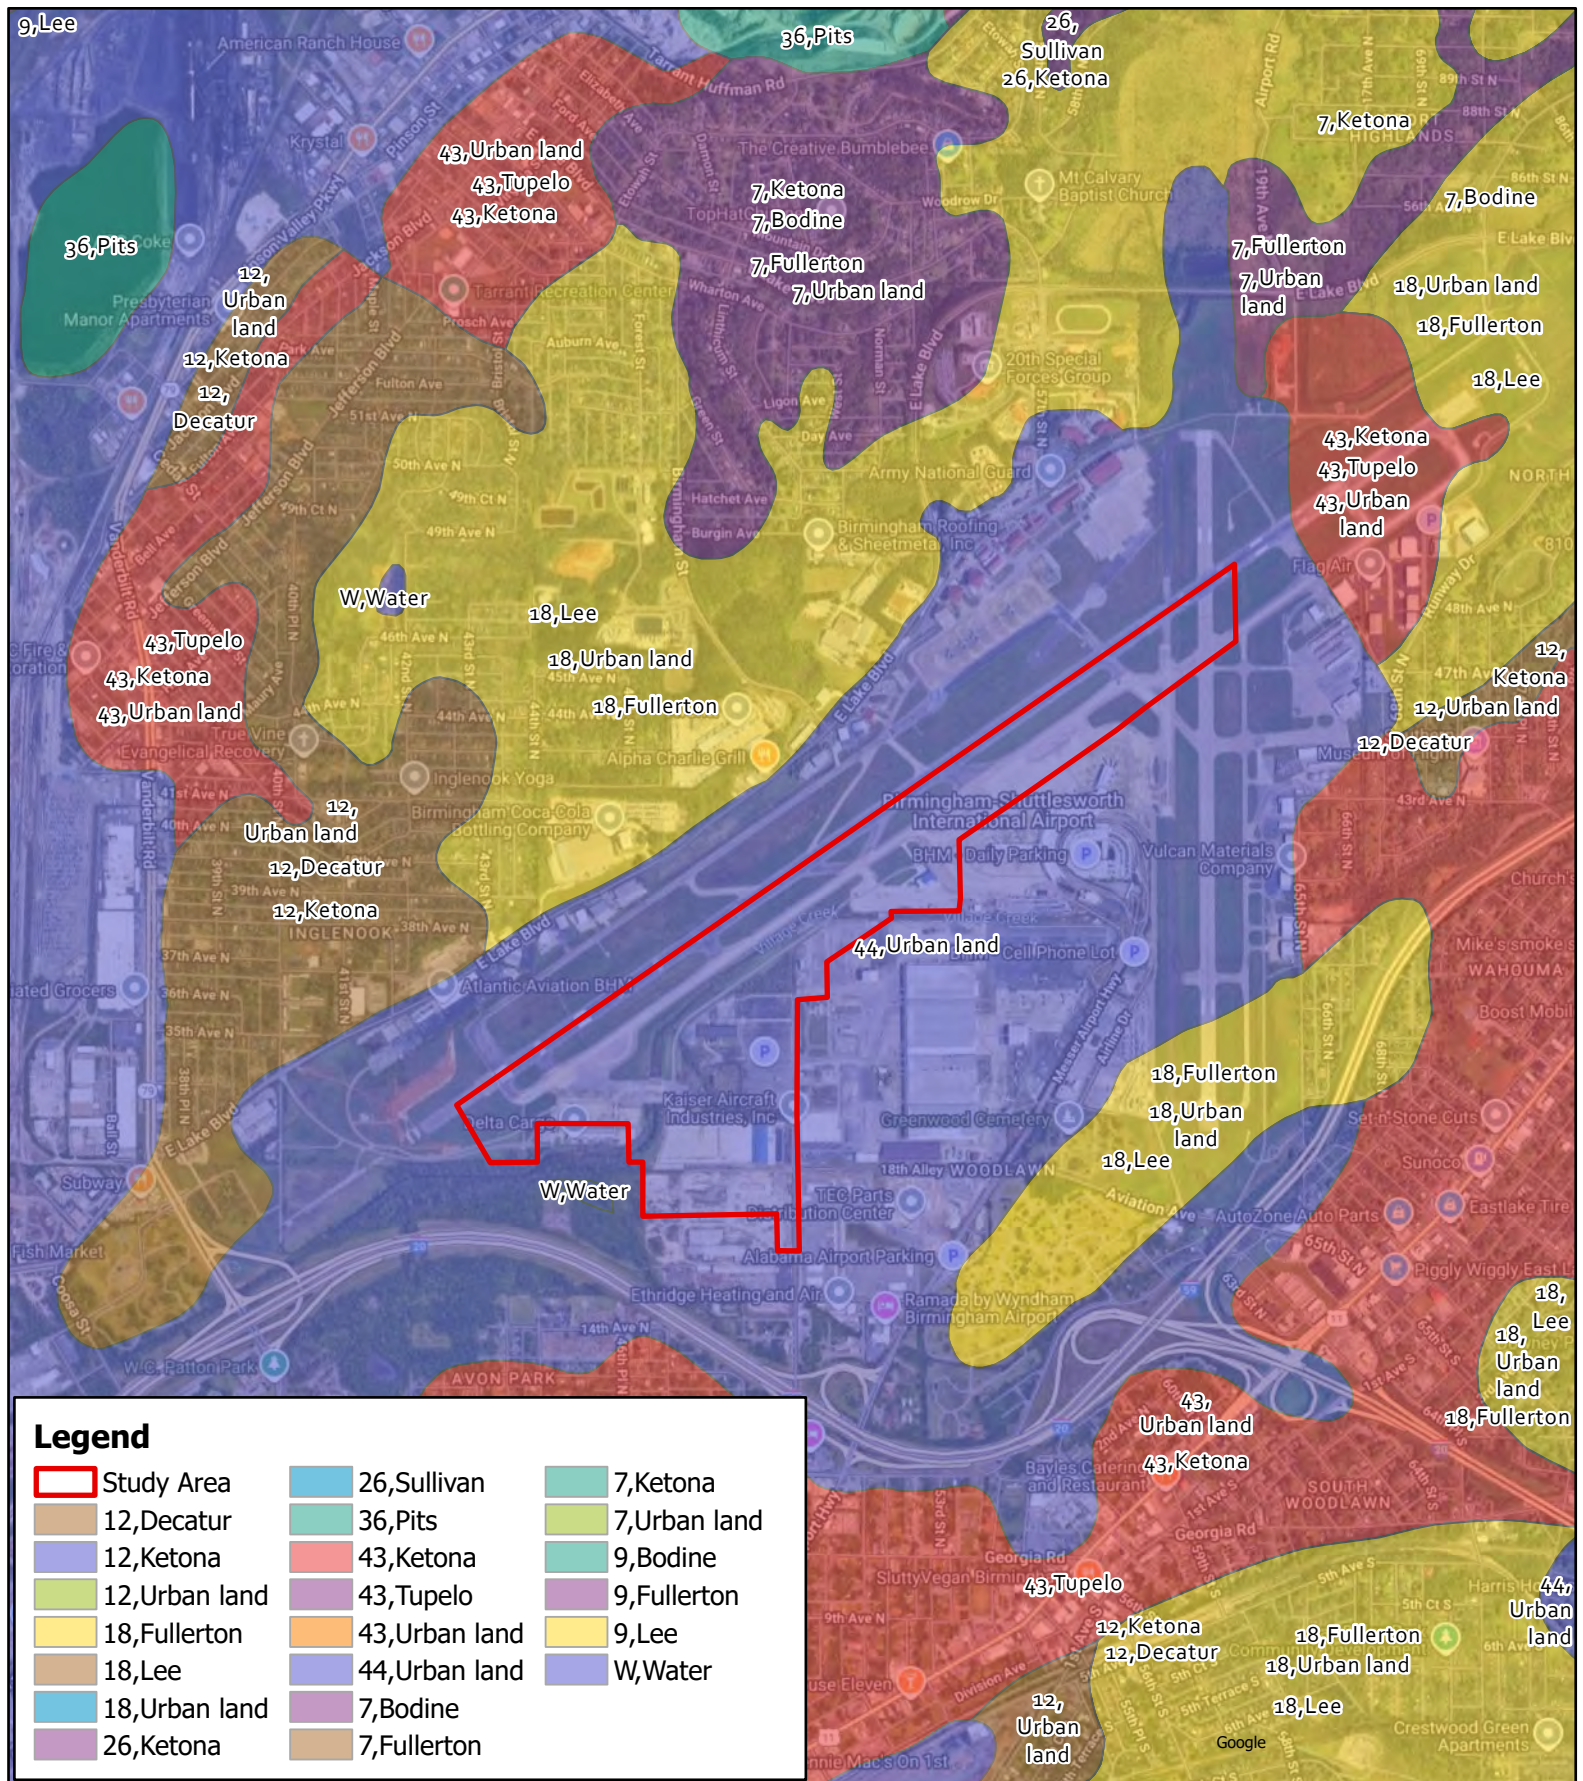
**Figure 4: NRCS Web Soil Survey  
BAA Taxiway A Relocation  
Birmingham, Alabama  
Jefferson County**

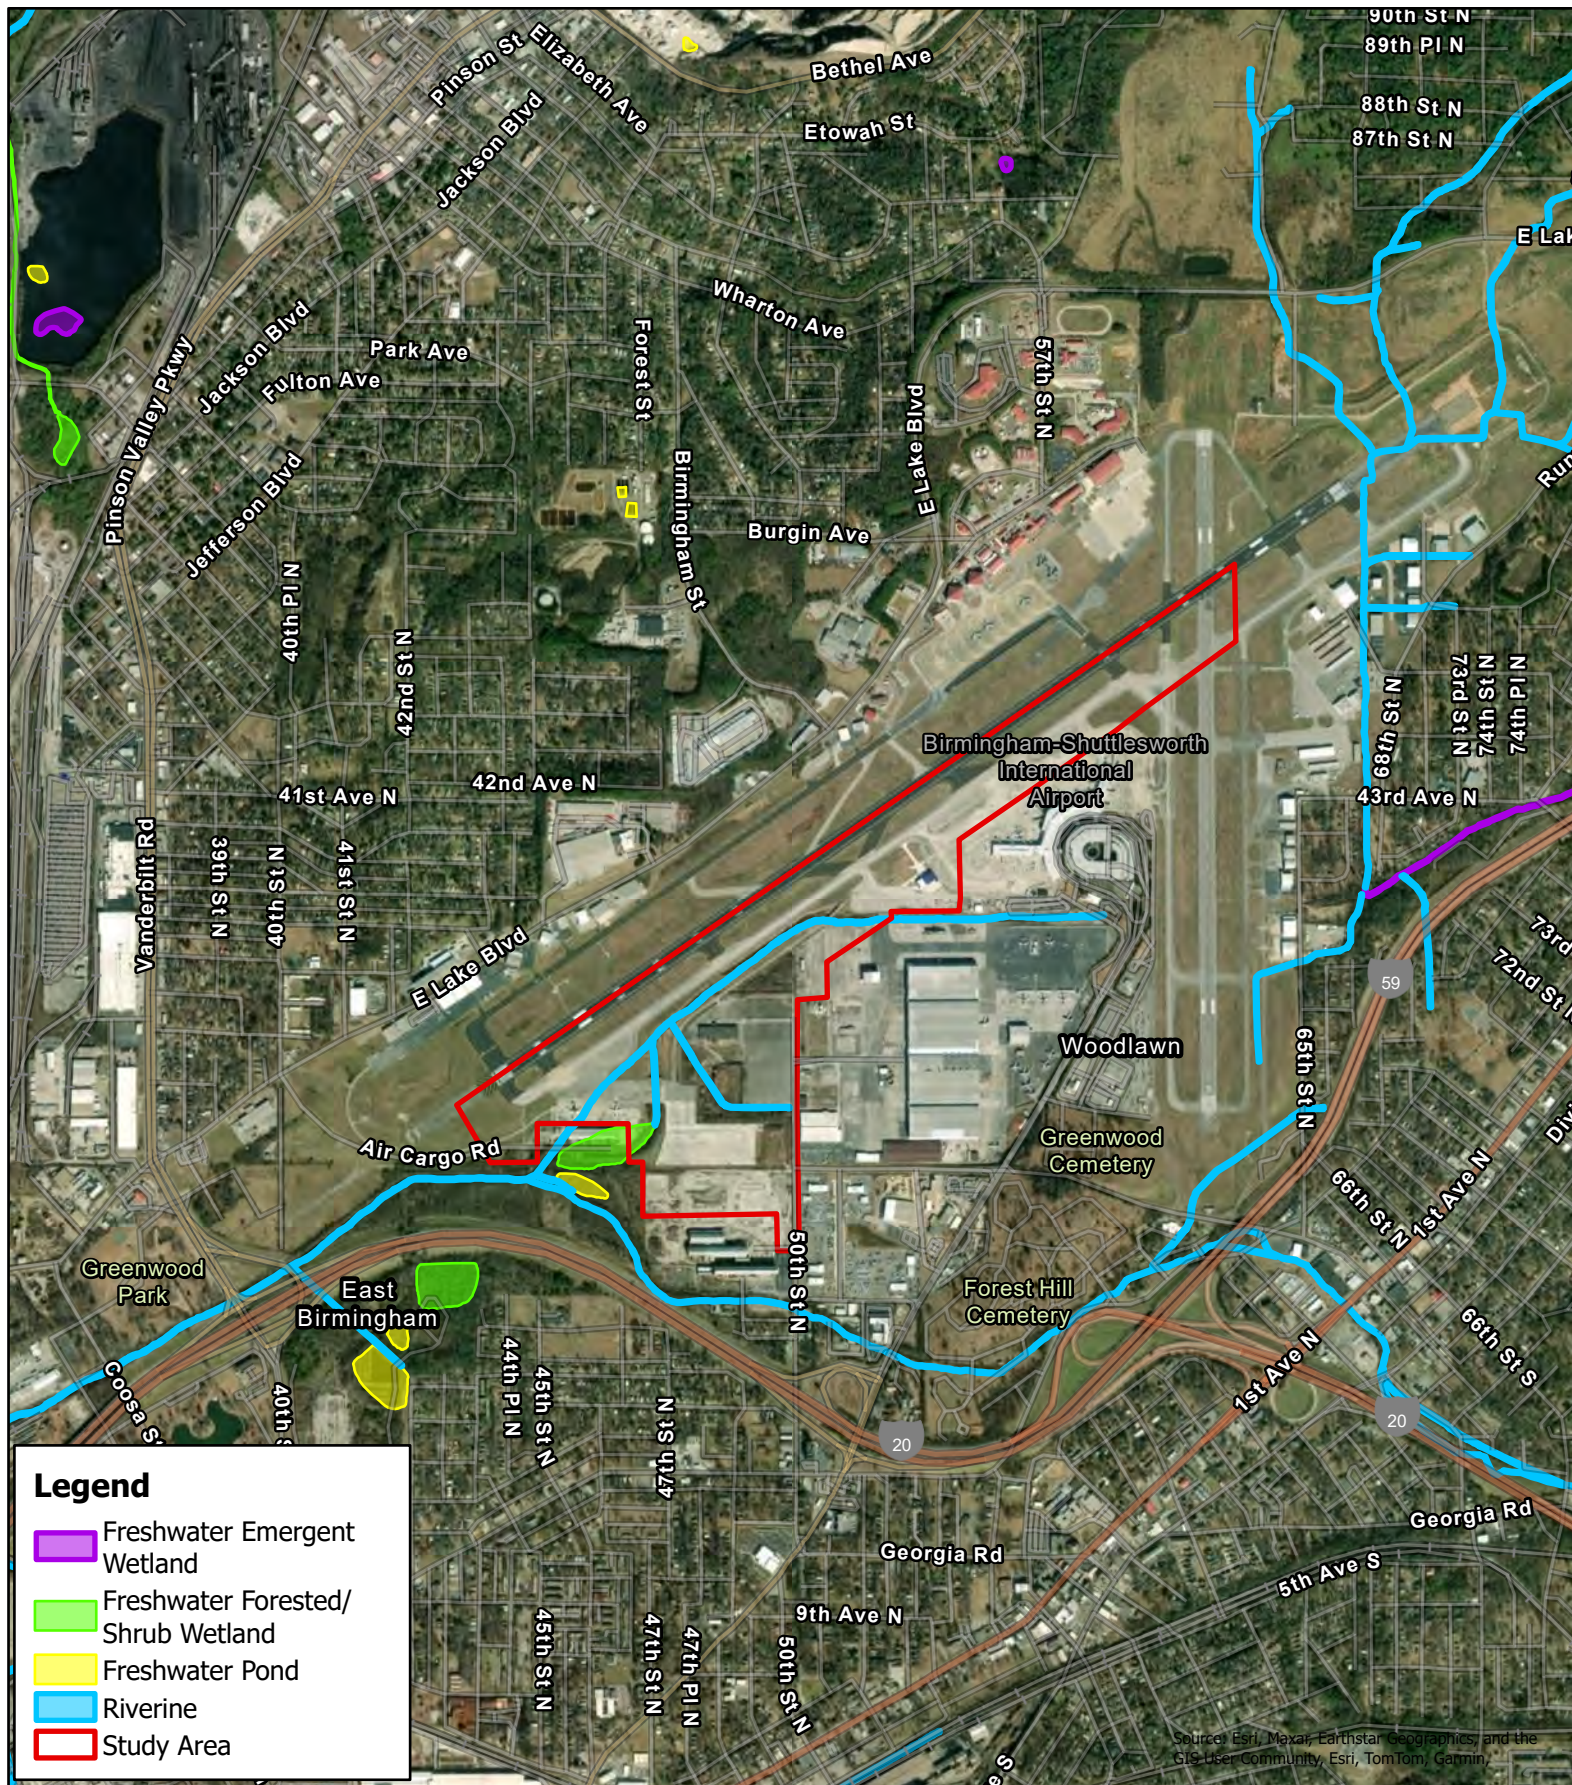
**Figure 5: National Wetland Inventory  
BAA Taxiway A Relocation  
Birmingham, Jefferson County, Alabama**

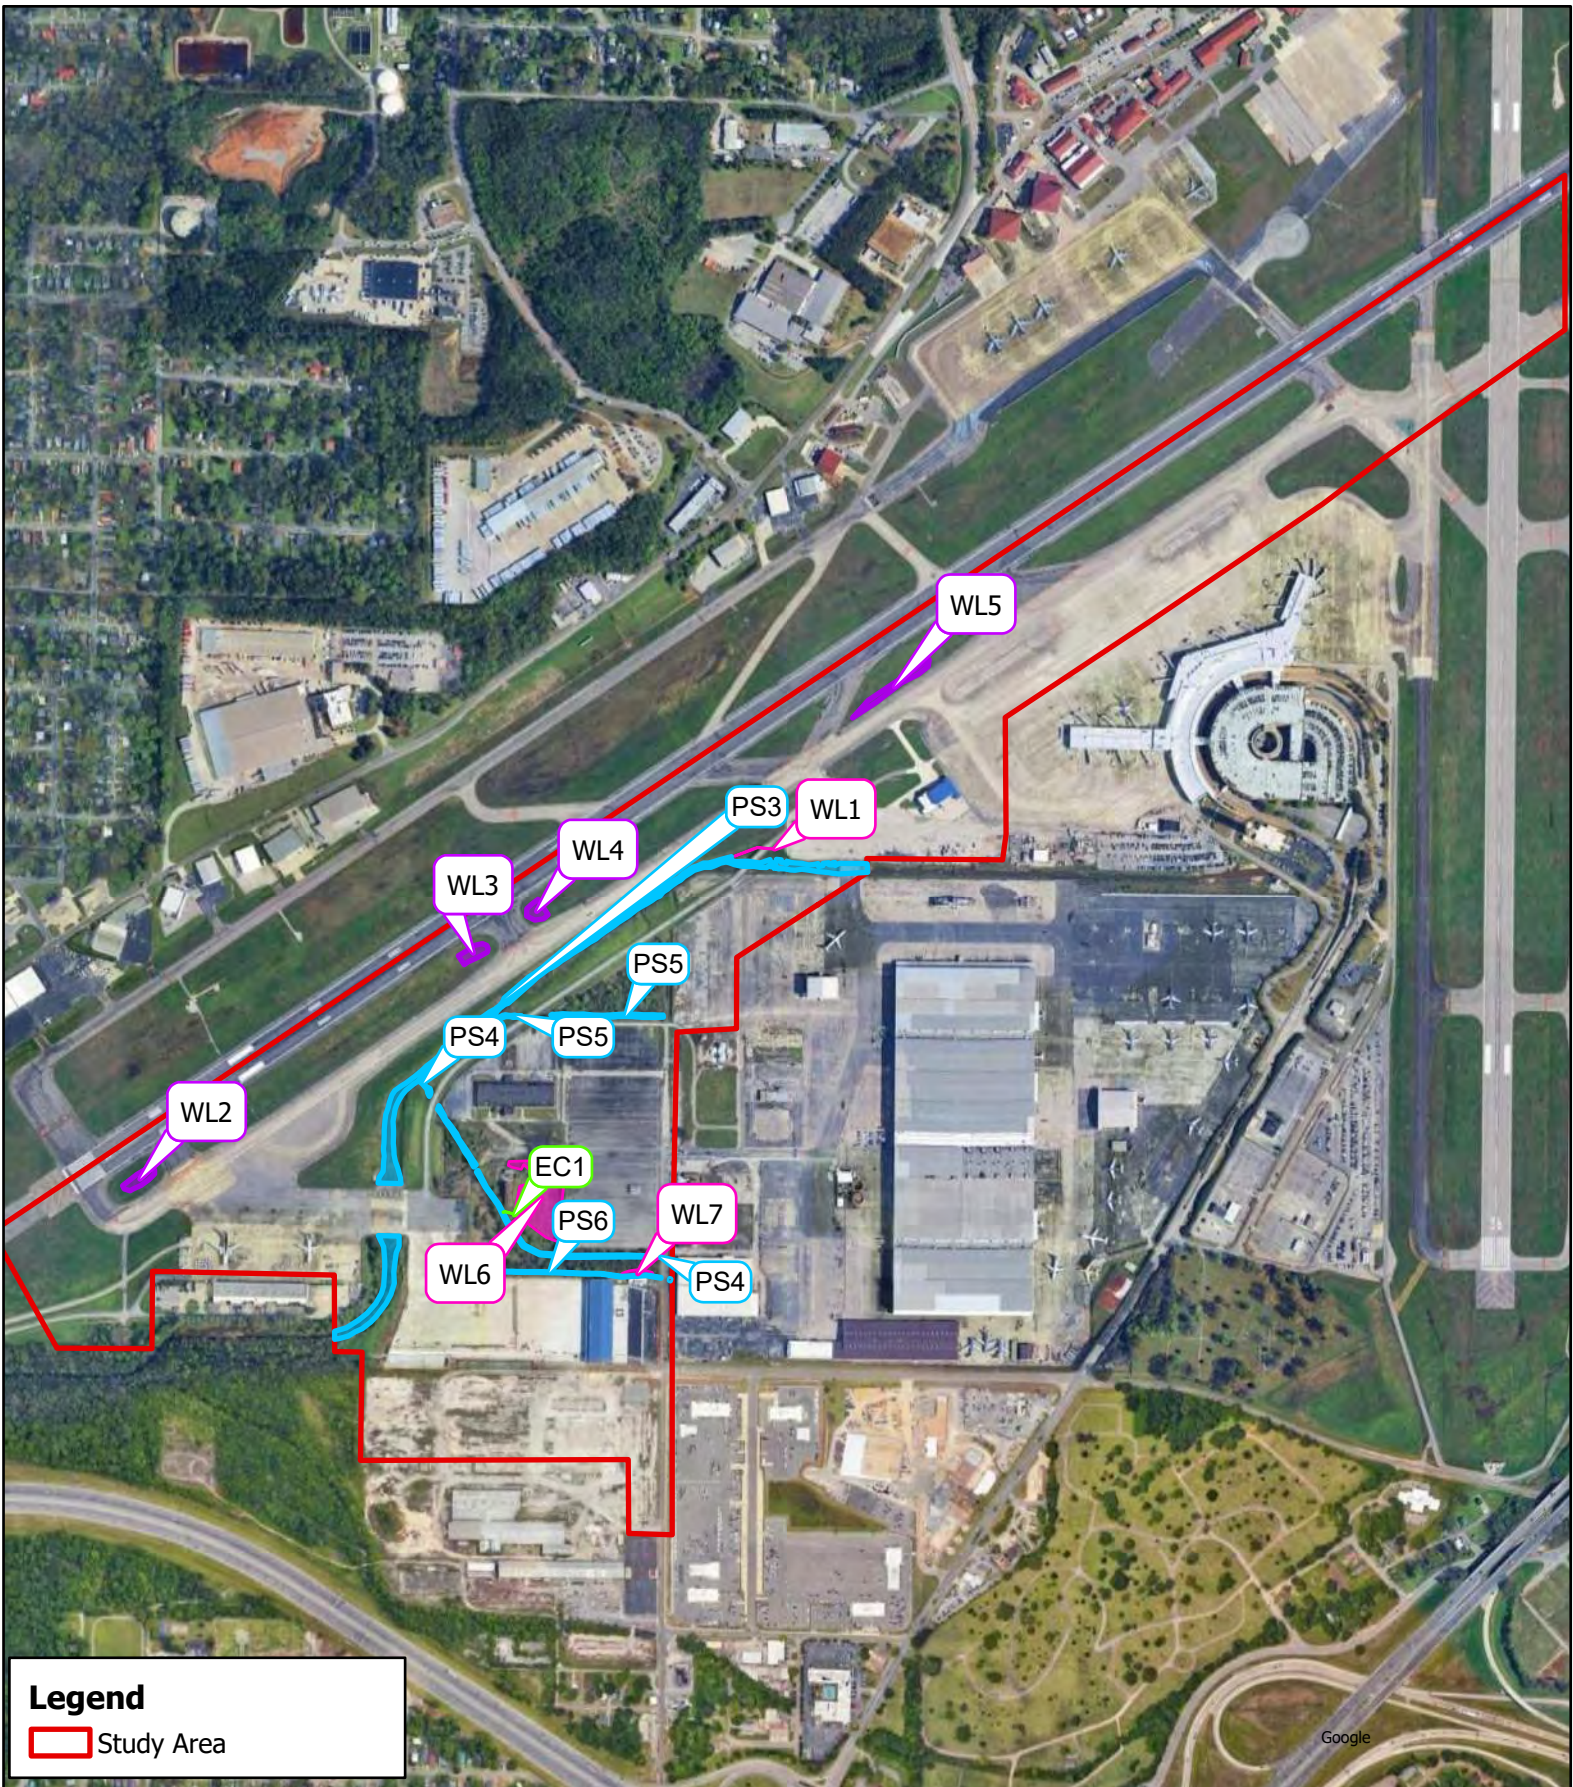
**Figure 7: Mapped Resources**  
**BAA Taxiway A Relocation**  
**Birmingham, Alabama**  
**Jefferson County**

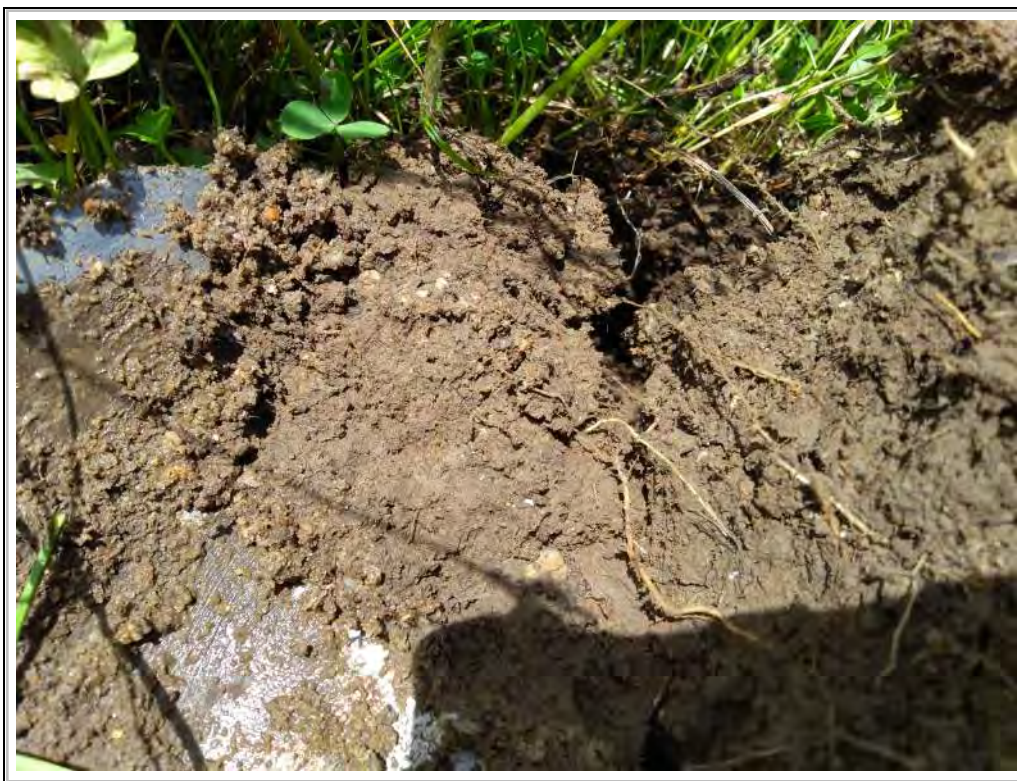
Picture 5: View of hydric soils with redox concentrations in WL4
