Appendix F: Taxiway A and Village Creek Relocation Design

BIRMINGHAM SHUTTLESWORTH  
INTERNATIONAL AIRPORT  
ENVIRONMENTAL ASSESSMENT  
OCTOBER 2024

**BIRMINGHAM-SHUTTLESWORTH INTERNATIONAL AIRPORT  
TAXIWAY A - 400' SEPARATION AND  
VILLAGE CREEK RELOCATION  
5900 MESSER AIRPORT HWY  
BIRMINGHAM, ALABAMA 35212**

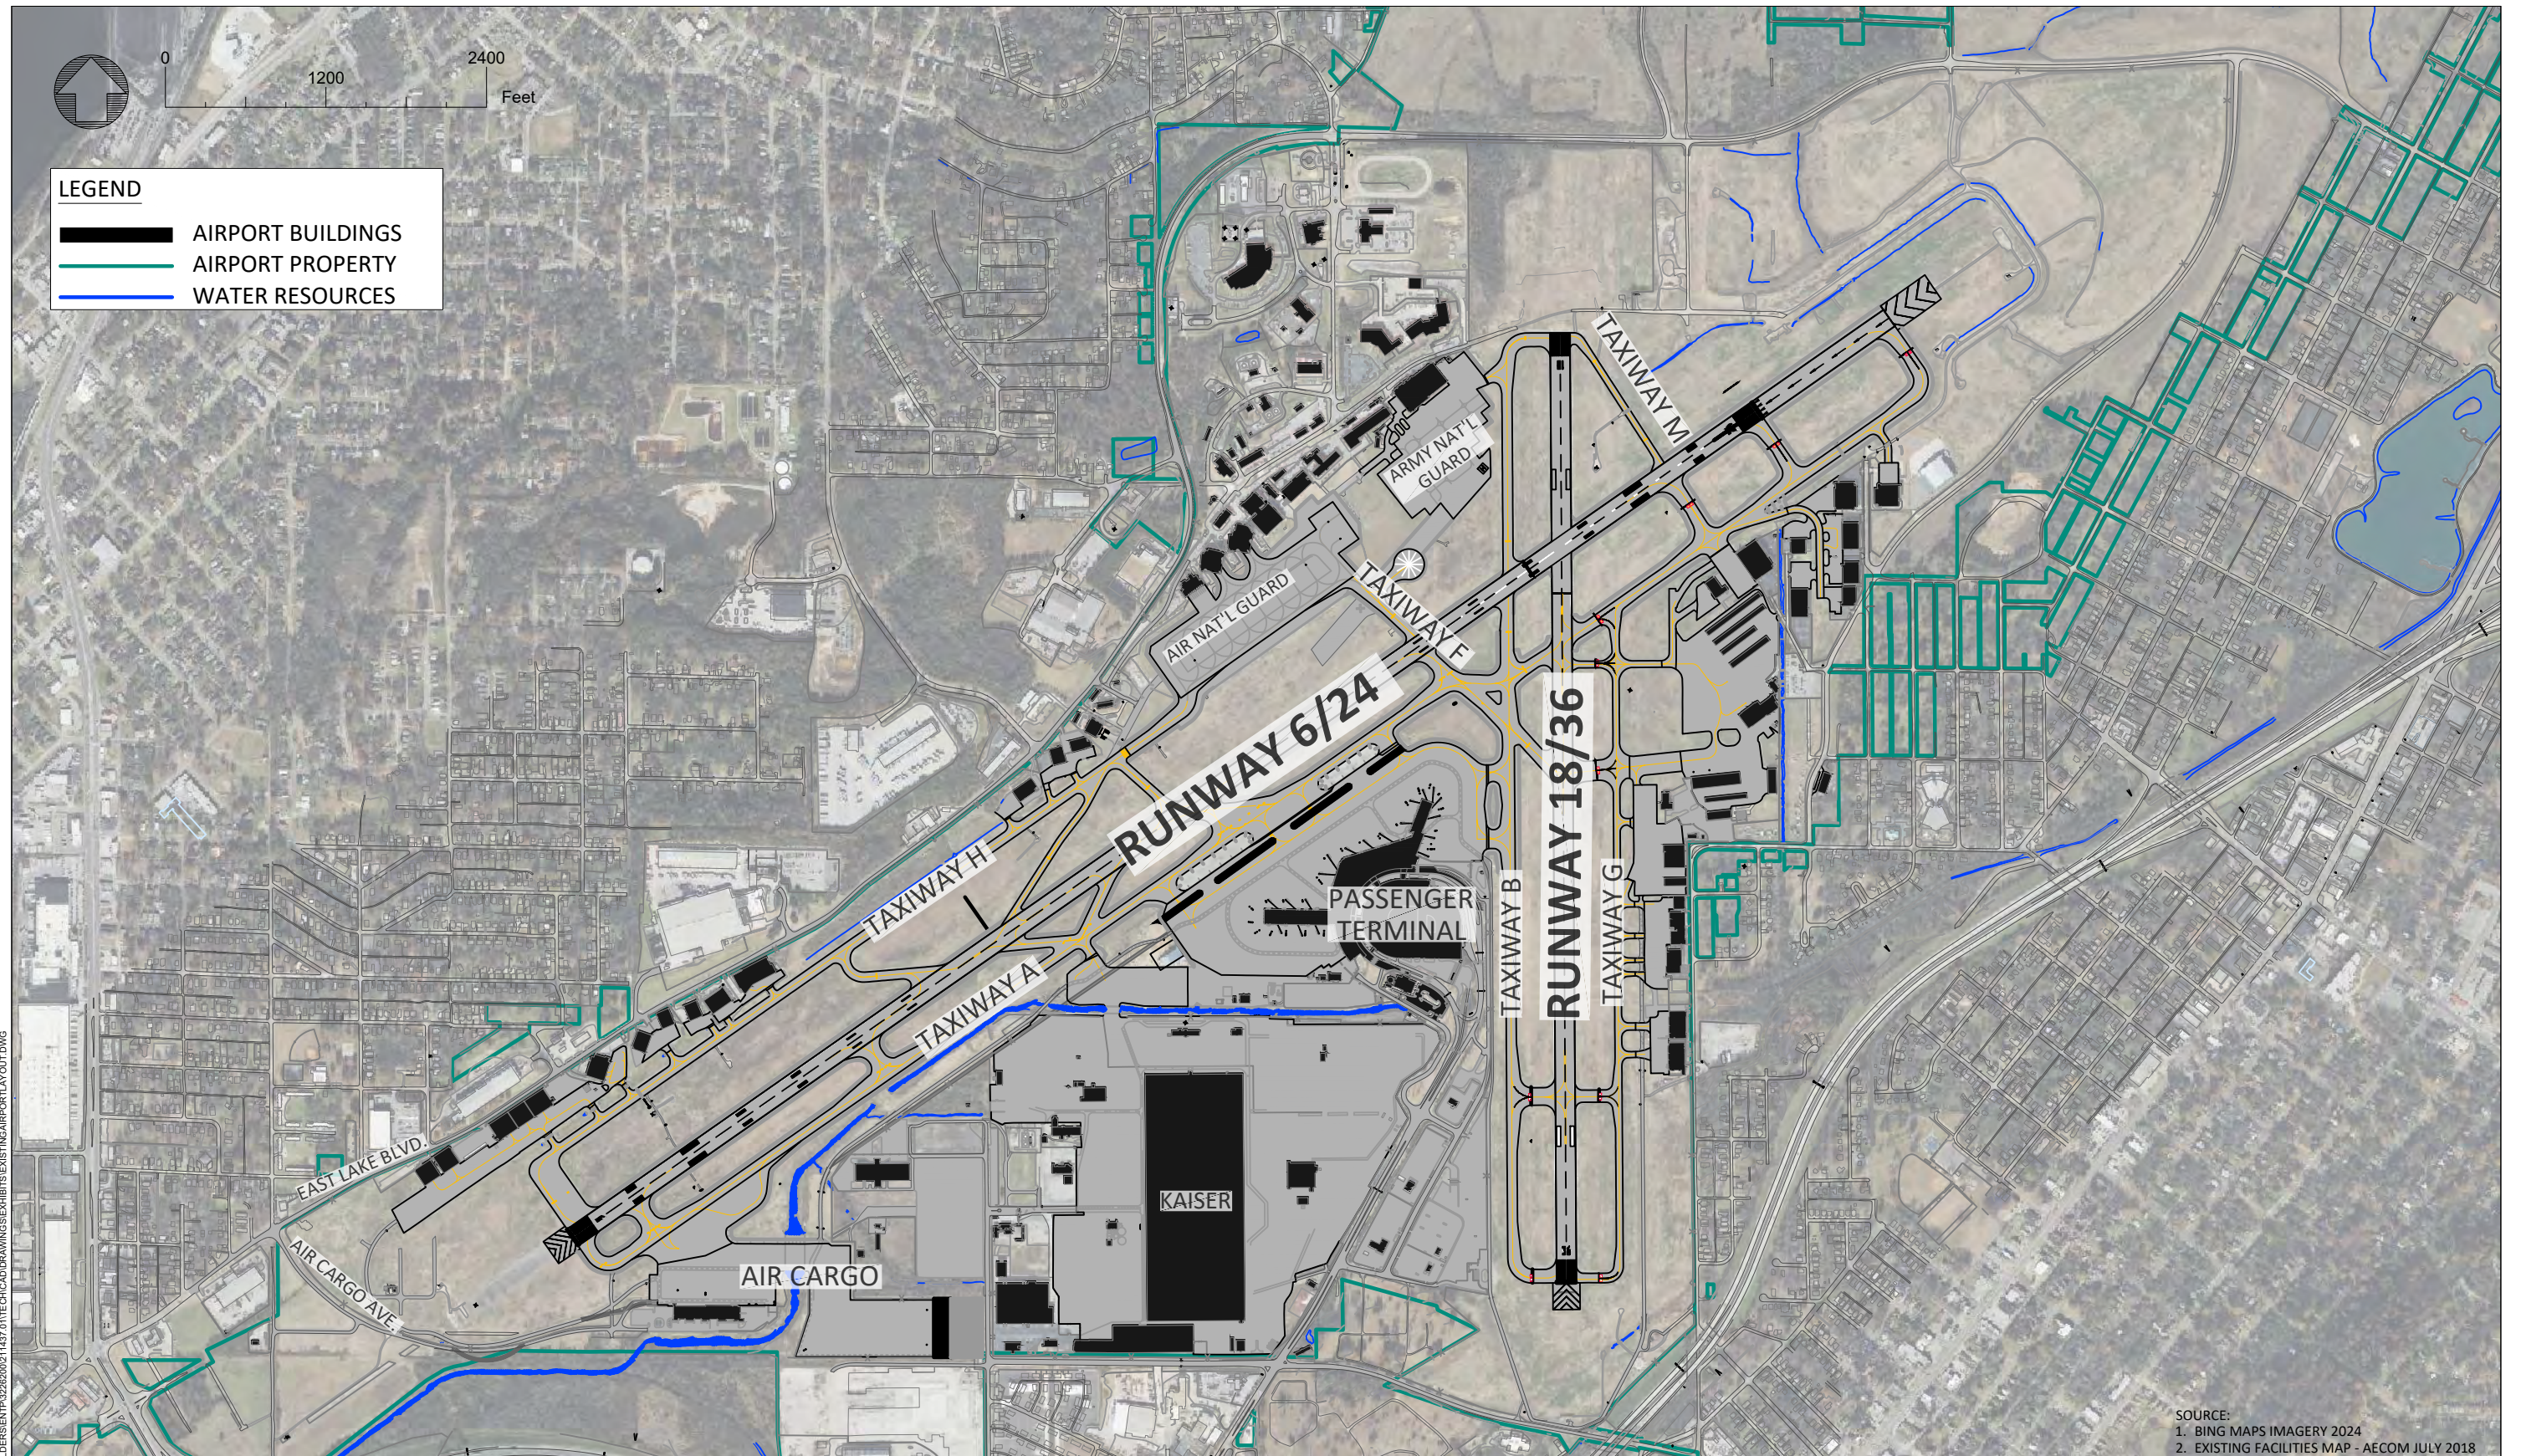
FIGURE A2 EXISTING AIRPORT LAYOUT

SOURCE:  
1. BING MAPS IMAGERY 2024  
2. EXISTING FACILITIES MAP - AECOM JULY 2018

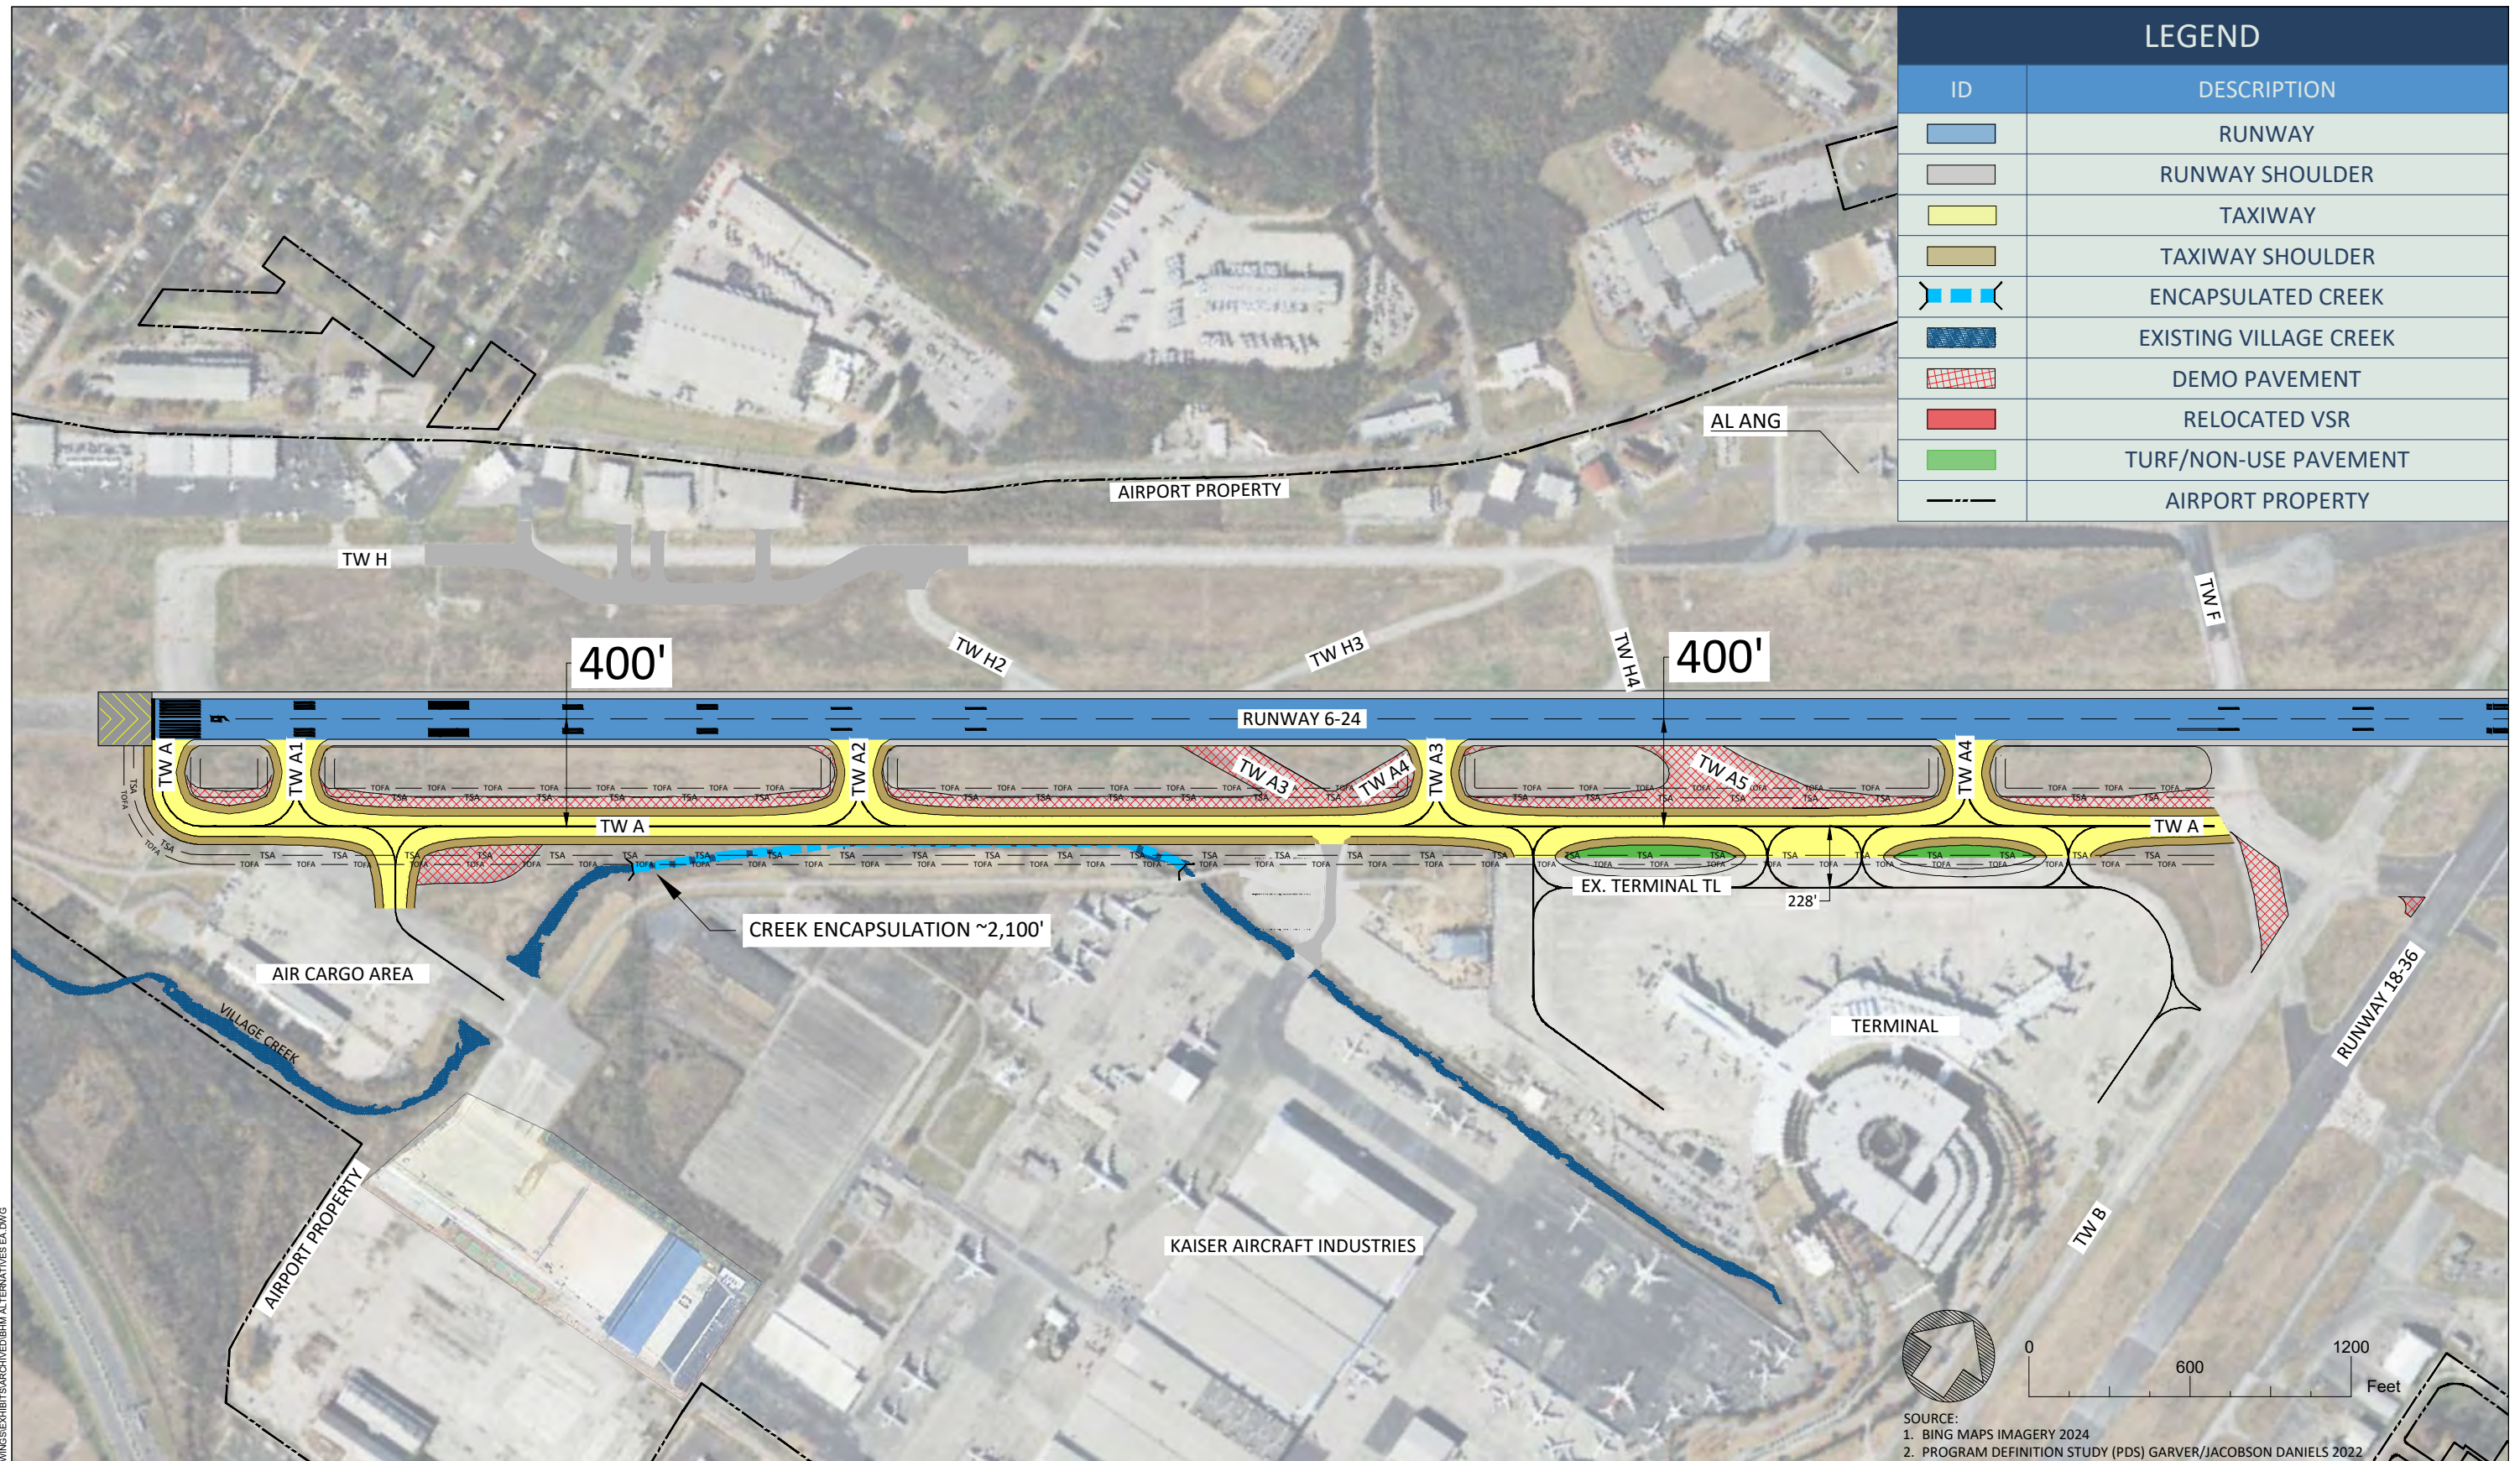
**FIGURE B1 ALTERNATIVE 1: VILLAGE CREEK ENCAPSULATION IN PLACE  
AND TAXIWAY A RELOCATION TO 400 FEET**

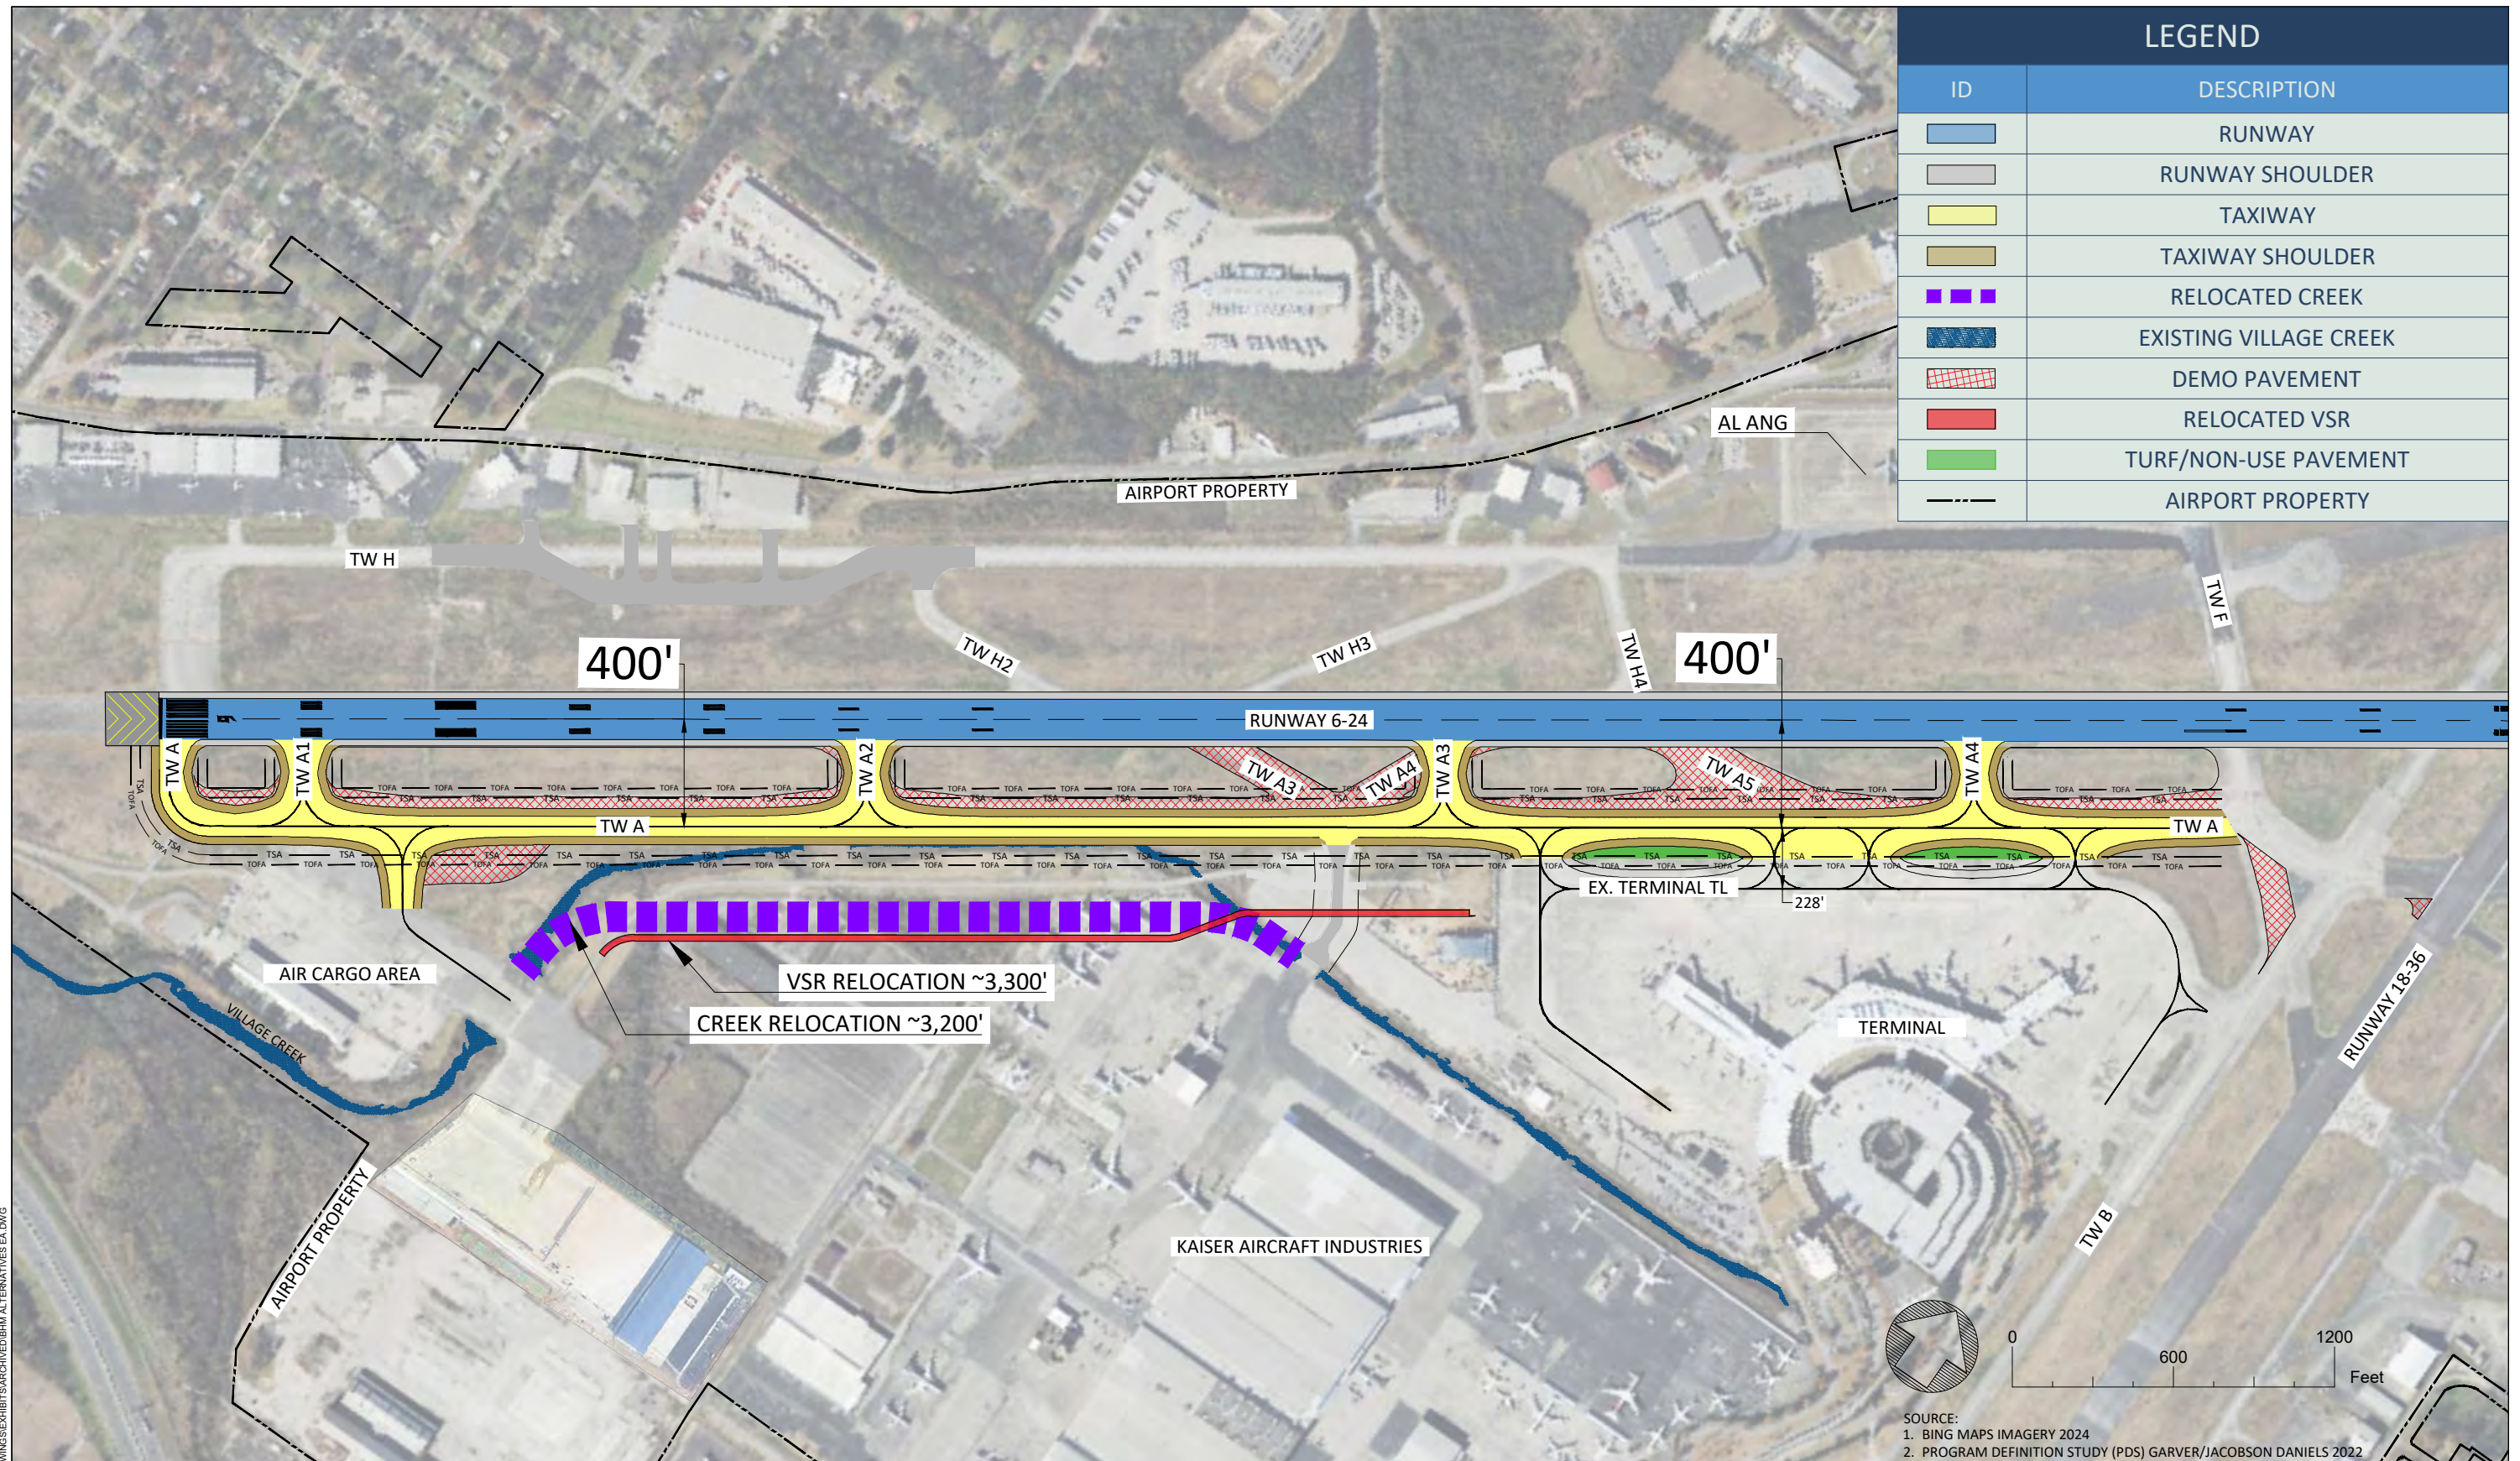
**FIGURE B2** ALTERNATIVE 2: VILLAGE CREEK RELOCATION  
AND TAXIWAY A RELOCATION TO 400 FEET

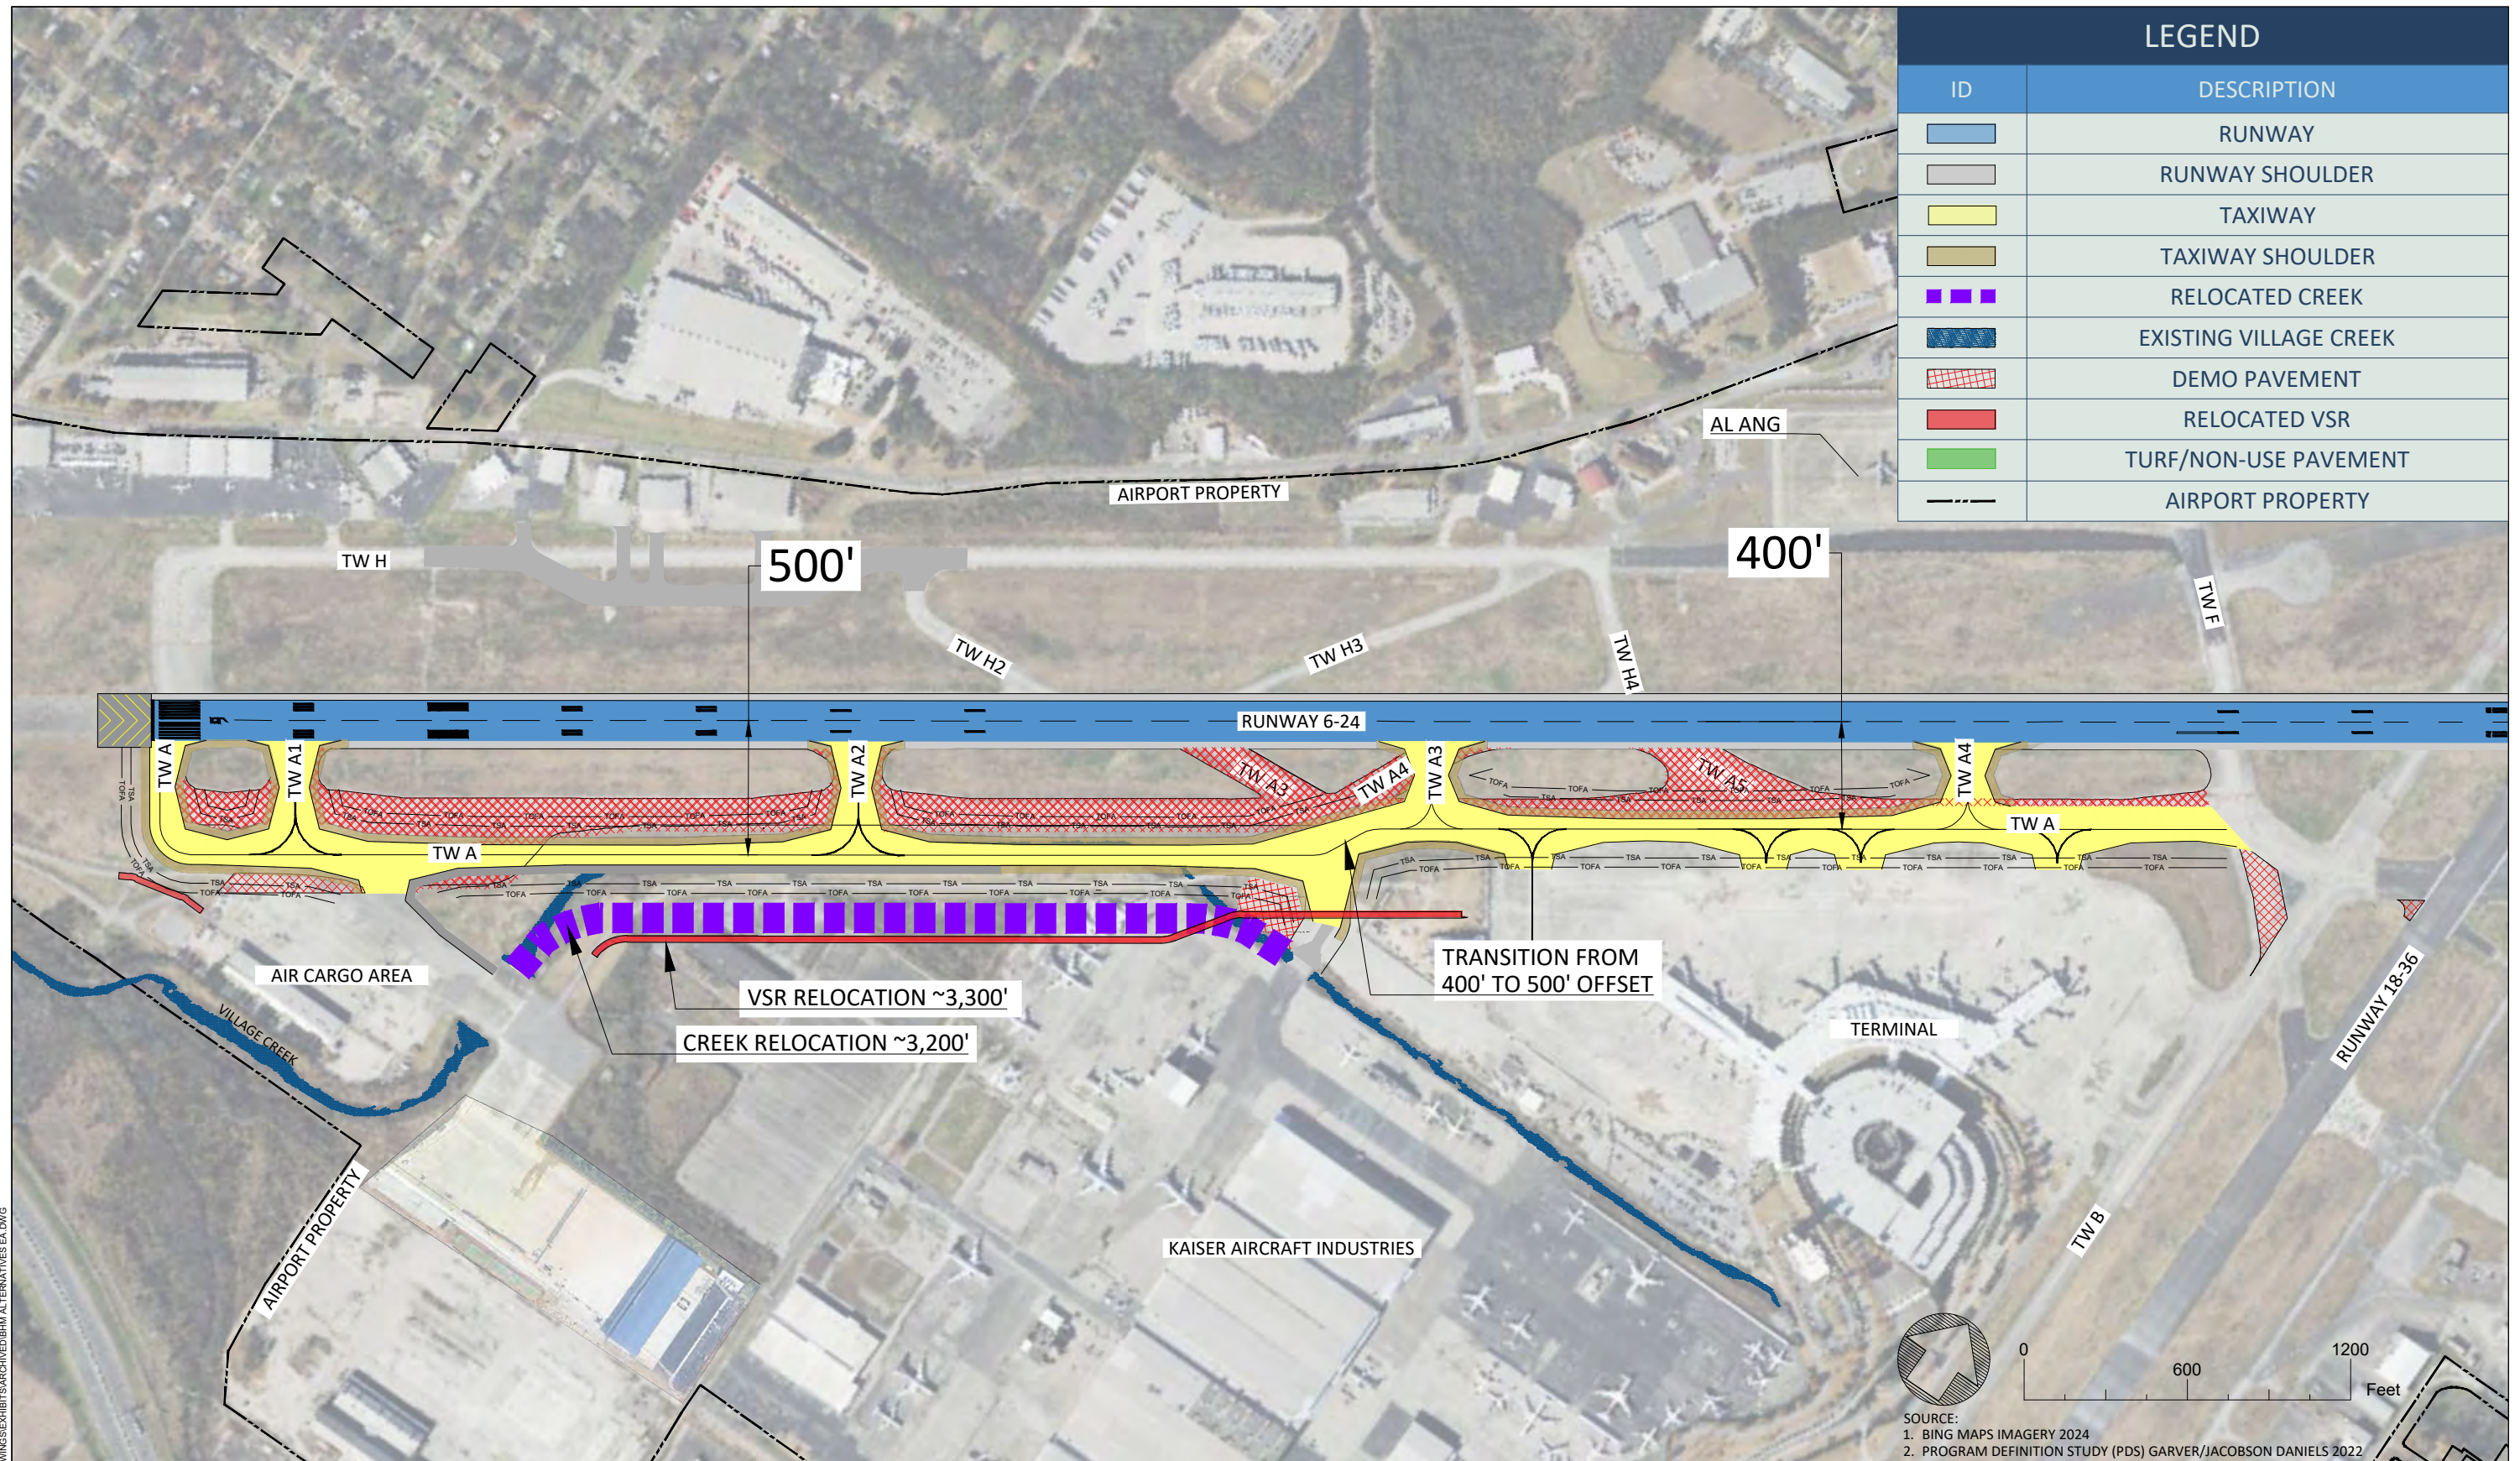
**FIGURE B6** ALTERNATIVE 5: VILLAGE CREEK RELOCATION  
AND HYBRID 400'/500' TAXIWAY A RELOCATION

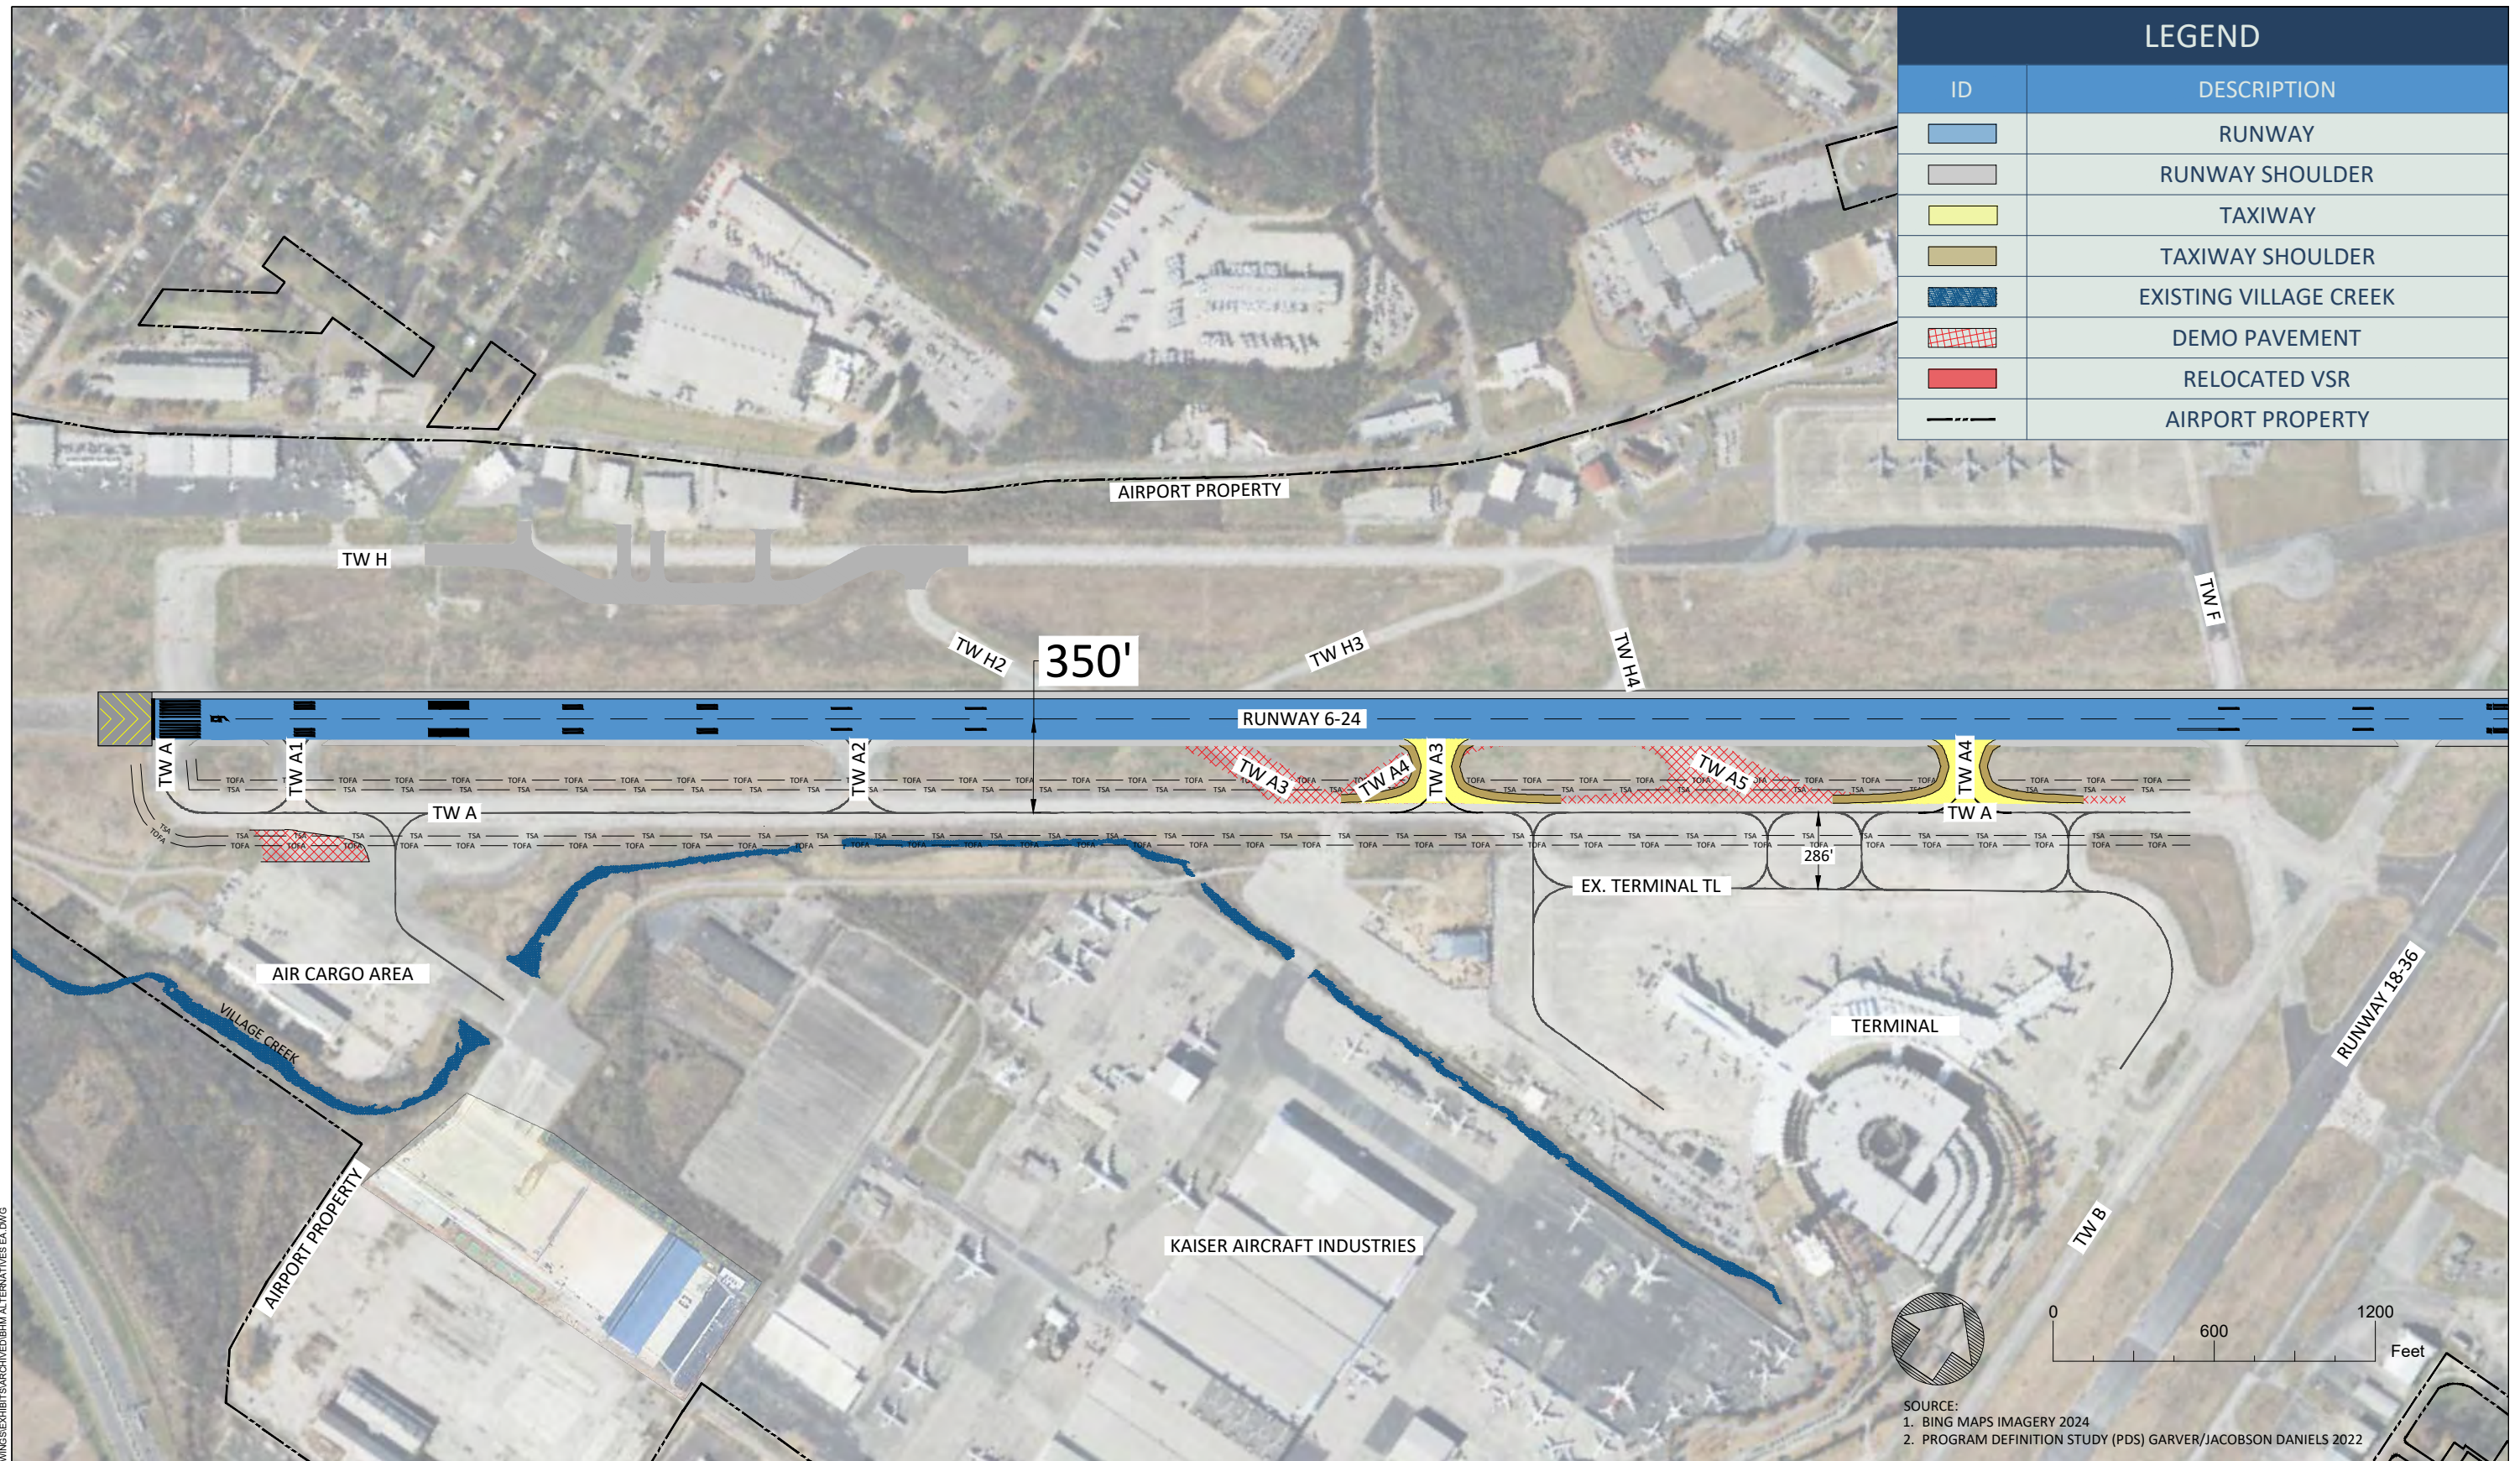
FIGURE B7 NO ACTION - REHAB AND RECONSTRUCT IN CURRENT LOCATION

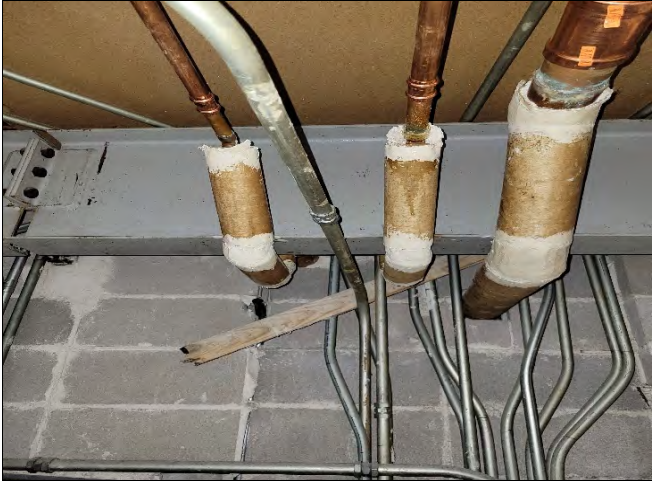
Asbestos Insulation on Pipe Elbows-Damage Areas, Main Area behind East Side Restrooms

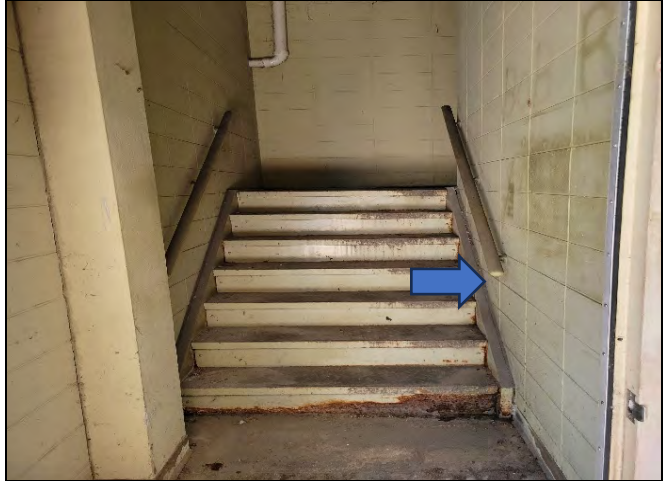
Asbestos Caulking between Wall and Stairs

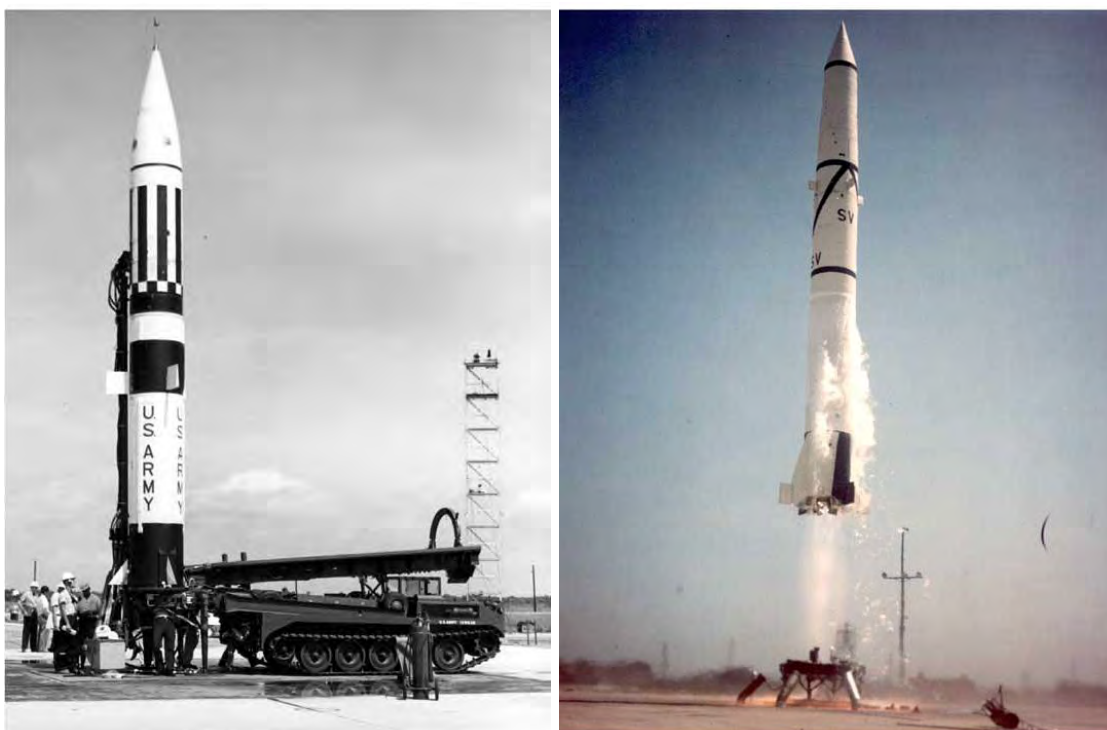
Figure 3. An example of a Pershing Missile (at left) and Saturn rocket (at right), both designed and built by Hayes in the 1960s.<sup>15</sup>

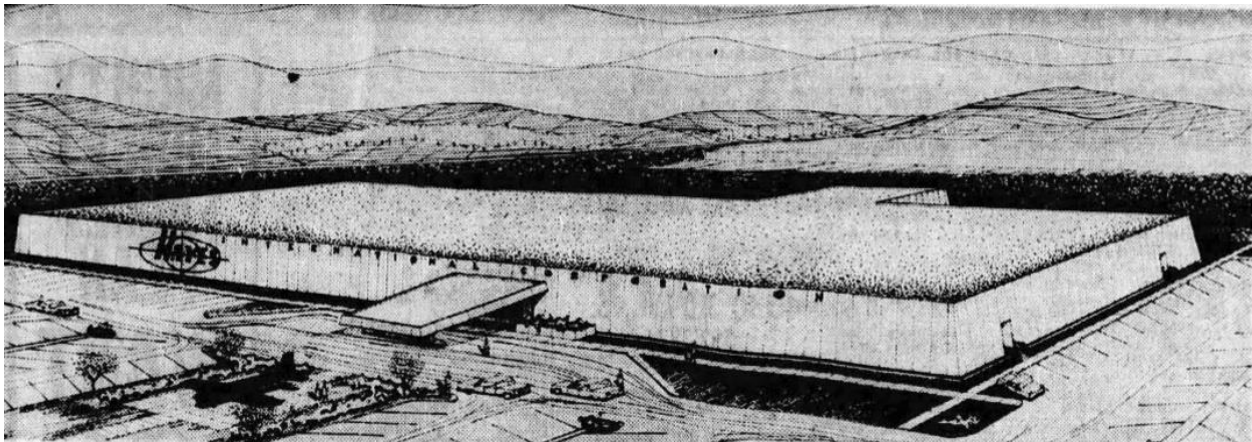
Figure 5. 1967 design sketch of the proposed office and research building.<sup>29</sup>
