Appendix F: Taxiway A and Village Creek Relocation Design

BIRMINGHAM SHUTTLESWORTH  
INTERNATIONAL AIRPORT  
ENVIRONMENTAL ASSESSMENT  
OCTOBER 2024

**BIRMINGHAM-SHUTTLESWORTH INTERNATIONAL AIRPORT  
TAXIWAY A - 400' SEPARATION AND  
VILLAGE CREEK RELOCATION  
5900 MESSER AIRPORT HWY  
BIRMINGHAM, ALABAMA 35212**

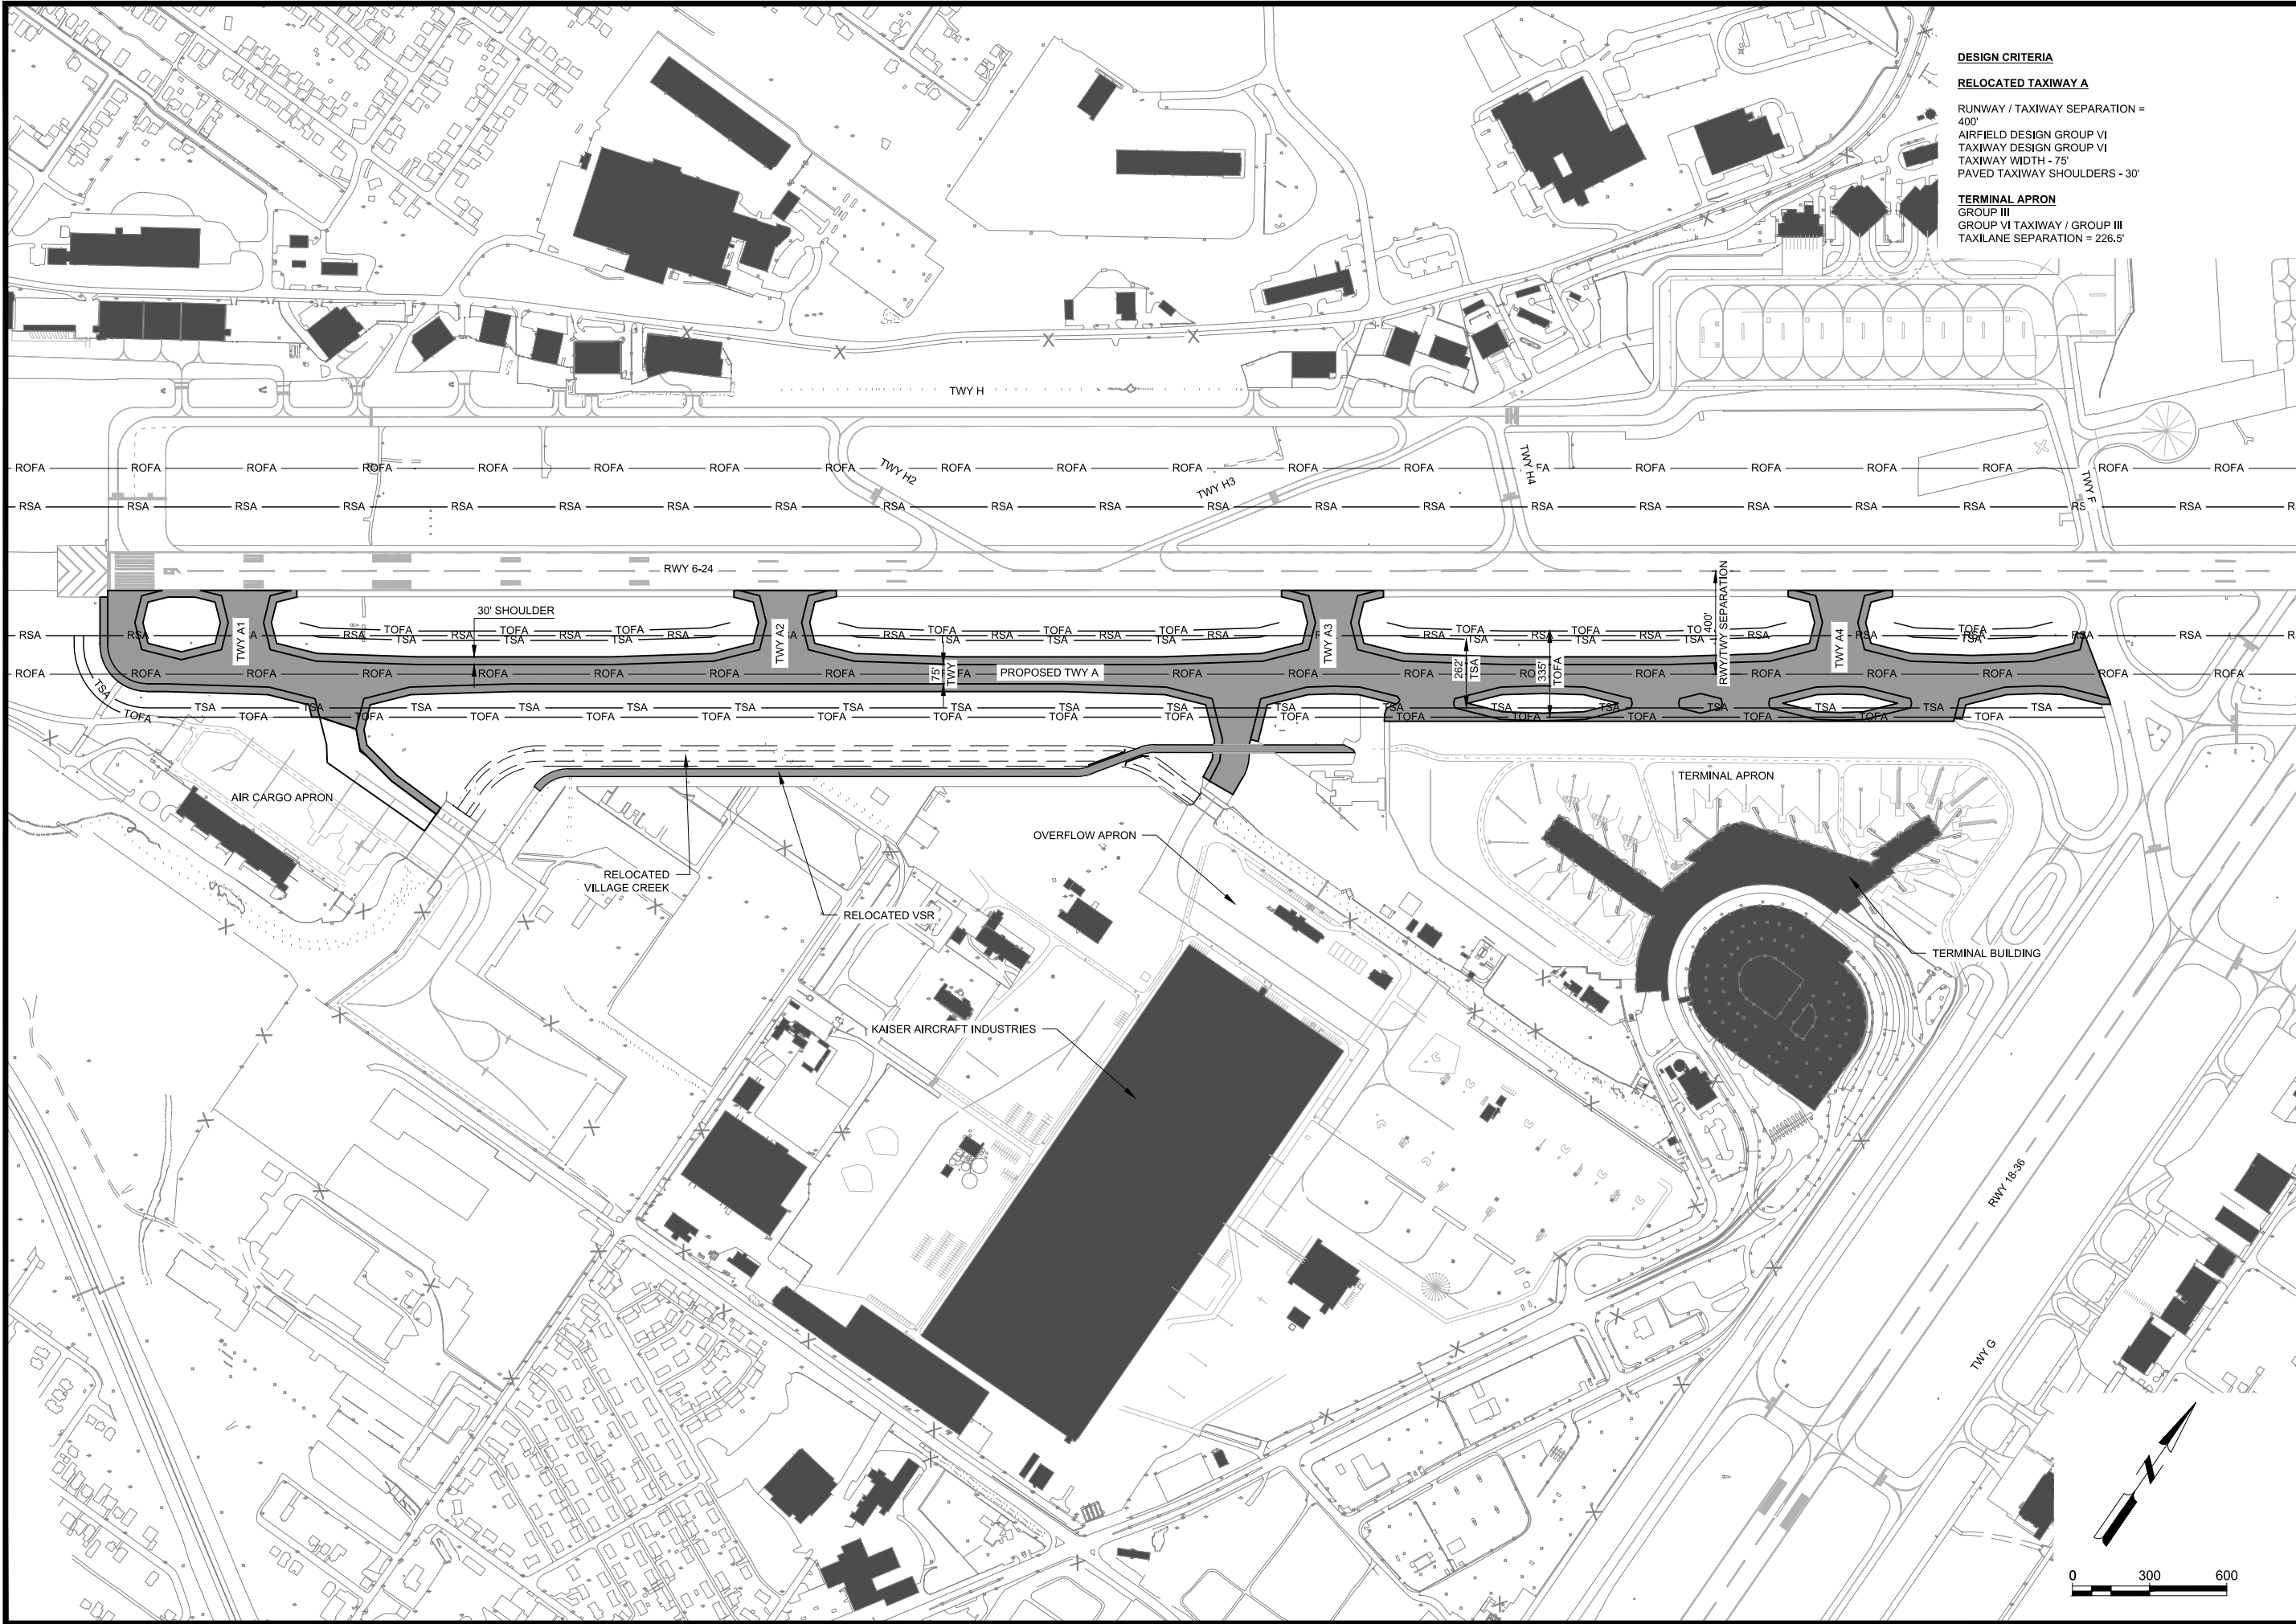
# G-002

**DESIGN CRITERIA**  
**RELOCATED TAXIWAY A**  
RUNWAY / TAXIWAY SEPARATION = 400'  
AIRFIELD DESIGN GROUP VI  
TAXIWAY DESIGN GROUP VI  
TAXIWAY WIDTH - 75'  
PAVED TAXIWAY SHOULDERS - 30'  
**TERMINAL APRON**  
GROUP III  
GROUP VI TAXIWAY / GROUP III  
TAXILANE SEPARATION = 226.5'

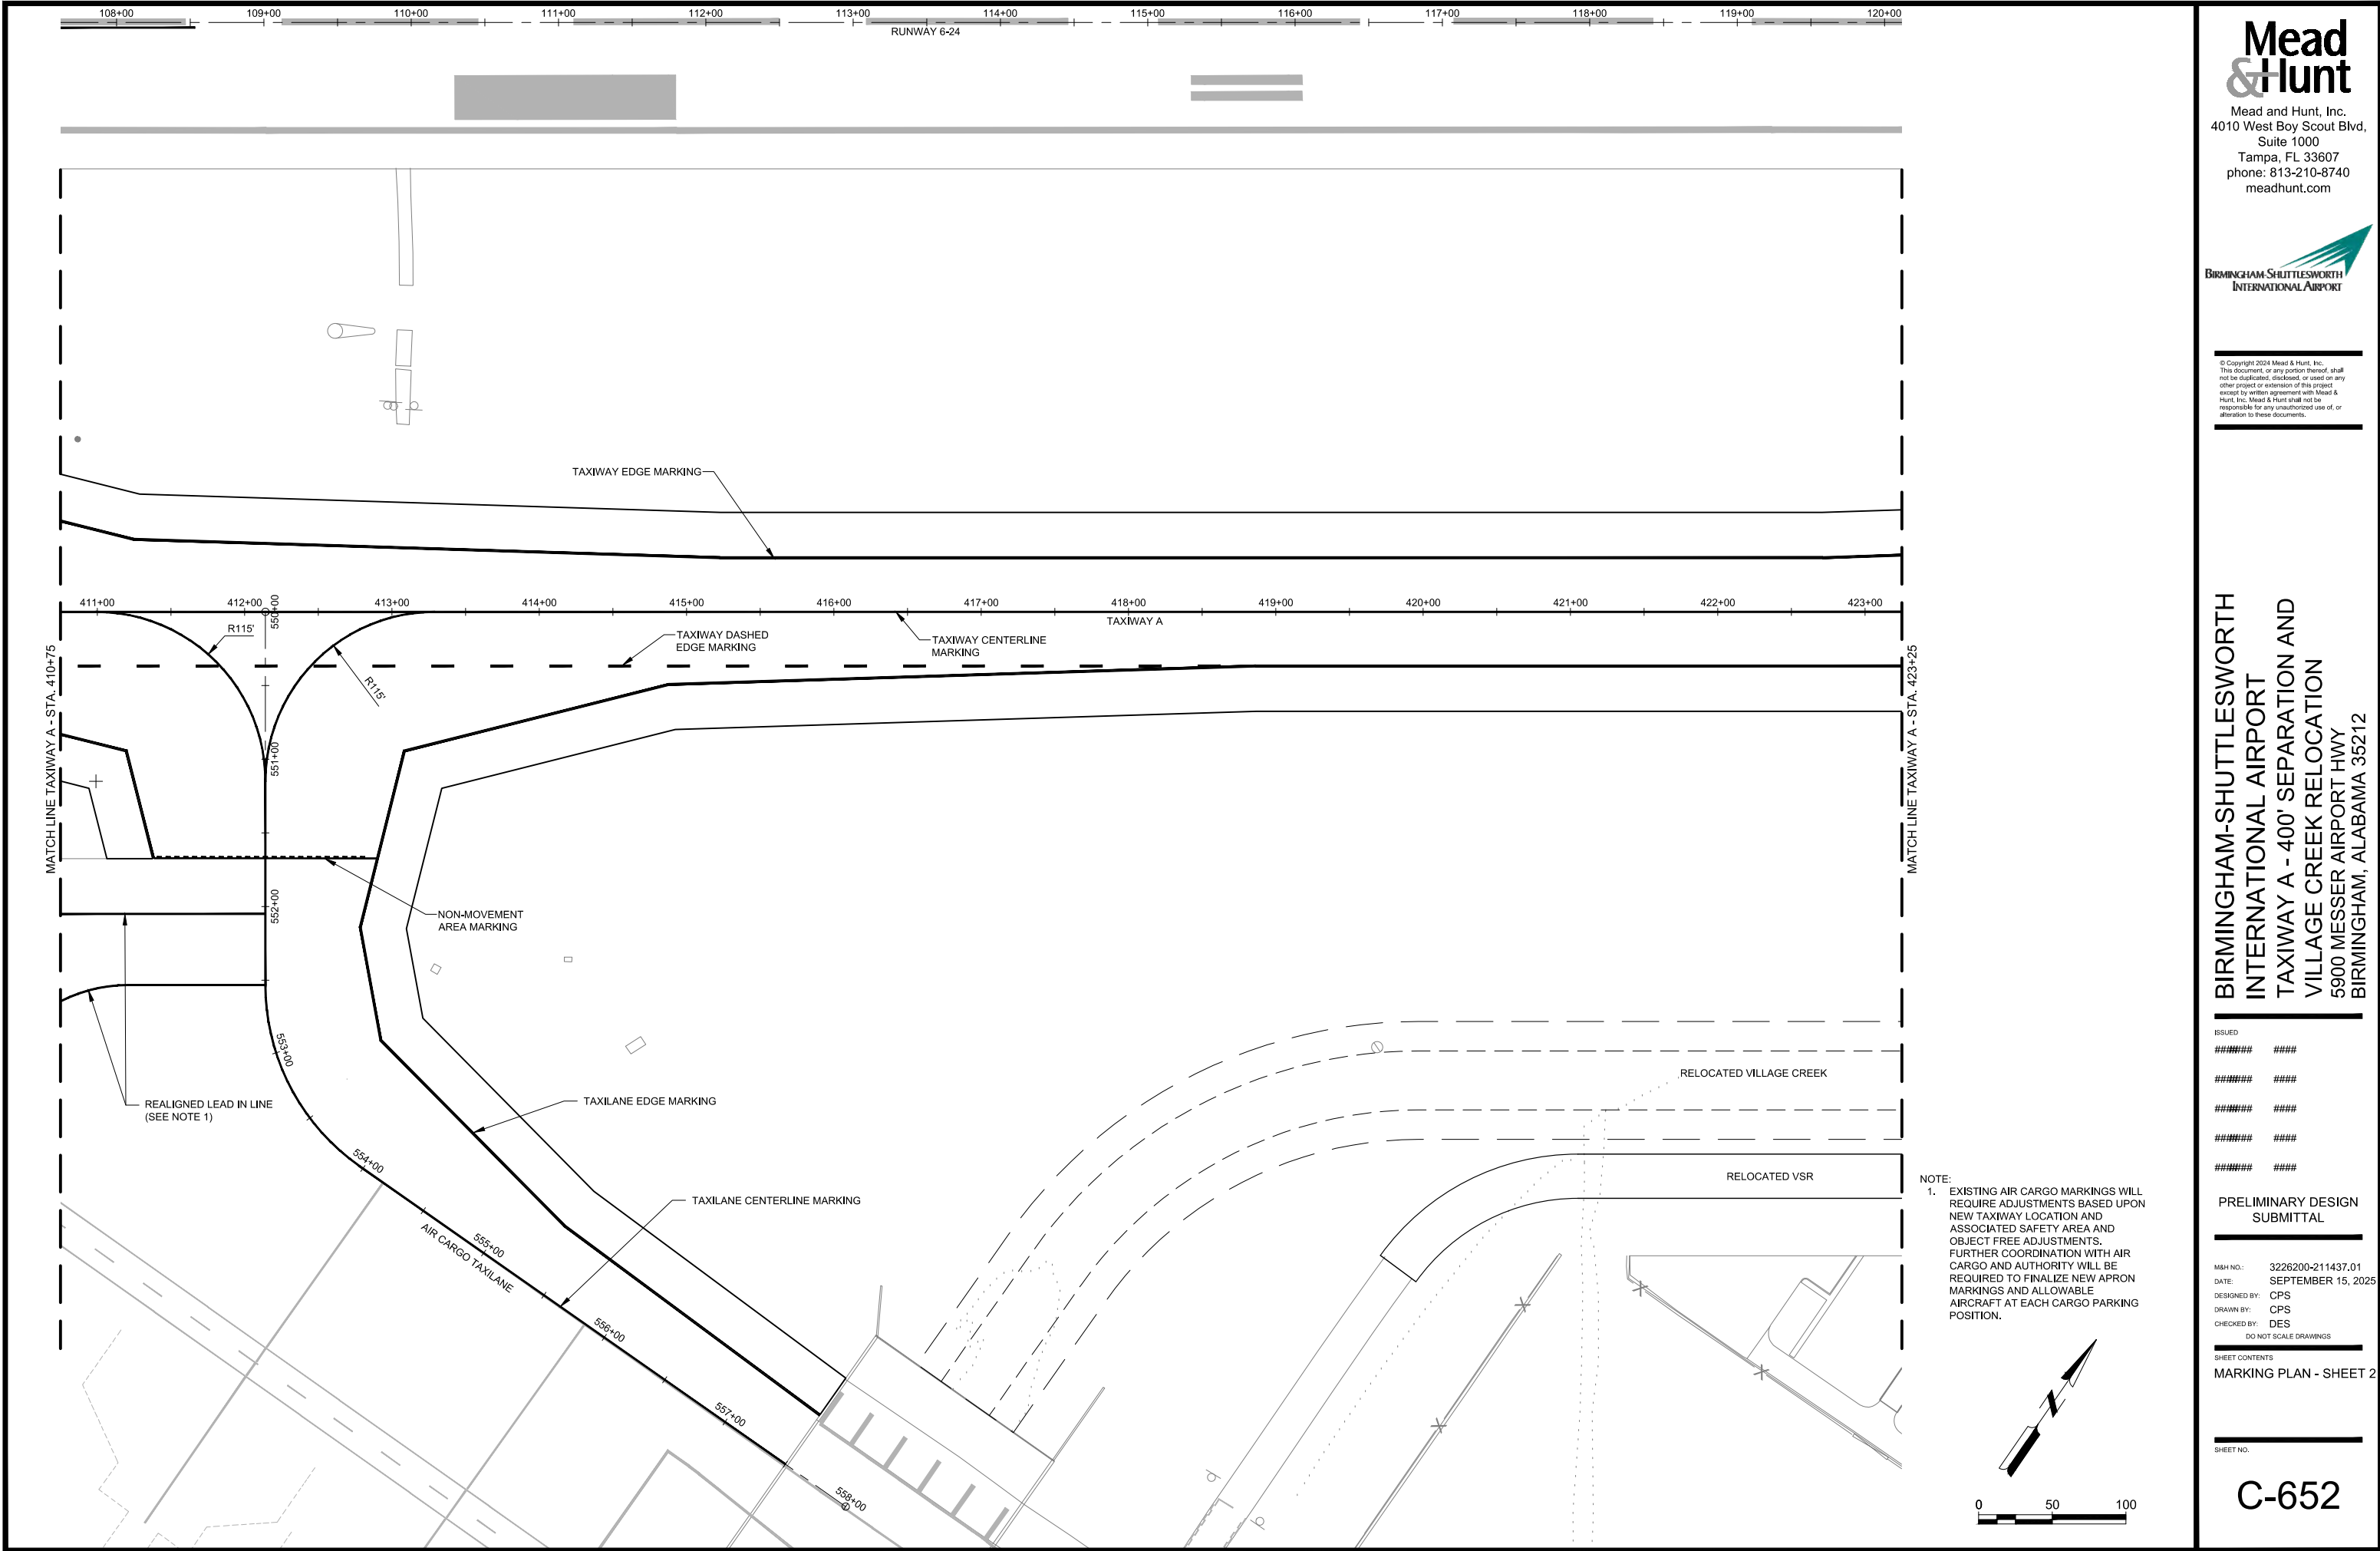
**SHEET CONTENTS  
MARKING PLAN - SHEET 1**

NOTE:  
1. EXISTING AIR CARGO MARKINGS WILL REQUIRE ADJUSTMENTS BASED UPON NEW TAXIWAY LOCATION AND ASSOCIATED SAFETY AREA AND OBJECT FREE ADJUSTMENTS. FURTHER COORDINATION WITH AIR CARGO AND AUTHORITY WILL BE REQUIRED TO FINALIZE NEW APRON MARKINGS AND ALLOWABLE AIRCRAFT AT EACH CARGO PARKING POSITION.

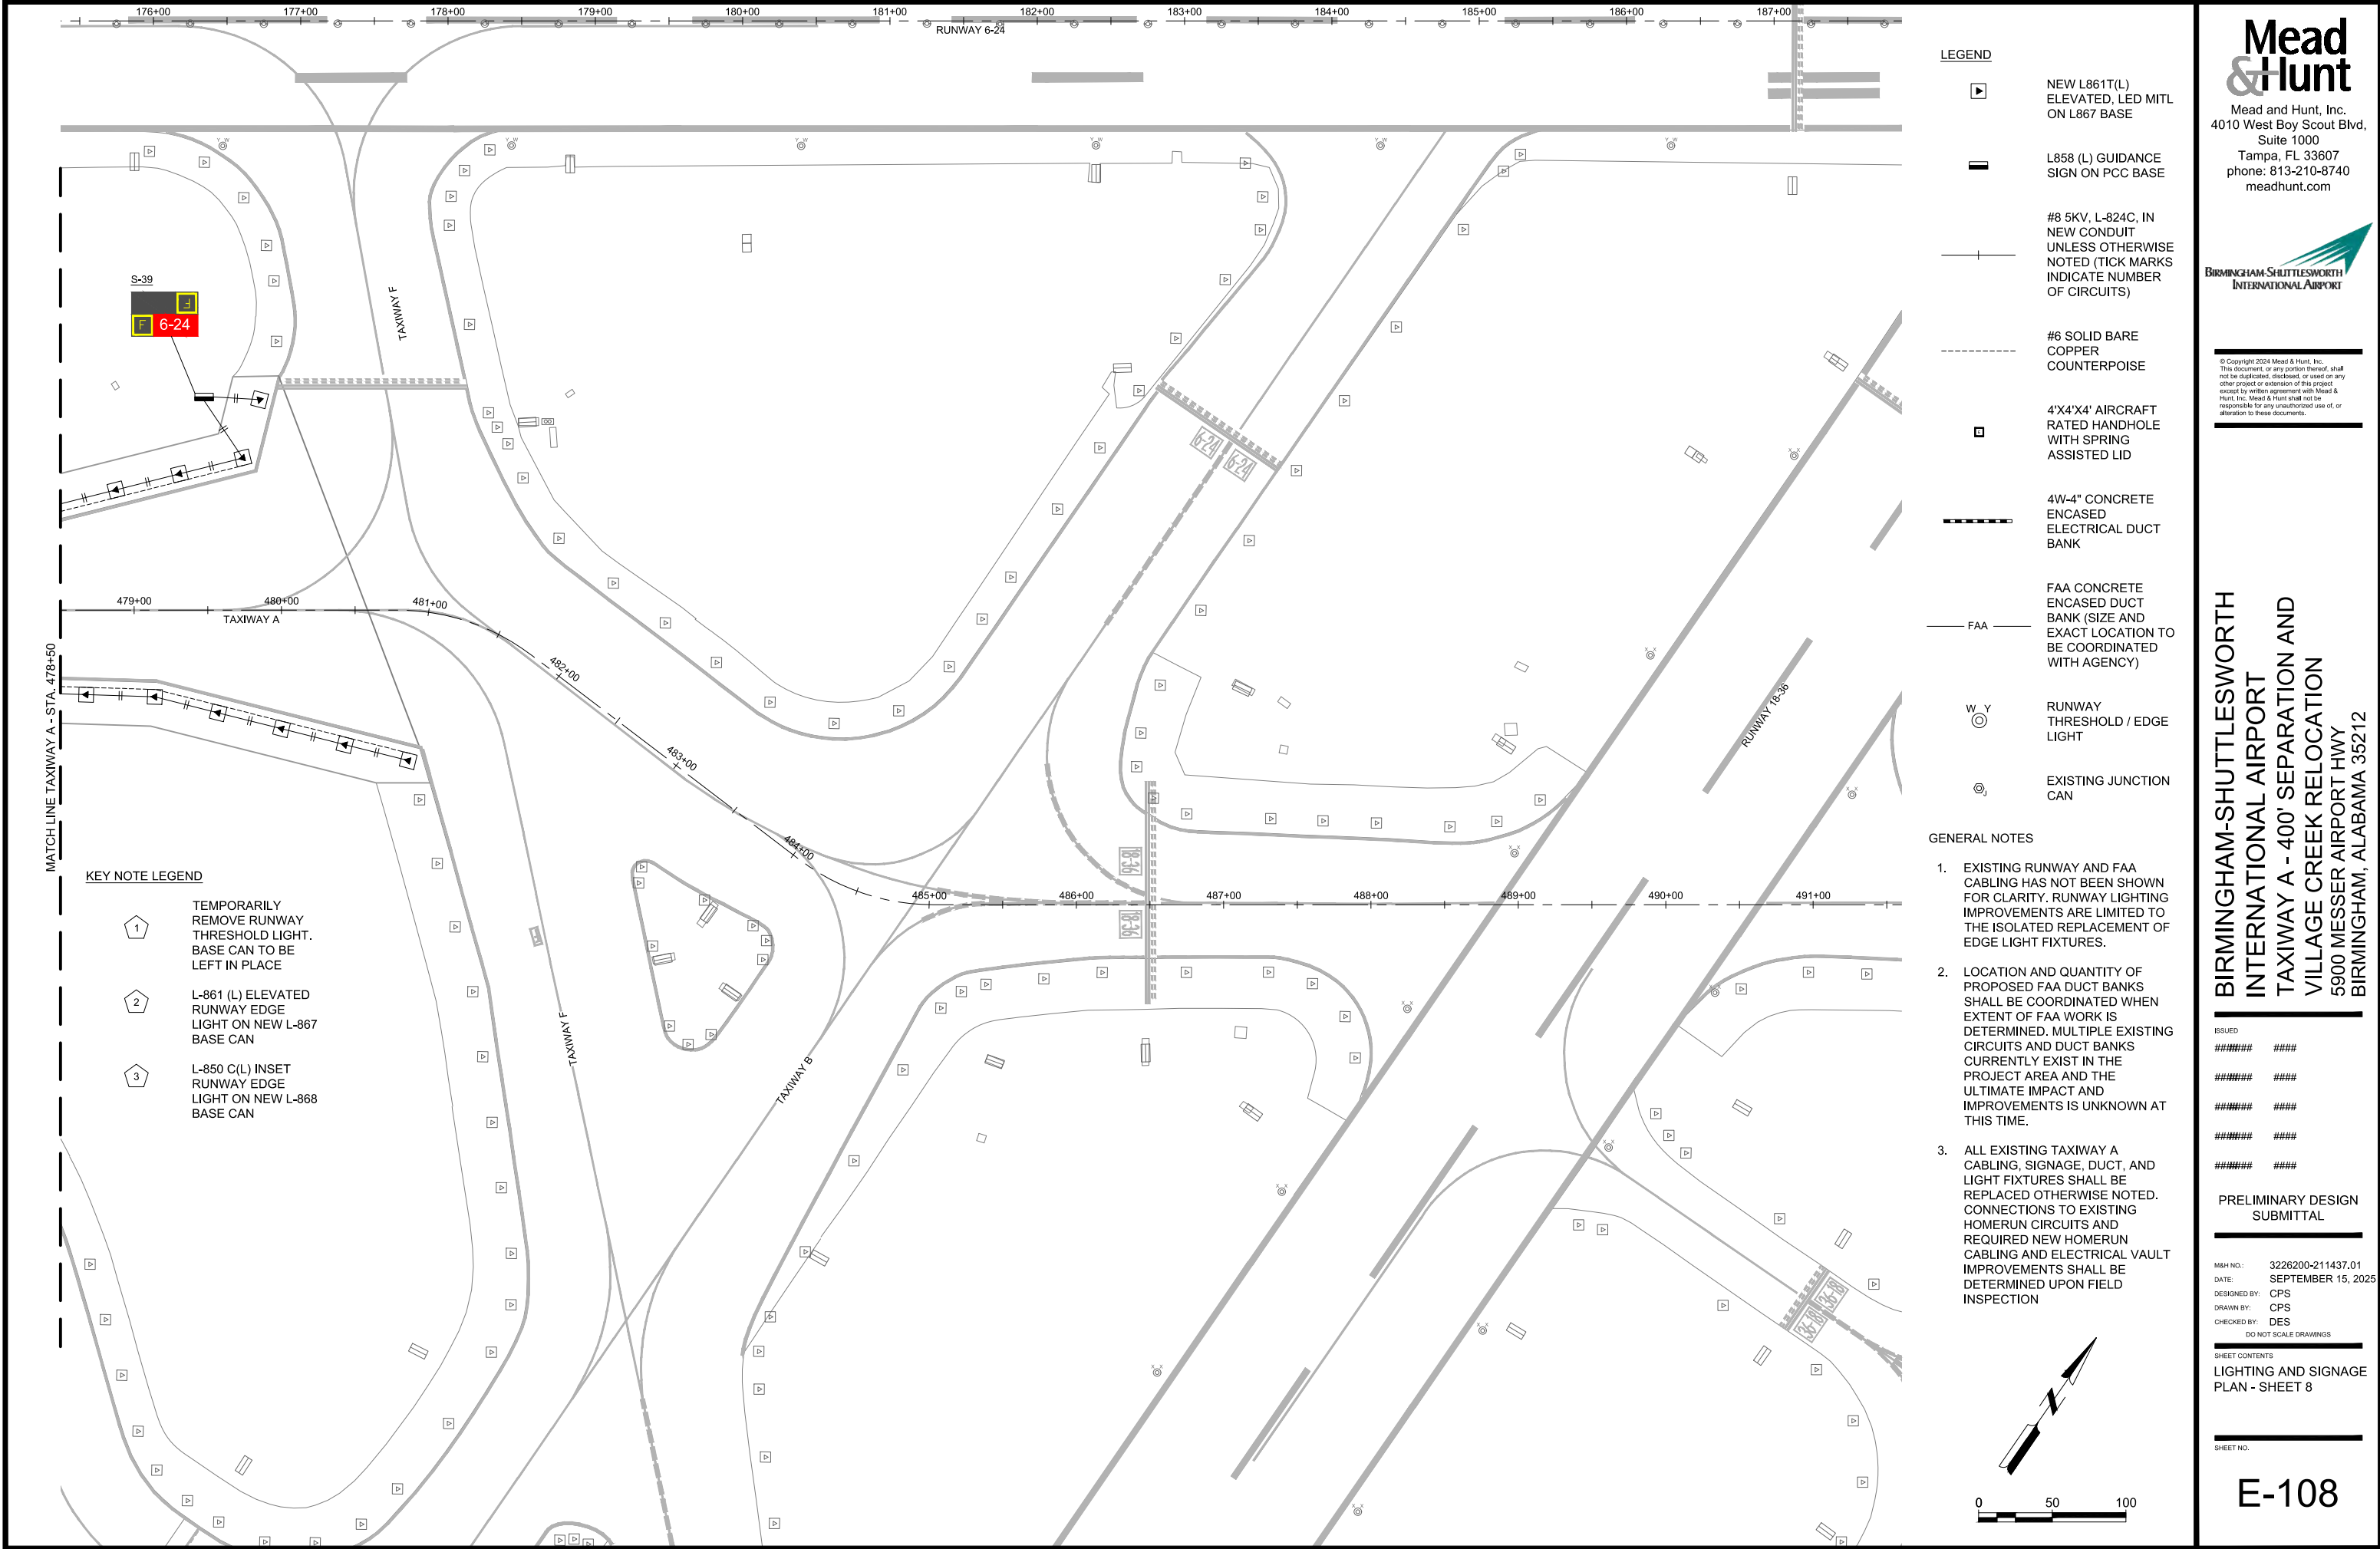
- LEGEND**
- NEW L861T(L) ELEVATED, LED MITL ON L867 BASE
  - L858 (L) GUIDANCE SIGN ON PCC BASE
  - #8 5KV, L-824C, IN NEW CONDUIT UNLESS OTHERWISE NOTED (TICK MARKS INDICATE NUMBER OF CIRCUITS)
  - #6 SOLID BARE COPPER COUNTERPOISE
  - 4'X4'X4' AIRCRAFT RATED HANDHOLE WITH SPRING ASSISTED LID
  - 4W-4" CONCRETE ENCASED ELECTRICAL DUCT BANK
  - FAA CONCRETE ENCASED DUCT BANK (SIZE AND EXACT LOCATION TO BE COORDINATED WITH AGENCY)
  - W Y RUNWAY THRESHOLD / EDGE LIGHT
  - EXISTING JUNCTION CAN
