Traffic Signal Remedial Inspection and Condition Assessment

TRB Lectern Session 2002

Management and Operation of Traffic Signals: Scrambled Transportation Systems Management and Operations For Assets

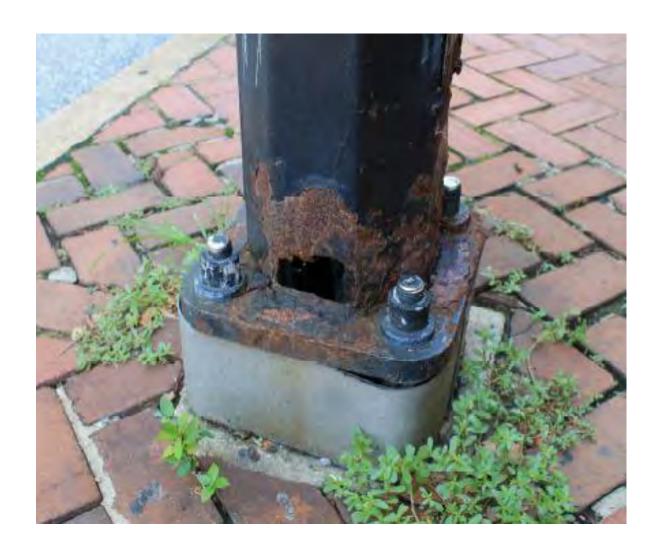
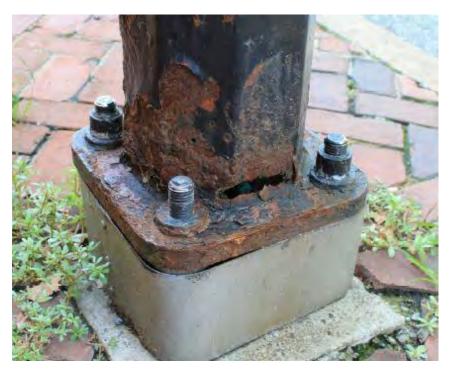
Pole Bases

Sometimes the structural damage is immediately visible.

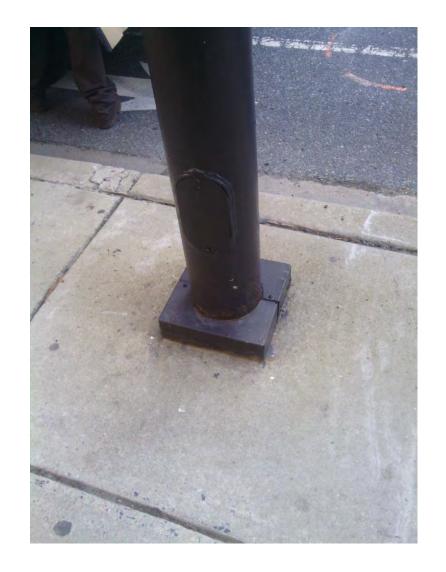
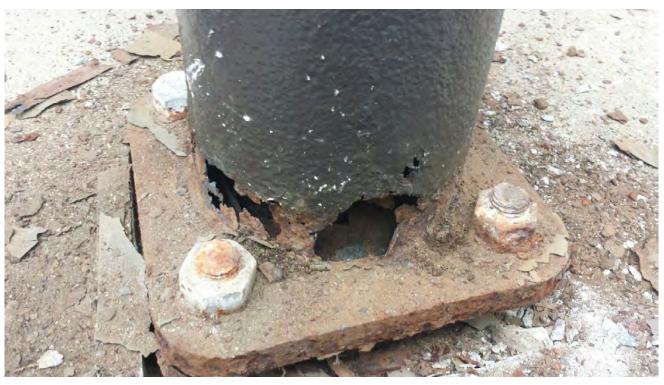
Pole Bases

Sometimes a deficiency is not immediately obvious. In this case removal of the decorative "shoebox" cover revealed major structural damage to the base of the pole.

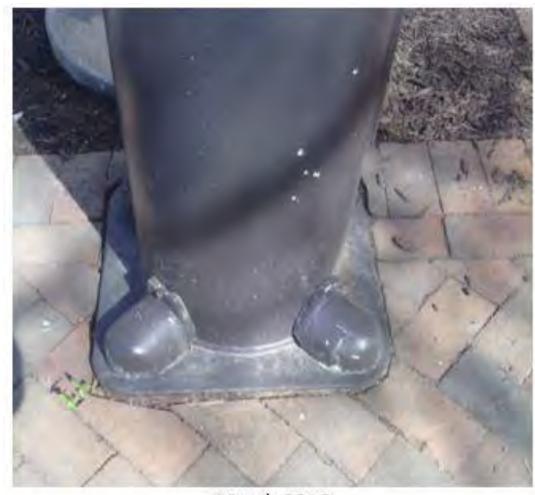
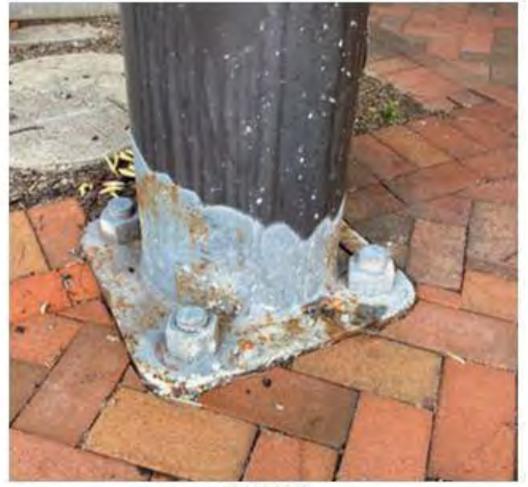
Side by Side Comparison at 5 Years

March 2016

July 2021

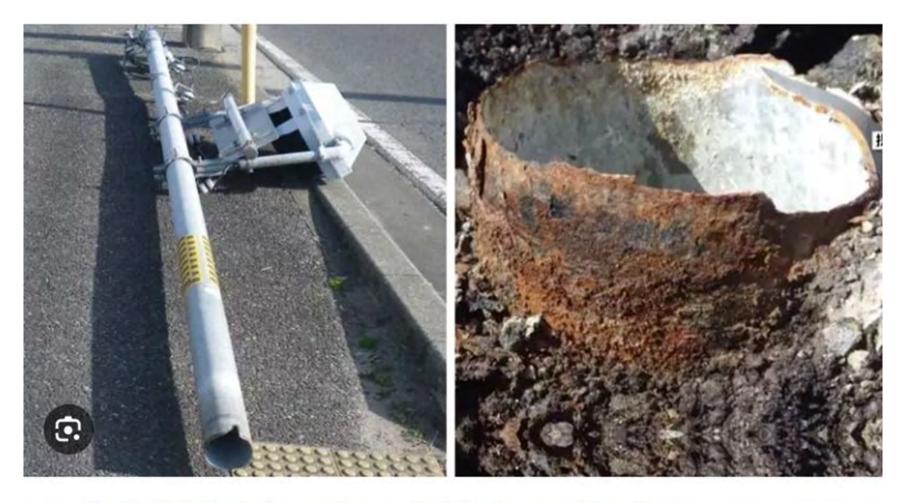
Our "Four-Legged Canine Friends"

Traffic Light Pole In Japan Snaps And Collapses After Dogs Constantly Peed On It - WORLD OF BUZZ

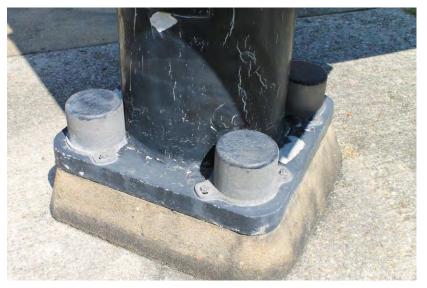
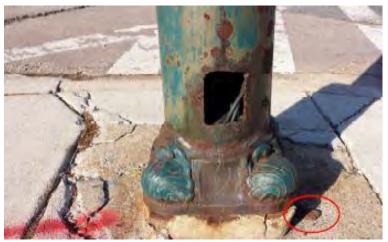
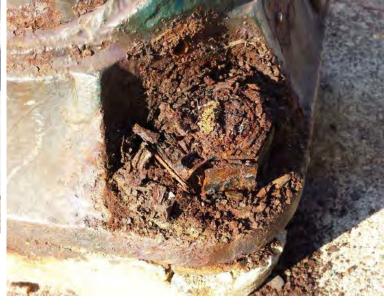
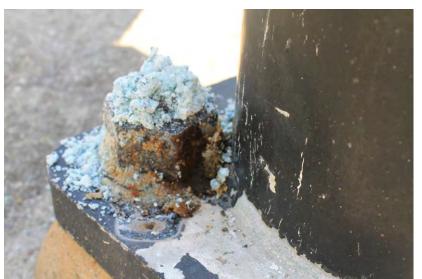
Decorative Caps

Decorative anchor bolt caps which can trap moisture and roadway and sidewalk de-icing chemicals can also hide deterioration.

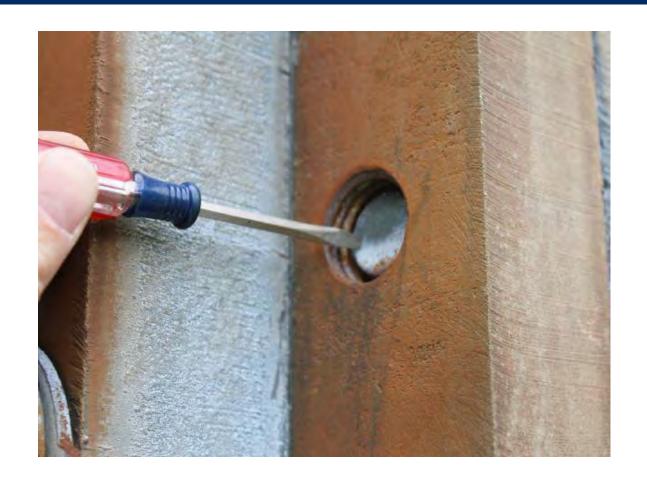
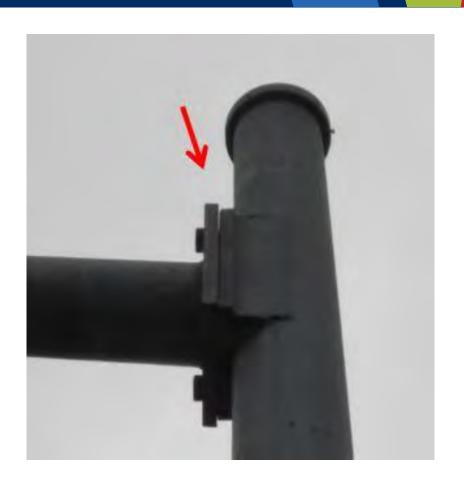
Overhead Issues

Incorrect mast-arm bolts not fully threaded, or not fully tightened.

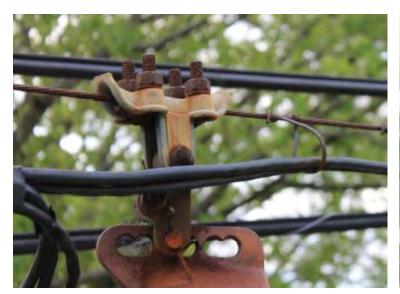
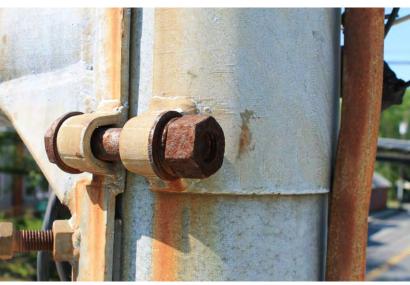
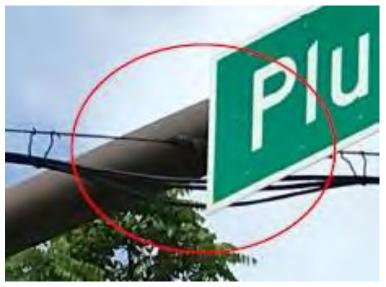
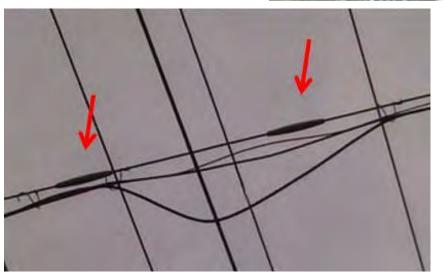
Span Wires

- Aged hardware
- Span wire splices
- Span wires with significant coercion
- Span wires in danger of being cut

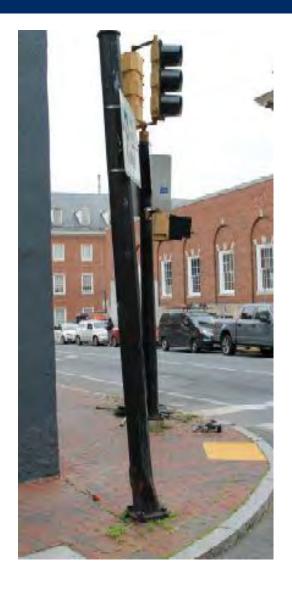
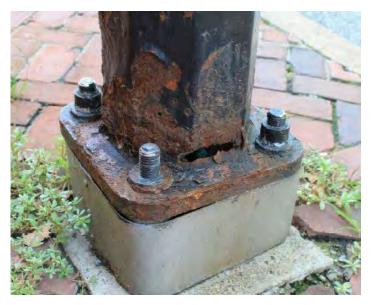
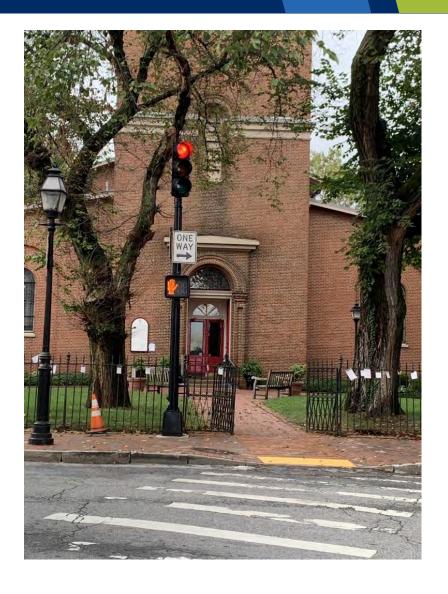
Agency D

- 25 agency owned traffic signals
- Completed their 1st inspection cycle in 2021
- Prioritized list of needed repairs
- Began almost immediate design for full traffic signal reconstruction at their highest priority location
- Highest priority location had extreme pole deterioration, vehicle impact damage, crumbling hand holes, and a signal cabinet and controller that was aged and difficult to maintain
- New traffic signal at this location was recently activated
- Asset Management Database

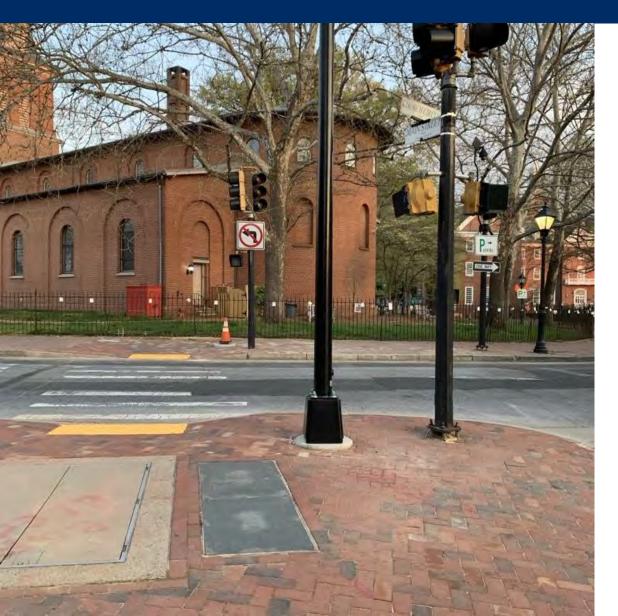
Agency D - Design Improvement

- New poles mounted on "T" Bases to mitigate potential damage from our four-legged friends
- It's easier and more cost effective to replace the "T" base than it is to have to replace the entire pole
- "T" Bases also provide breakaway capability in case of vehicle impact
