Appendix A: Threatened and Endangered Species

Project Code: 2024-0132672

Project Name: Casselton Robert Miller Regional Airport Runway Relocation

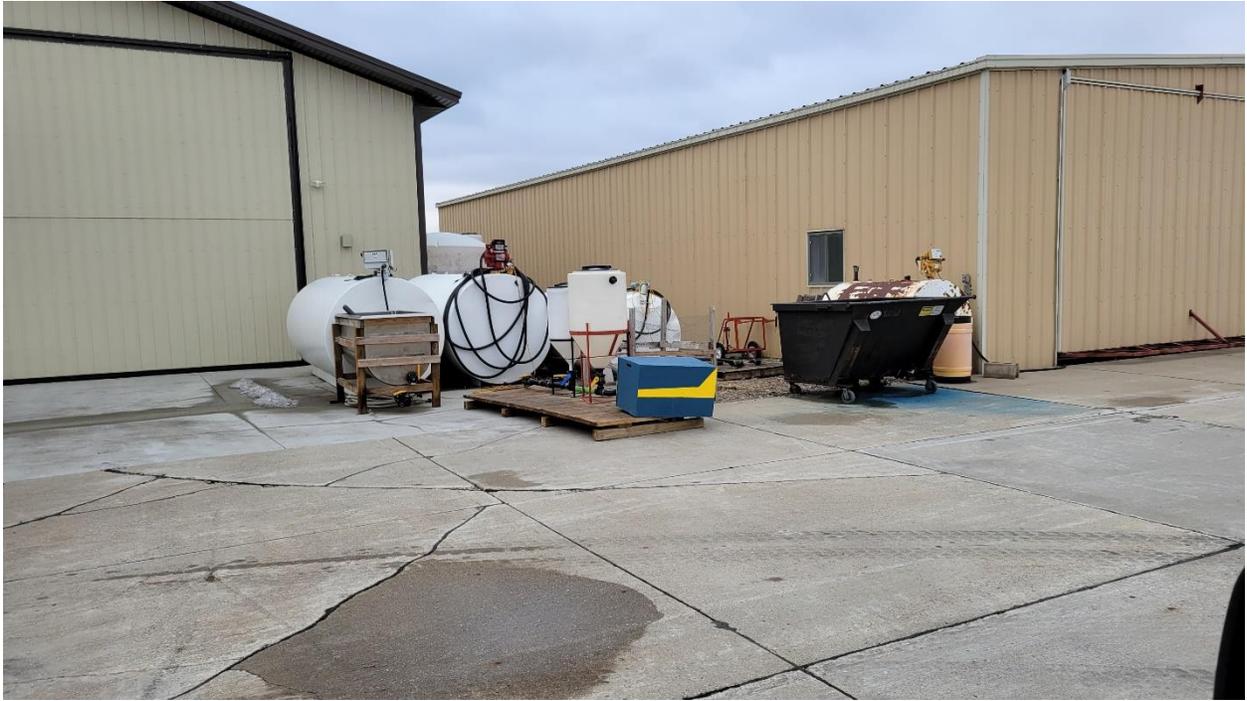
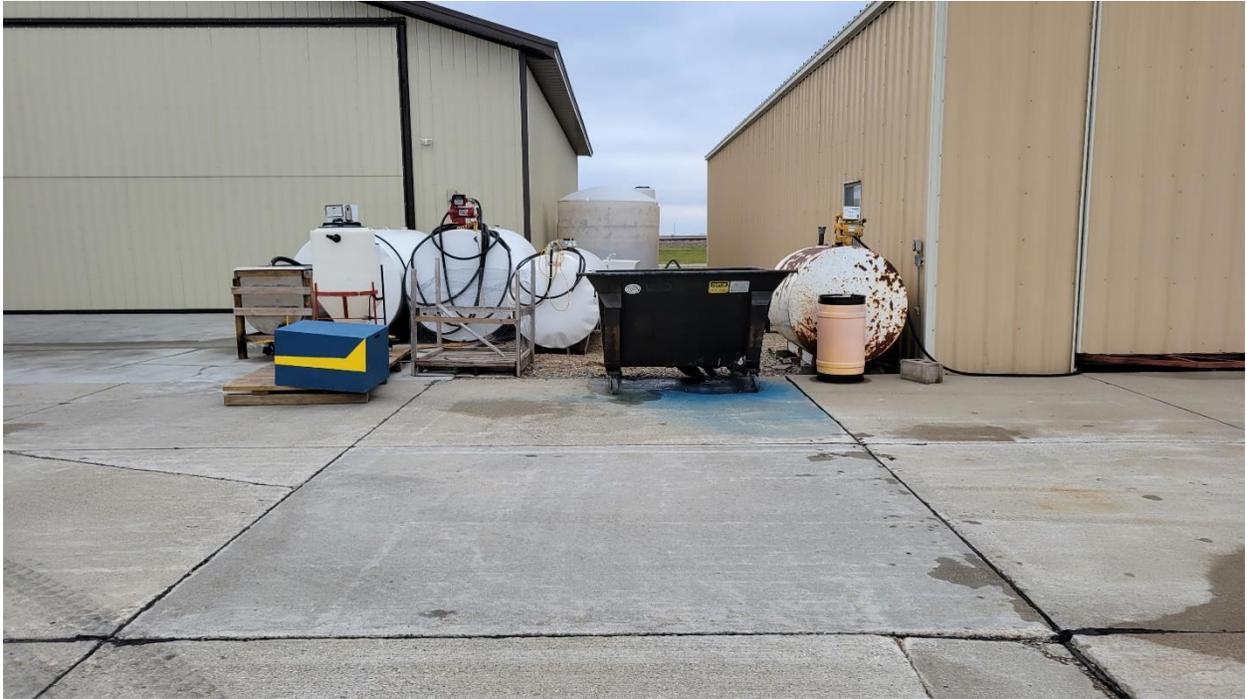
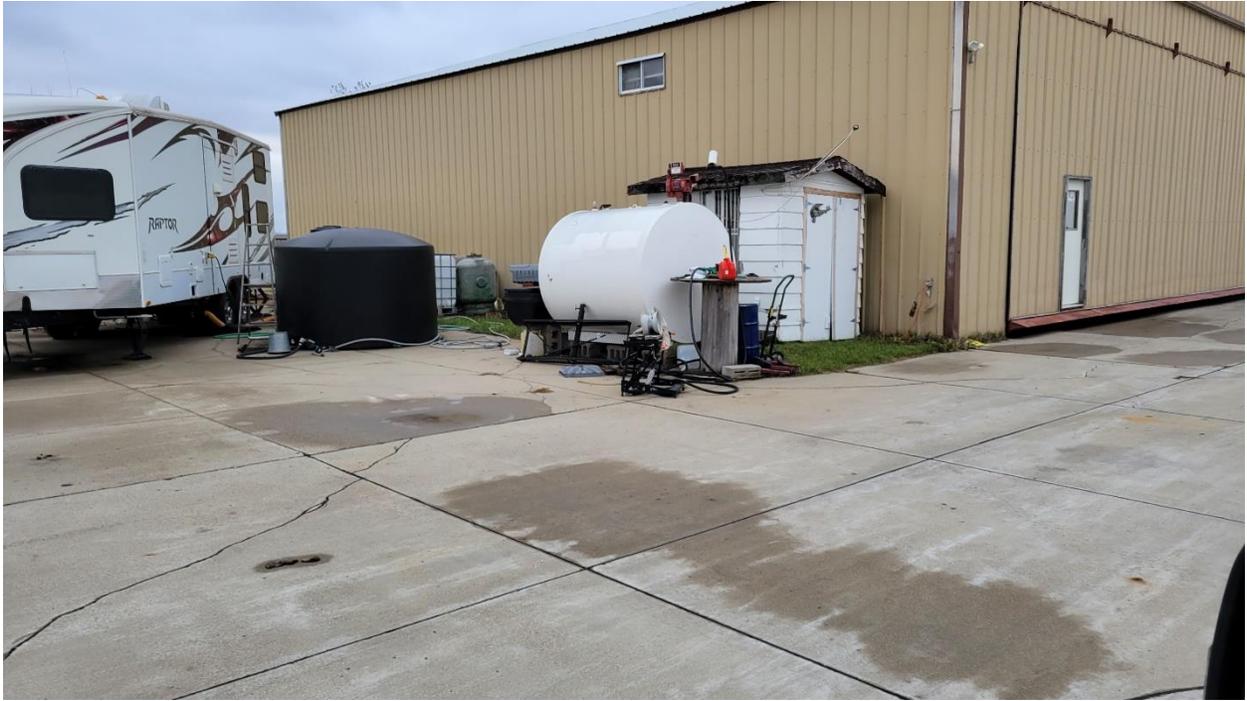
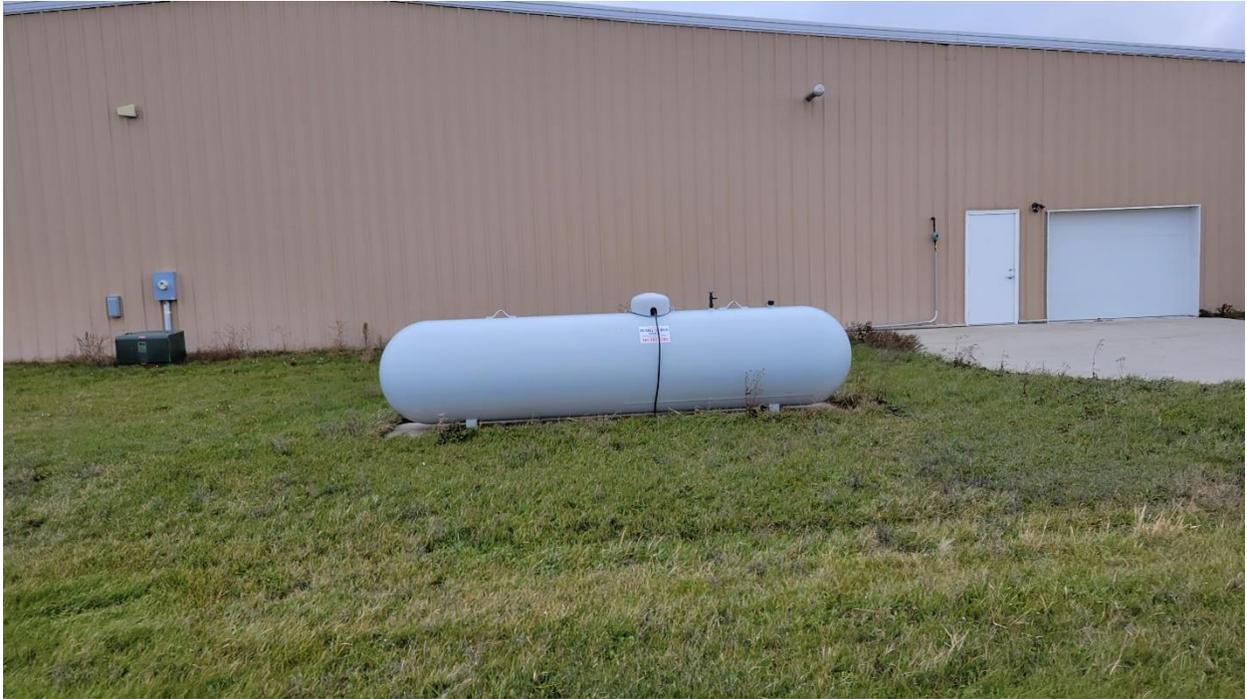
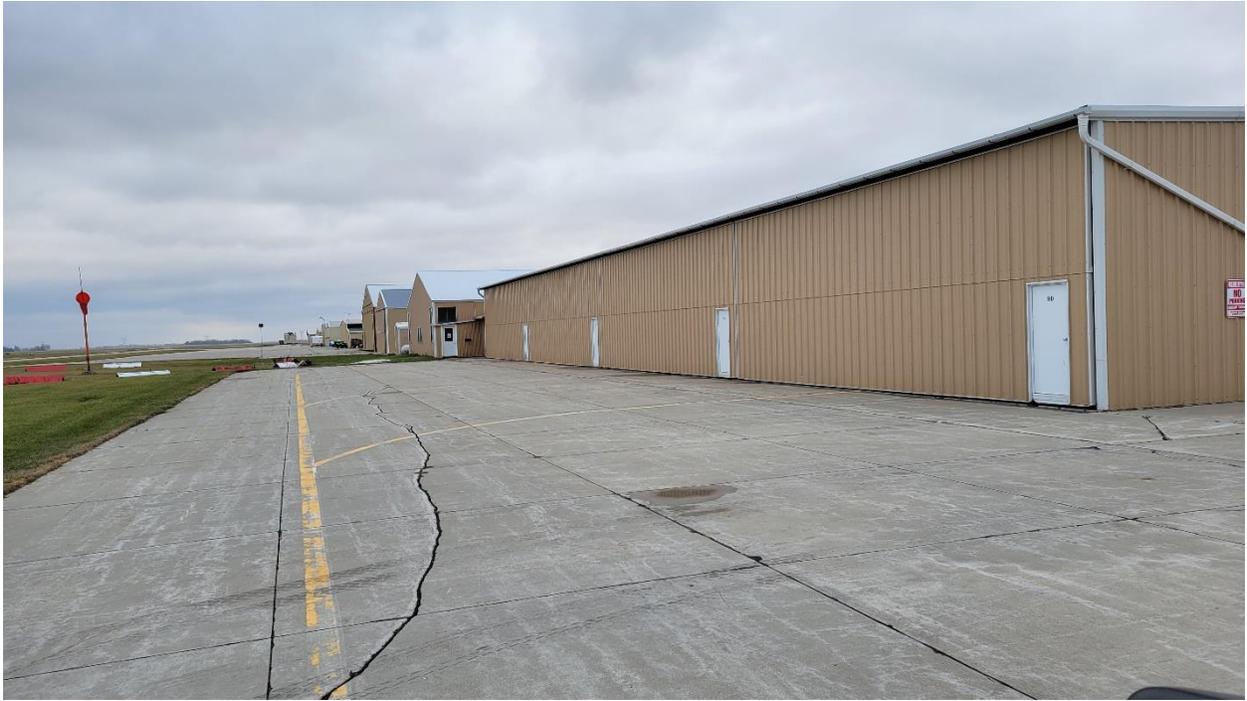
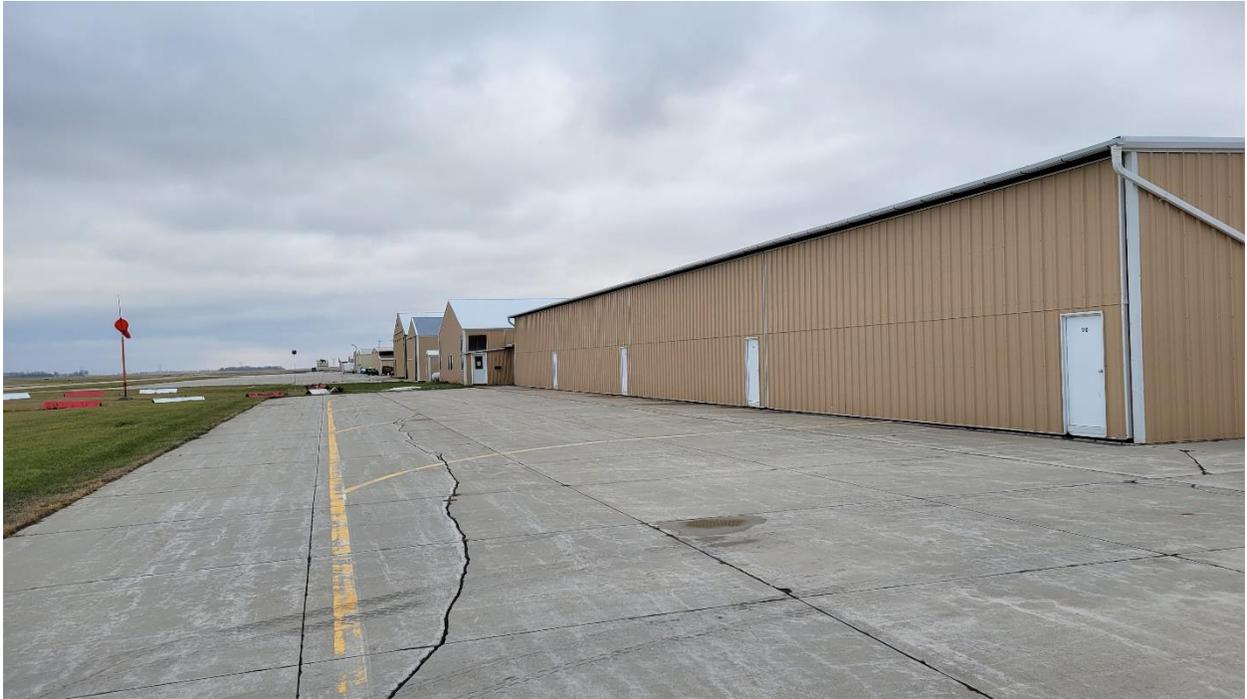
Appendix F. Photographs of On-site Structures

No evidence of underground storage tanks (USTs), aboveground storage tanks (ASTs), stained soils, stressed vegetation, landfilling, or foul odors were noted. No pits were identified on the property or immediate vicinity. No monitoring wells were found on the property. No railroad ties or other discarded items were visible along the railroad property adjacent to the Airport.

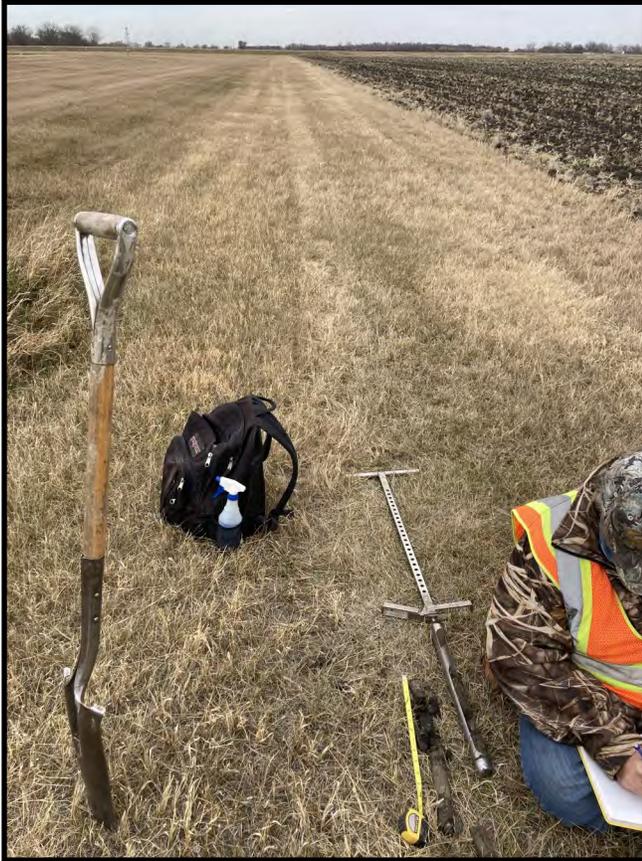
Photo 1. Non-Wetland 1 Point. Survey point for Non-Wetland Point 1 was located in the foreground of the photo near the edge of the tilled farmland on the mowed airport property. November 2, 2022 view northwest.

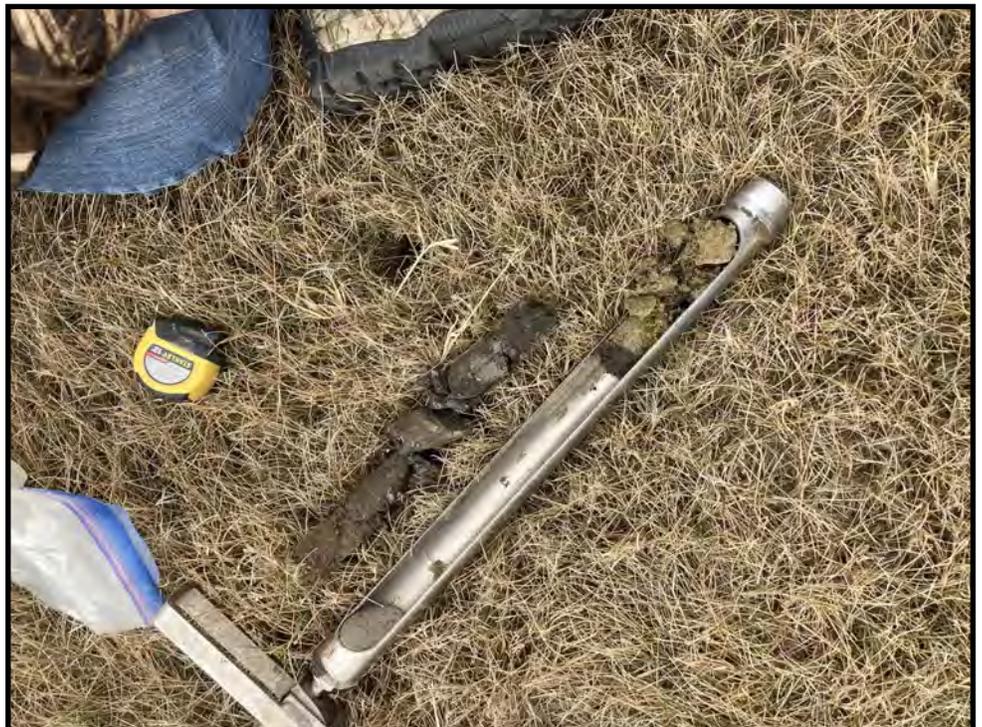
Photo 2. Upland 1 Point. View of the soils for the Upland point (Upl-1) for Wetland 1. The soil had salts present in the upper layer where mixing was present. The lighter layer present had a high value and chroma which characterized it as an upland soil. November 2, 2022.

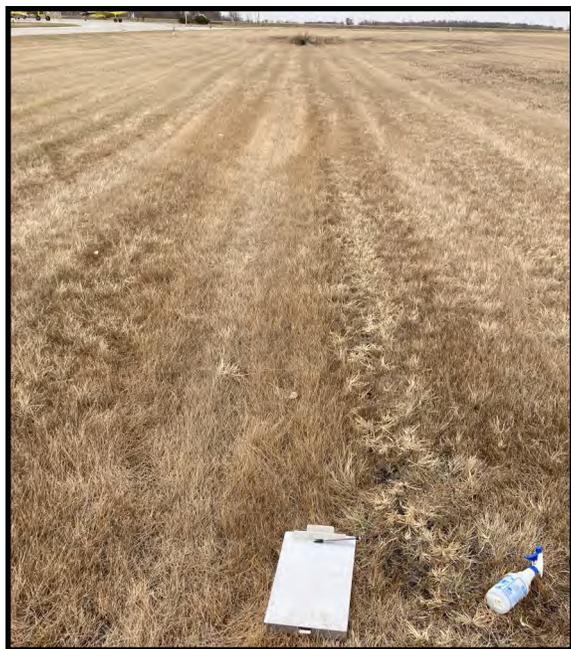
Photo 3 at left. Wetland 1 Point. View of Wetland 1B toward the culvert that connects to Wetland 1A. Near the clipboard in the foreground was the Wetland Point (W-1) for Wetland 1. The presence of Rushes (*Juncus sp.*), which are commonly a wetland plant species, and a hydric soil made the classification of a wetland. November 2, 2022 view northwest.

limited, and identification was made difficult due to the lack of fruiting structure and the dormant season. However, WPC found the dominant species in the wetland survey area to be Rushes (*Juncus sp.*, FACW) covering 75 percent of the area. There was also Kentucky Blue Grass (*Poa pratensis*, FACU) covering about 20 percent of the area with about 5 percent of bare ground present. See **Appendix C, Photographs**, Photos #3 and 4 for a visual of W-1. Plant communities did meet the Rapid Test for hydrophytic vegetation criteria.

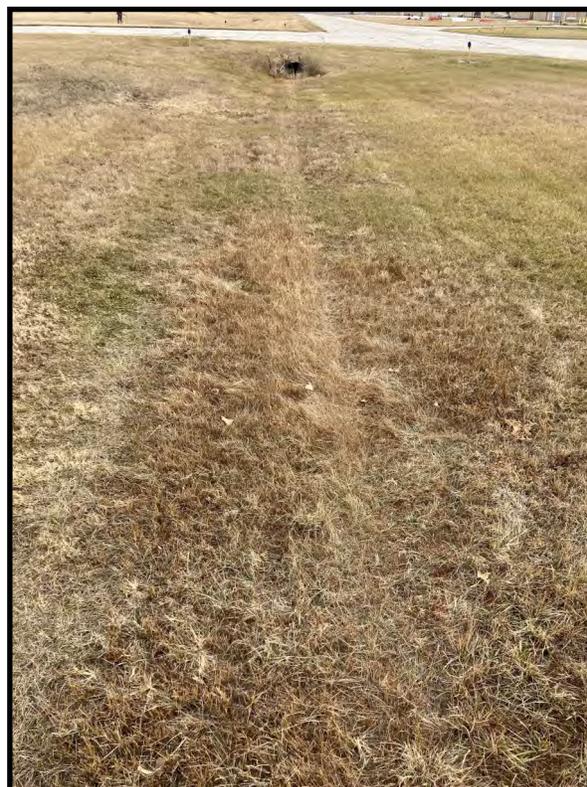
Photo 4 at right. Wetland 1A. View of Wetland 1A which had the same characteristics as Wetland 1B and was connected by the culvert under the airport taxiway. November 2, 2022 view southeast.

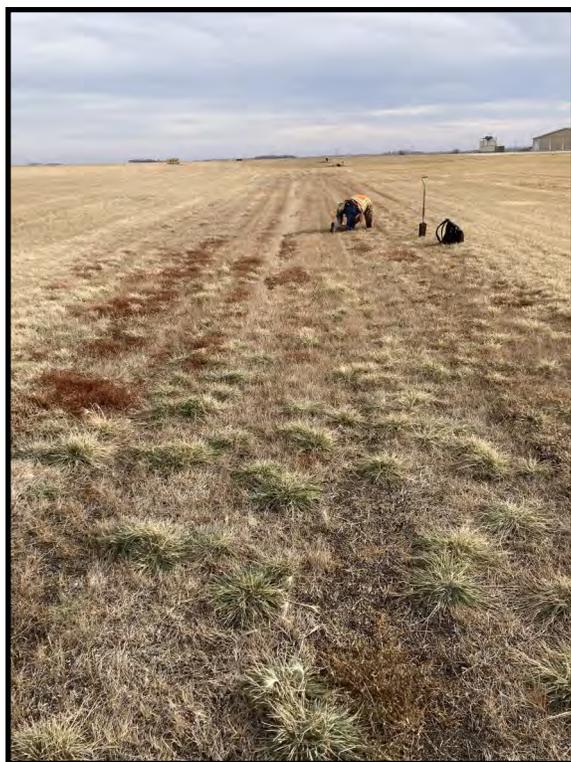
Photo 5 at left. View of Wetland 2A . Wetland 2A was mowed and was located between the airport runway and taxiway. November 2, 2022 view southeast.

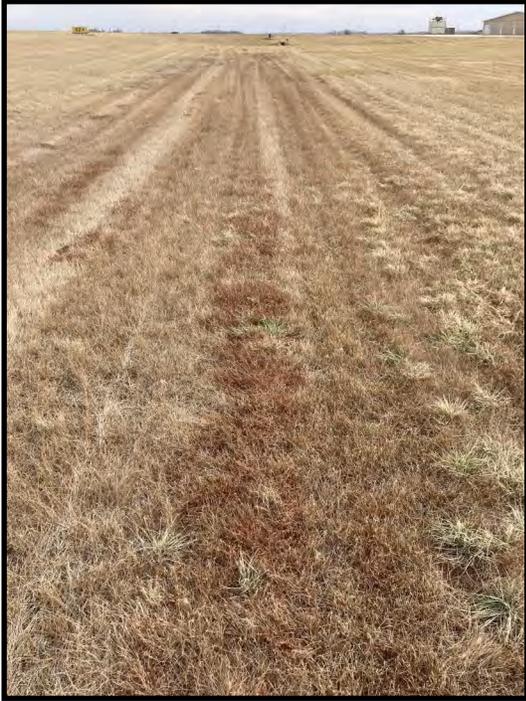
Photo 6 at left. Wetland 2 Point (W-2). View of where the survey point in foreground for Wetland 2 was located. Wetland 2 consisted of Rushes (*Juncus sp.*), Common Knotweed (*Polygonum arenastrum*), and Western Wheatgrass (*Pascopyrum smithii*). Hydric soils were also present indicating the wetland status for this area. November 2, 2022 view southeast.

The airport property where the wetland survey point (W-2) and upland survey point (Upl-2) for this wetland was maintained and mowed. Therefore, the species diversity was limited, and identification was made difficult due to the lack of fruiting structure and the dormant season. However, WPC found the dominant species in the wetland survey area to be Rushes (*Juncus sp.*, FACW) covering 55 percent of the area. Common Knotweed (*Polygonum arenastrum*, FACU) at 35 percent cover and Western Wheatgrass (*Pascopyrum smithii*, FACU) at 10 percent cover. See **Appendix C, Photographs**, Photos #5, 6, 8 for a visual of W-2 and Wetland 2A and B. Plant communities did meet the Prevalence Index for hydrophytic vegetation criteria.

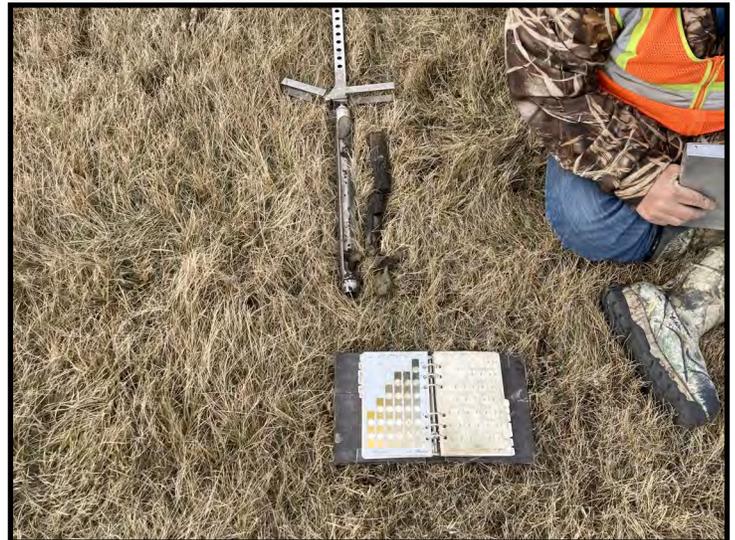
Photo 7 at right. Upland 2 Point (Upl-2). The upland point for Wetland 2 was dominated by upland grasses and hydric soils were not present. November 2, 2022

The upland point for Wetland 2 was mostly dominated by upland grasses. Kentucky Blue Grass (*Poa pratensis*, FACU) covered approximately 50 percent of the survey area followed by Smooth Brome (*Bromus inermis*, UPL) at 50 percent and a slight presence of Common Dandelion (*Taraxacum officinale*, FACU) at 10 percent. See **Appendix C, Photographs**, Photo 7 for a visual of Upl-2. Plant communities did not meet any hydrophytic vegetation criteria at the upland survey point.

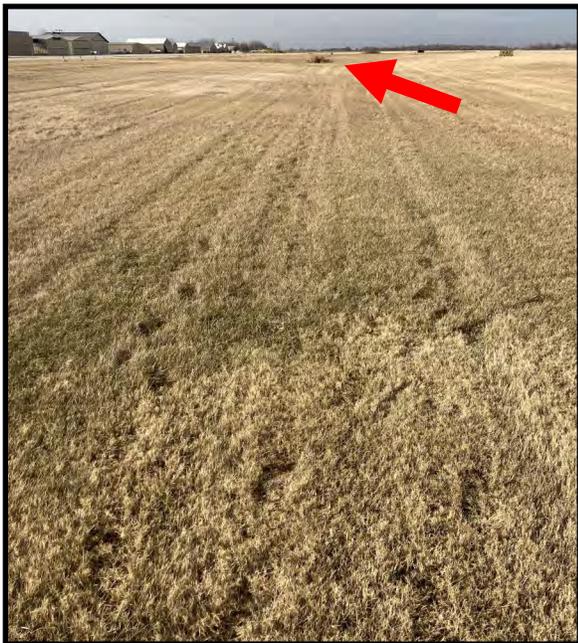
Photo 8 at left. View of Wetland 2B. Wetland 2B was connected to Wetland 2A by a culvert located in the background (red arrow) that goes underneath the taxiway. November 2, 2022 view northwest.

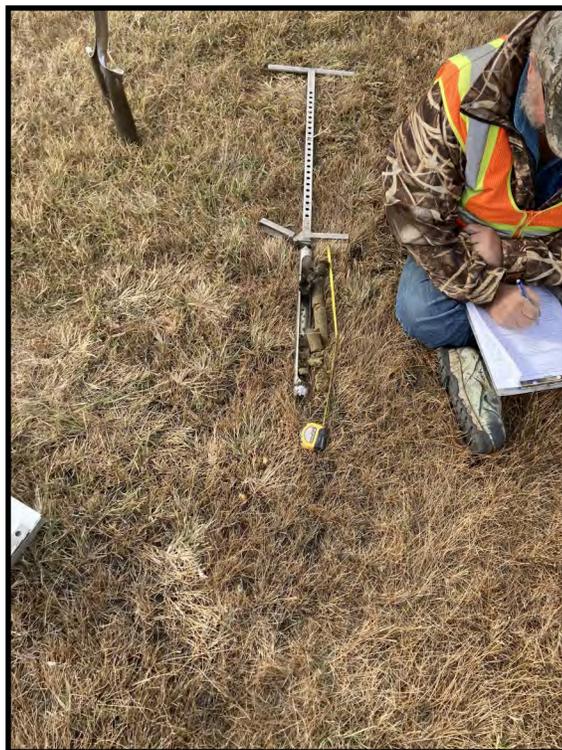
Photo 9 at left. Non-Wetland 2 Point was located to the southwest of Wetland 2B to the southwest of the taxi-way. The soils in this area were not hydric because of the high value and chroma that was present in the B horizon. November 2, 2022.

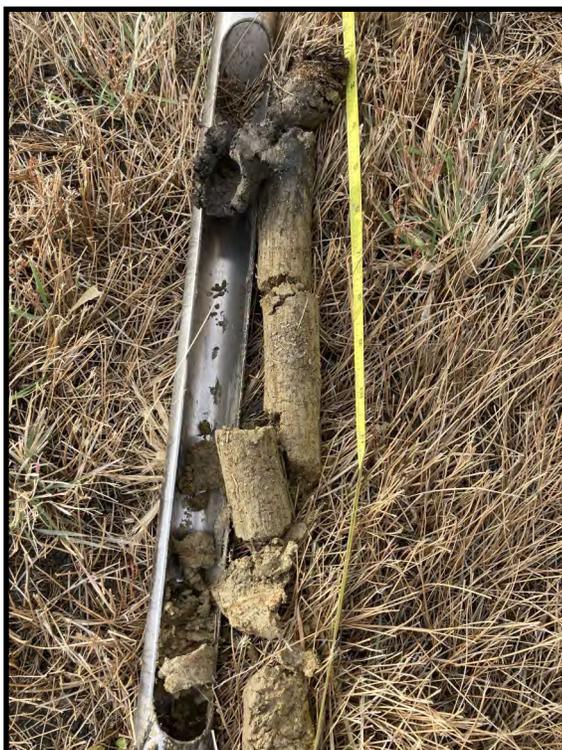
Photo 11 at left. Brightly colored soils mentioned in photo 9. Presence of the lightly colored soils indicate there was no wetland present. November 2, 2022

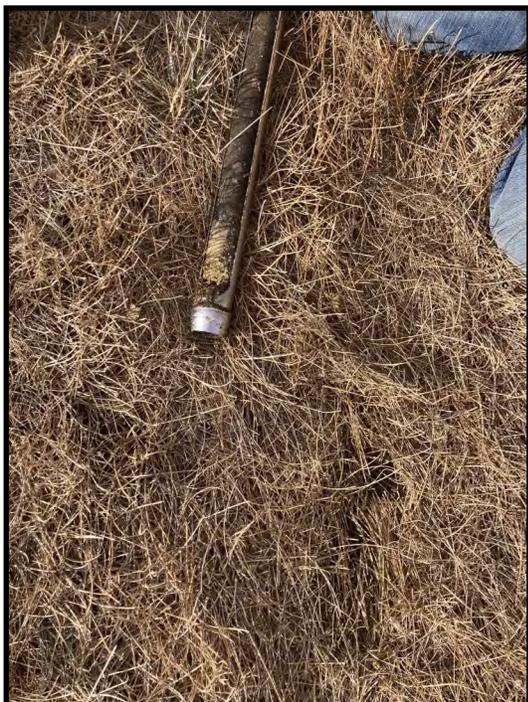
Photo 12 at left. Non-Wetland 3 Point. November 2, 2022. Soils from Non-Wetland 3 survey that were similar to the soils shown in photo 11. The Value and Chroma of the soils had too high of a value to be characterized as a hydric soil.

The airport property where survey point Non-Wetland 3 was located was maintained and mowed. Therefore, the species diversity was limited, and identification was made difficult due to the lack of fruiting structure and the dormant season. However, WPC found the dominant species in the survey area to be Rushes (*Juncus sp.*, FACW) covering 100 percent of the area with 5 percent bare ground. See **Appendix C, Photographs**, Photos #12 and 13 for a visual of the survey area of Non-Wetland 3. Plant communities did meet the Rapid Test for hydrophytic vegetation criteria.

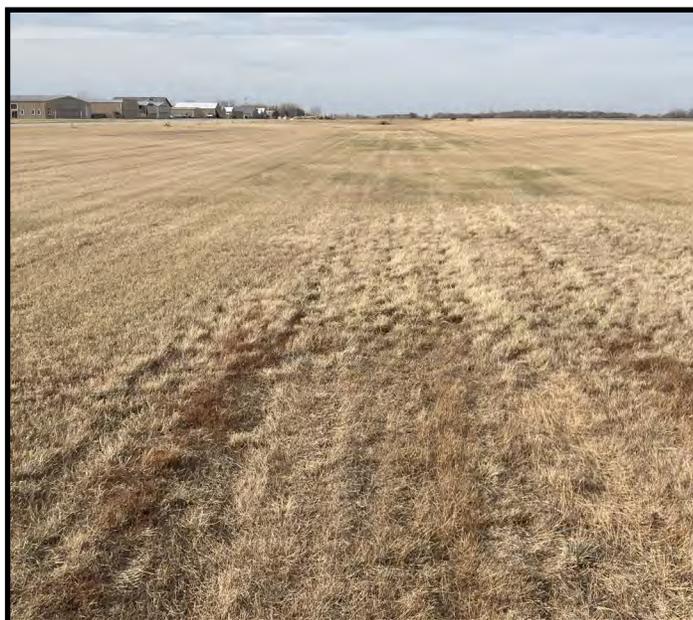
Photo 13 at right. Non-Wetland 3 point view. Area from where the survey in photo 12 was taken. Rushes (*Juncus sp.*), were present but the lack of hydric soils and strong hydrology indicated that a wetland was not present. November 2, 2022 view northwest.

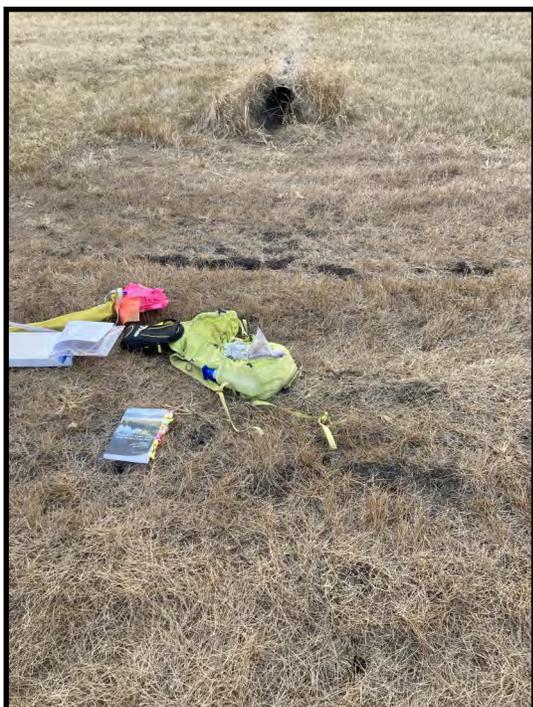
Photo 14 at left. Wetland 3 point (W-3) November 2, 2022 view southwest. Wetland 3 sampling point was located near the equipment in the middle of the photo. Water appeared to have been ponding in this area after moving through the culvert in the background of the photo. Wetland vegetation, soils, and hydrology were present here.

The airport property where the wetland survey point (W-3) and upland survey point (Upl-3) for this wetland were maintained and mowed. Therefore, the species diversity was limited, and identification was made difficult due to the lack of fruiting structure and the dormant season. However, WPC found the dominant species in the wetland survey area to be Rushes (*Juncus sp.*, FACW) covering 85 percent of the area with a sparse 2 percent of Kentucky Bluegrass (*Poa pratensis*, FACU). There was approximately 25 percent bare ground within the survey point radius. See **Appendix C, Photographs**, Photos #14 for a visual of Wetland 3. Plant communities did meet the Rapid Test for hydrophytic vegetation criteria.

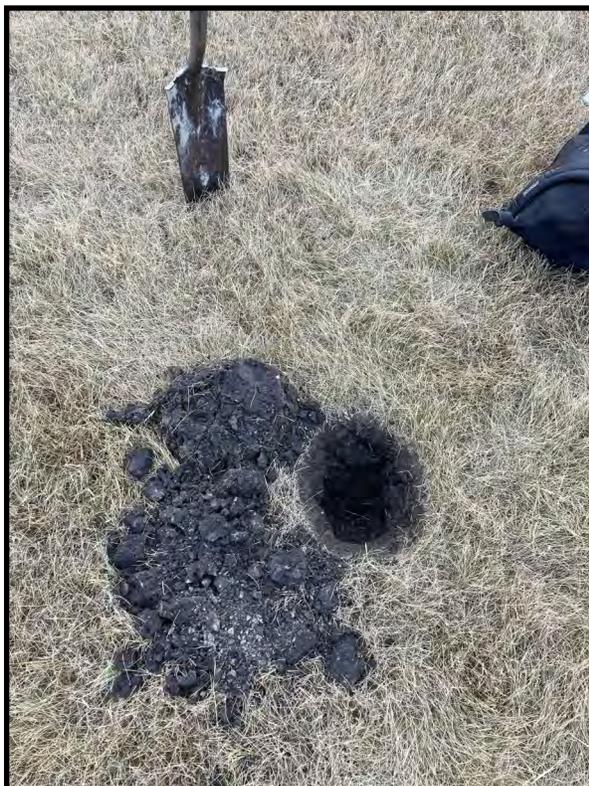
Photo 15 at left. Upland 3 Point (Upl-3). Upland 3 point was dominated by upland grasses such as Kentucky Bluegrass (*Poa pratensis*) and Common Dandelion (*Taraxacum officinale*). Hydrology and hydric soils were not present. November 2, 2022.

The upland point for Wetland 3 was mostly dominated by upland grasses. Kentucky Blue Grass (*Poa pratensis*, FACU) covered approximately 50 percent of the survey area followed by Smooth Brome (*Bromus inermis*, UPL) at 50 percent and a slight presence of Common Dandelion (*Taraxacum officinale*, FACU) at 5 percent. There was approximately 5 percent bare ground within the point radius. See **Appendix C, Photographs**, Photos #15 for a visual of Upl-3. Plant communities did not meet any hydrophytic vegetation criteria at the upland survey point.

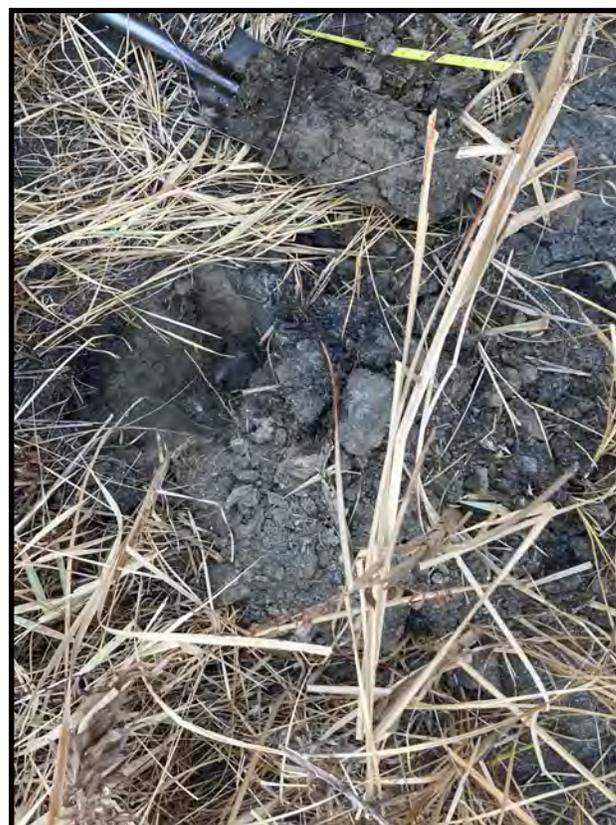
Photo 16 at right. Wetland 4 Point (W-4). November 3, 2022. View of the hydric soils that were present for the Wetland 4 area.

The wetland survey point (W-4) was within a channel that was near the railroad tracks off-Site. The upland survey point (Upl-4) and additional wetland point (W-4E) for this wetland was maintained and mowed because it was near or in the road ditch. Therefore, the species diversity was limited in Upl-4 and W-4E, and identification was made difficult due to the lack of fruiting structure and the dormant season. However, WPC found the dominant species in the wetland survey area W-4 to be Reed Canary Grass (*Phalaris arundinacea*, FACW) covering 40 percent of the area and Cattails (*Typha sp.*, OBL) covering 30 percent. There was approximately 30 percent of bare ground within the survey point radius. See **Appendix C, Photographs**, Photos #17 and 18 for a visual of the W-4 survey point area. Plant communities did meet the Rapid Test for hydrophytic vegetation criteria.

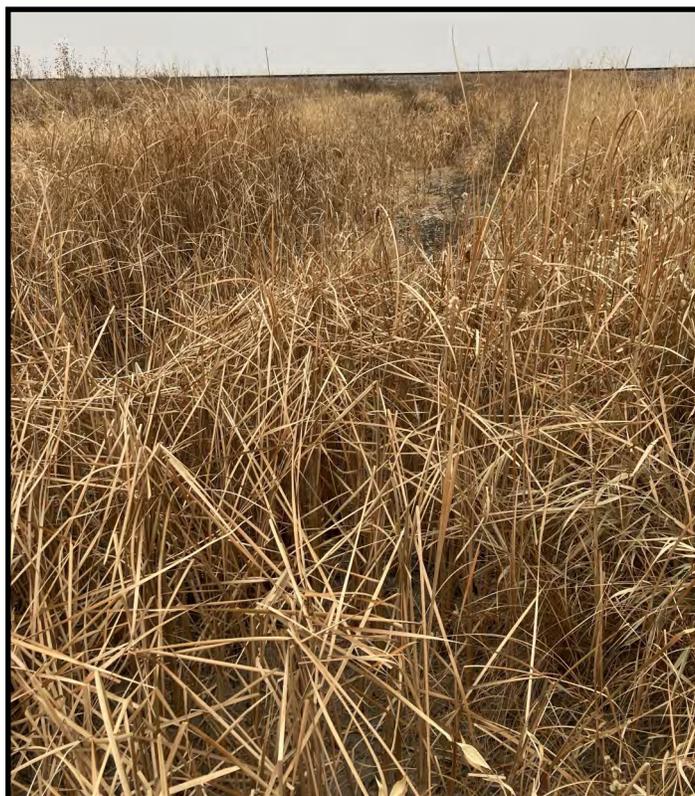
Photo 17 at left. Stand of Cattails (*Typha sp.*) present within Wetland 4A. November 3, 2022 view southeast.

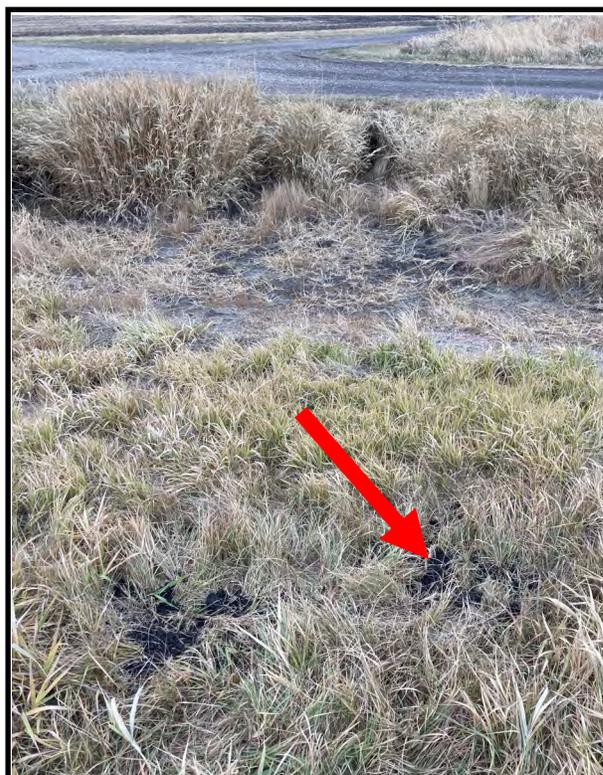
Photo 19 at right. Upland 4 Point (Upl-4) location for the Wetland 4 area. November 3, 2022 view southeast.

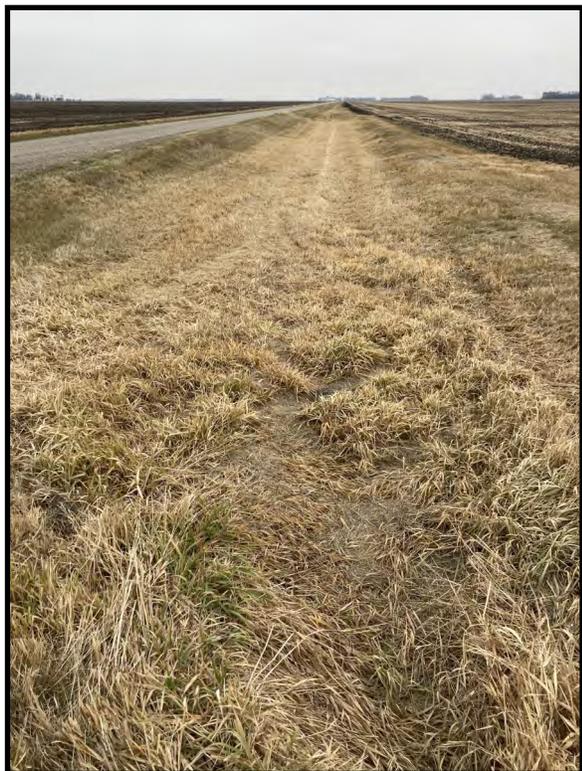
Photo 20 at left. Wetland 4B on the south side of the gravel road ditch and to the north of a farm field. The geomorphology of the ditch seemed to allow ponding and water collection. November 3, 2022 view east.

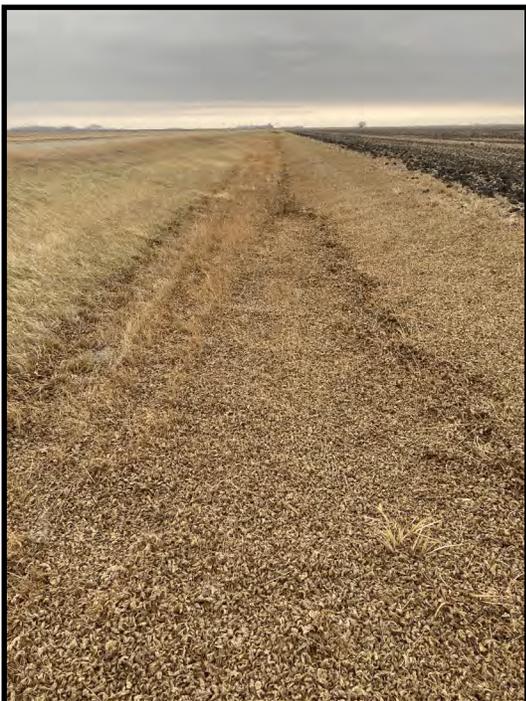
Photo 21 at left. Wetland 4D had some crop remnants within most of the wetland, but the soils and hydrology of the area classified it as a wetland. November 3, 2022 view west.

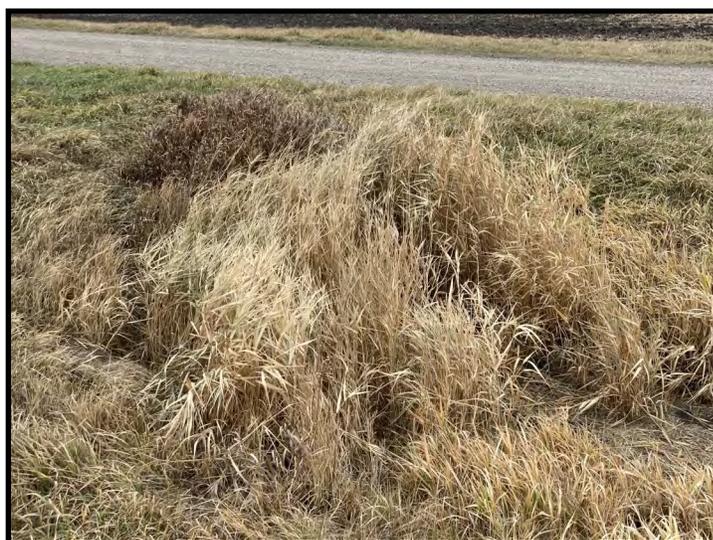
Photo 22 at right. Culvert on the edge of Wetland 4E connecting it to Wetland 4D. The stand of undisturbed grass at this point consisted of Reed canary grass (*Phalaris arundinacea*) and Prairie Cordgrass (*Spartina pectinata*). Both of these grass species are wetland indicators. November 3, 2022 view south-east.

WPC found the dominant species in the wetland survey area W-4E to be Reed Canary Grass (*Phalaris arundinacea*, FACW) covering 30 percent of the area and Rushes (*Juncus sp.*, FACW) covering 30 percent. There was approximately 20 percent of Prairie Cordgrass (*Spartina pectinata*, FACW) covering the survey point radius. See **Appendix C, Photographs**, Photos #23 and 24 for a visual of the W-4E survey point area. Plant communities did meet the Dominance Test for hydrophytic vegetation criteria.

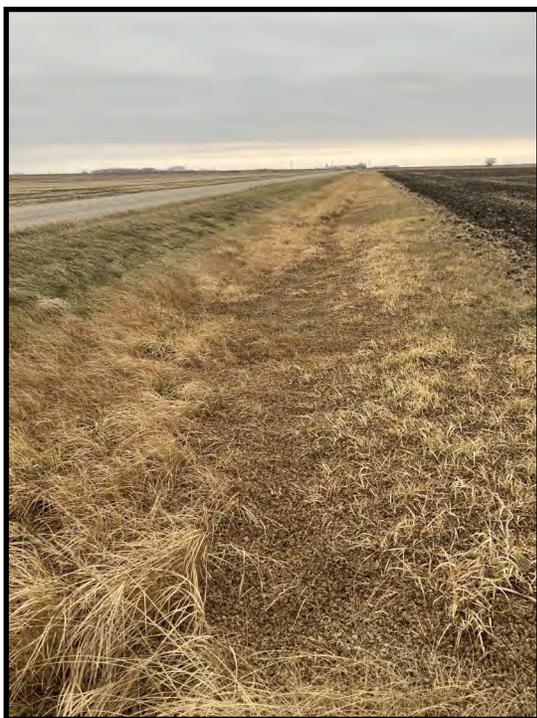
Photo 23 at left. View of Wetland 4E. This area also had an abundant amount of crop remnants within the ditch. November 3, 2022 view west.

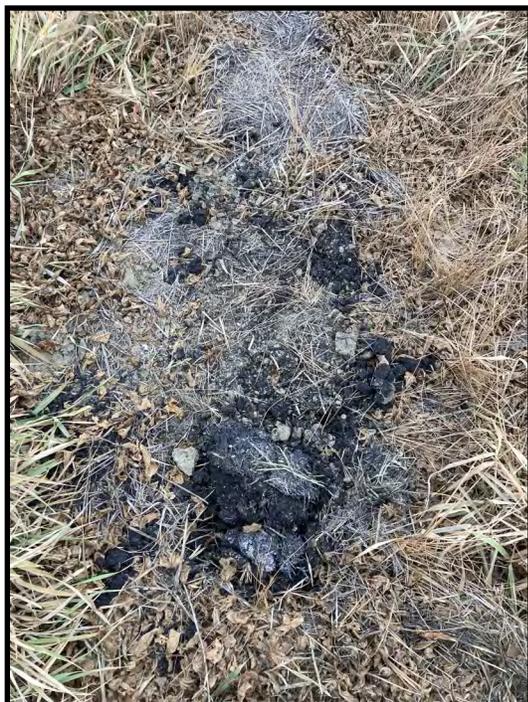
Photo 24 at left. Wetland 4E Point. This was an additional survey point to confirm that the ditches on both sides of the road have hydric soils present. November 3, 2022.

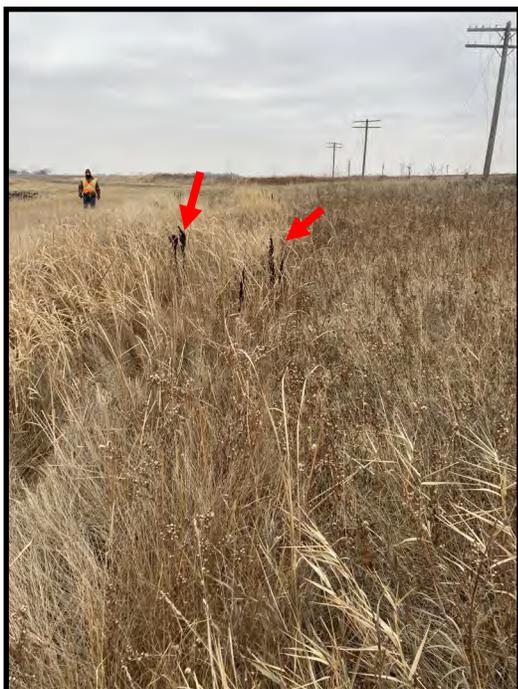
Photo 26 at left. Wetland 4H. Curled Dock (*Rumex crispus*) within the same wetland area in photo 25. November 3, 2022 view southeast.

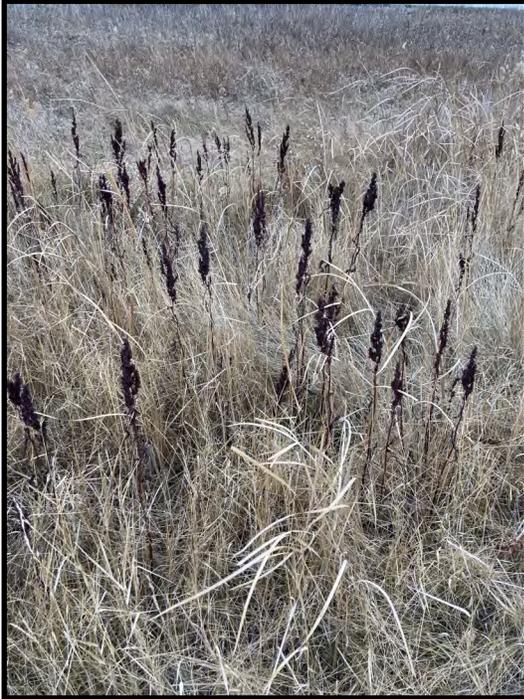
Photo 27 at left. Wetland 4H. Closer view of some Curled Dock (*Rumex crispus*) which has a facultative wetland indicator status. November 3, 2022 view west.

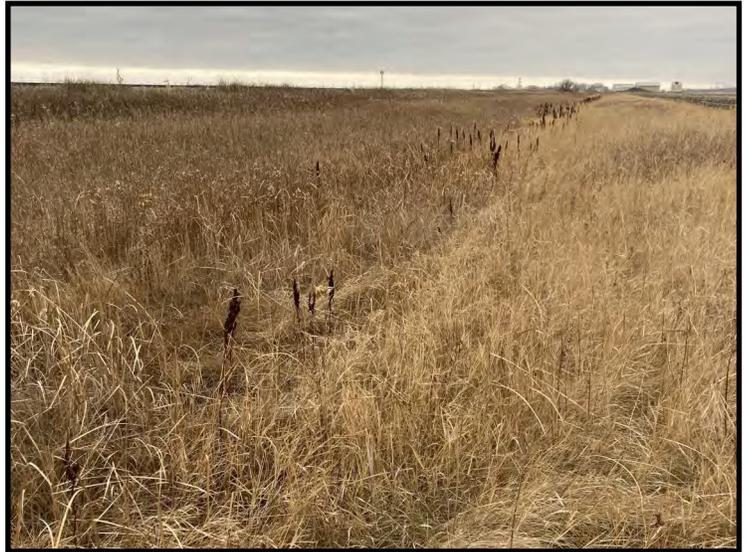
Photo 28 at right. View of Wetland 4H directly northeast of the railroad tracks (off-Site). November 3, 2022 view northwest.

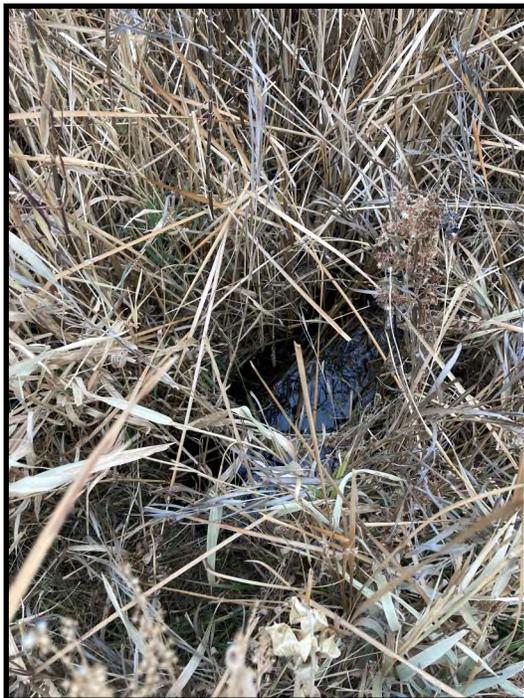
Photo 29 at left. Water present within Wetland 4H. November 3, 2022

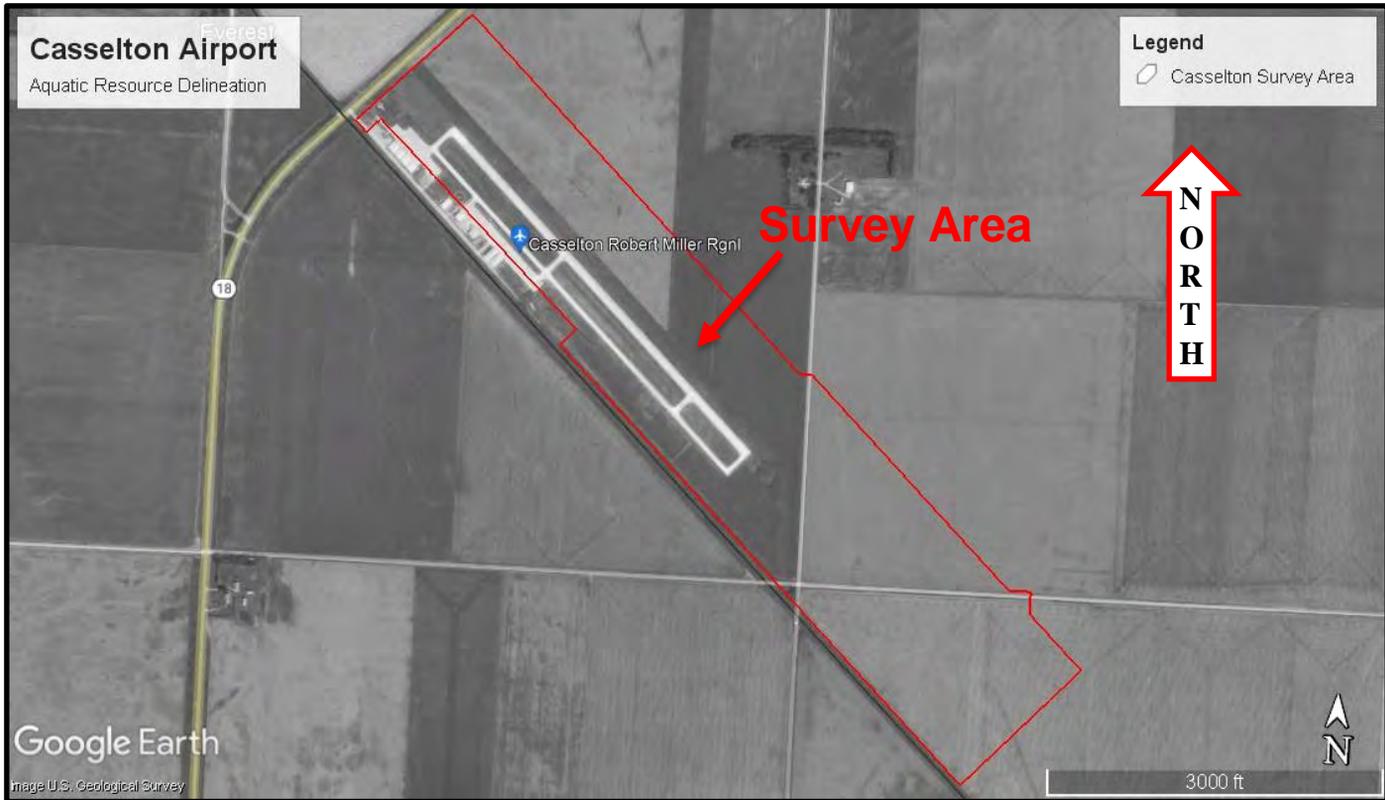
1997

Part of the Survey Area in Section 14 was already developed as the Casselton Airport. The airport appeared to have lengthened the runway and taxiway from the 1990 aerial photograph. The rest of the survey area appears to be used for agricultural purposes. There were developed roads along the section lines. There appears to be some indications of a wetland around the intersection of the roads developed in the survey area.

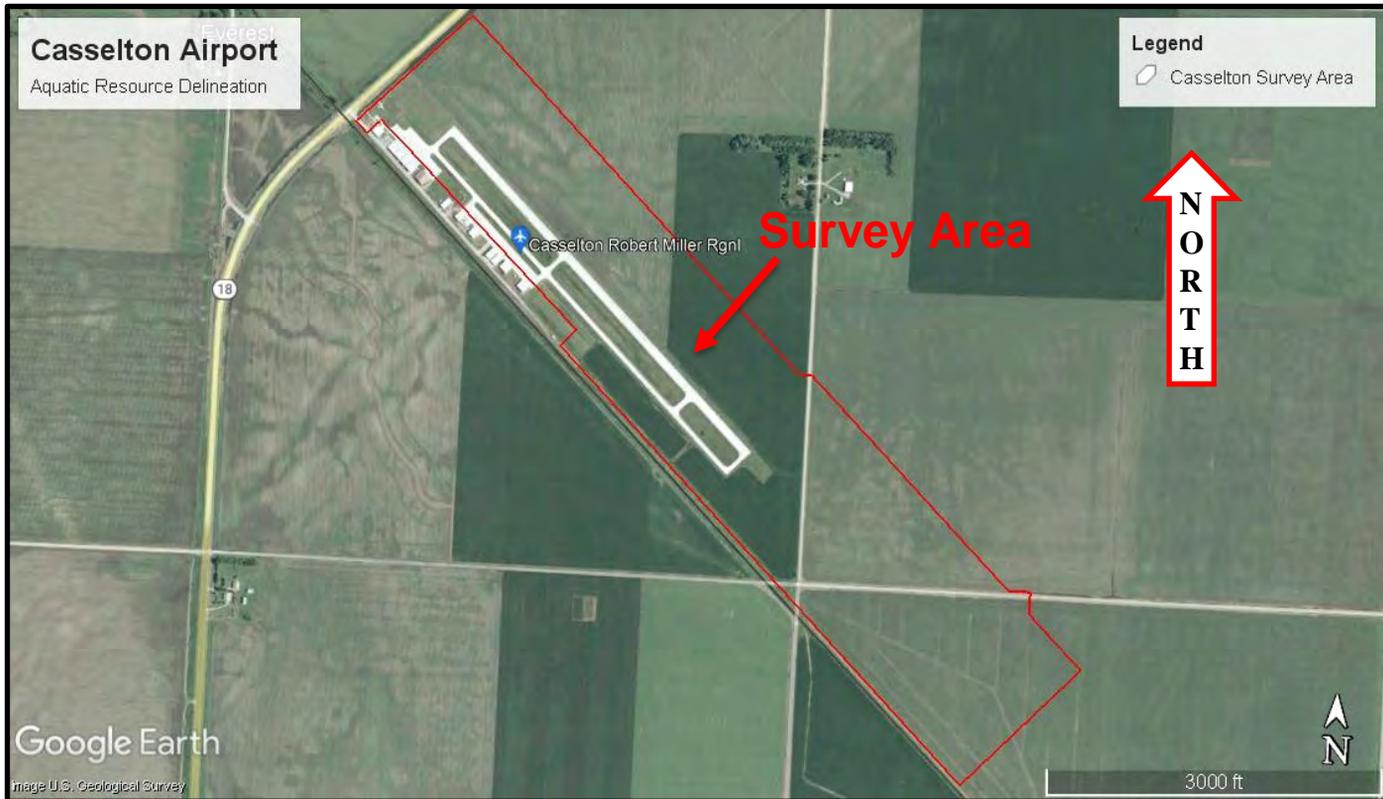
Appendix C. Aerial Photographs 2003

Part of the Survey Area in Section 14 was already developed as the Casselton Airport. The rest of the survey area appears to be used for agricultural purposes. There were developed roads along the section lines. There seems to be indication of wetlands between the airport runways and taxiways.

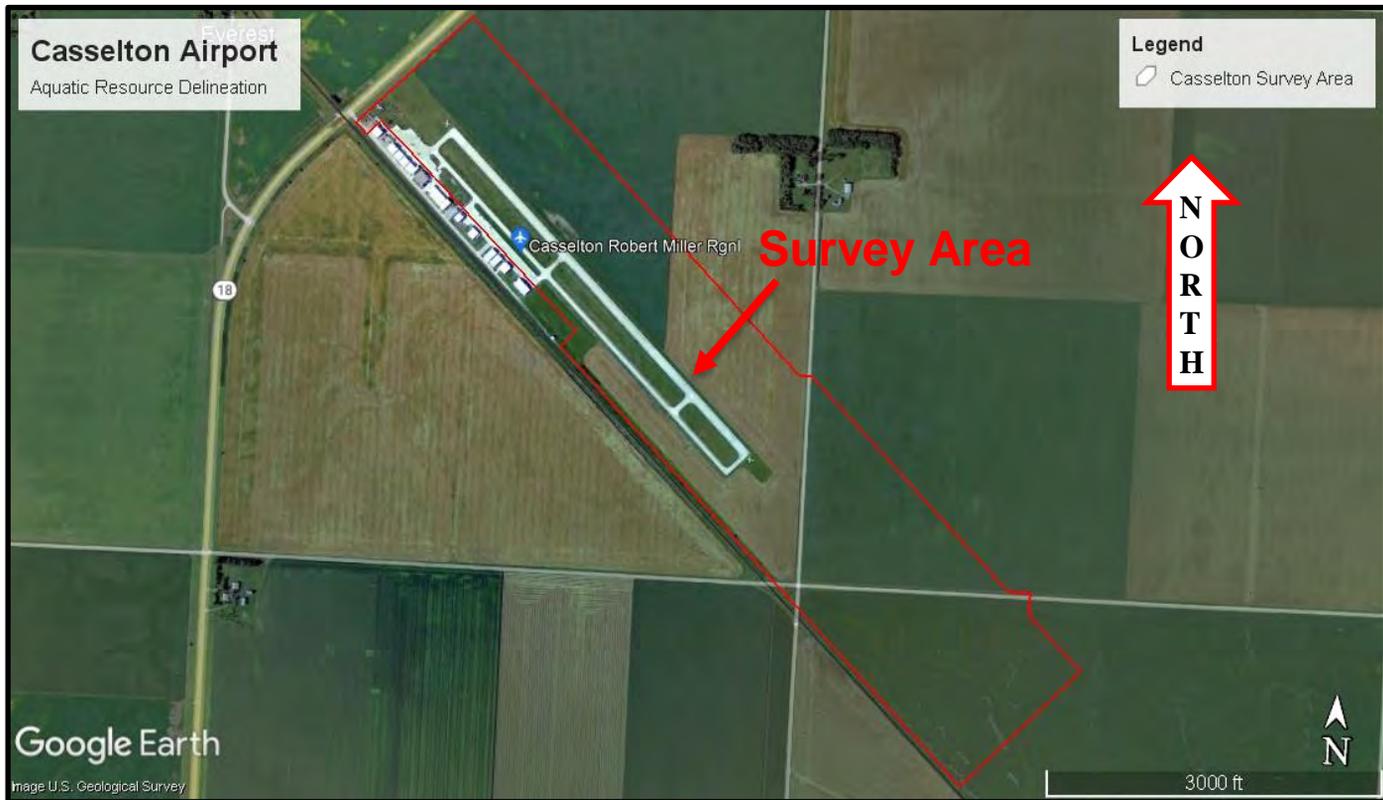
2009

Part of the Survey Area in Section 14 was already developed as the Casselton Airport. The rest of the survey area appears to be used for agricultural purposes. There were developed roads along the section lines. There seems to be indication of wetlands between the airport runways and taxiways. The appears to be increased hydrology between the railroad south of the survey area and the agricultural fields that were adjacent.
