Appendix A: Threatened and Endangered Species

Project Code: 2024-0132672

Project Name: Casselton Robert Miller Regional Airport Runway Relocation

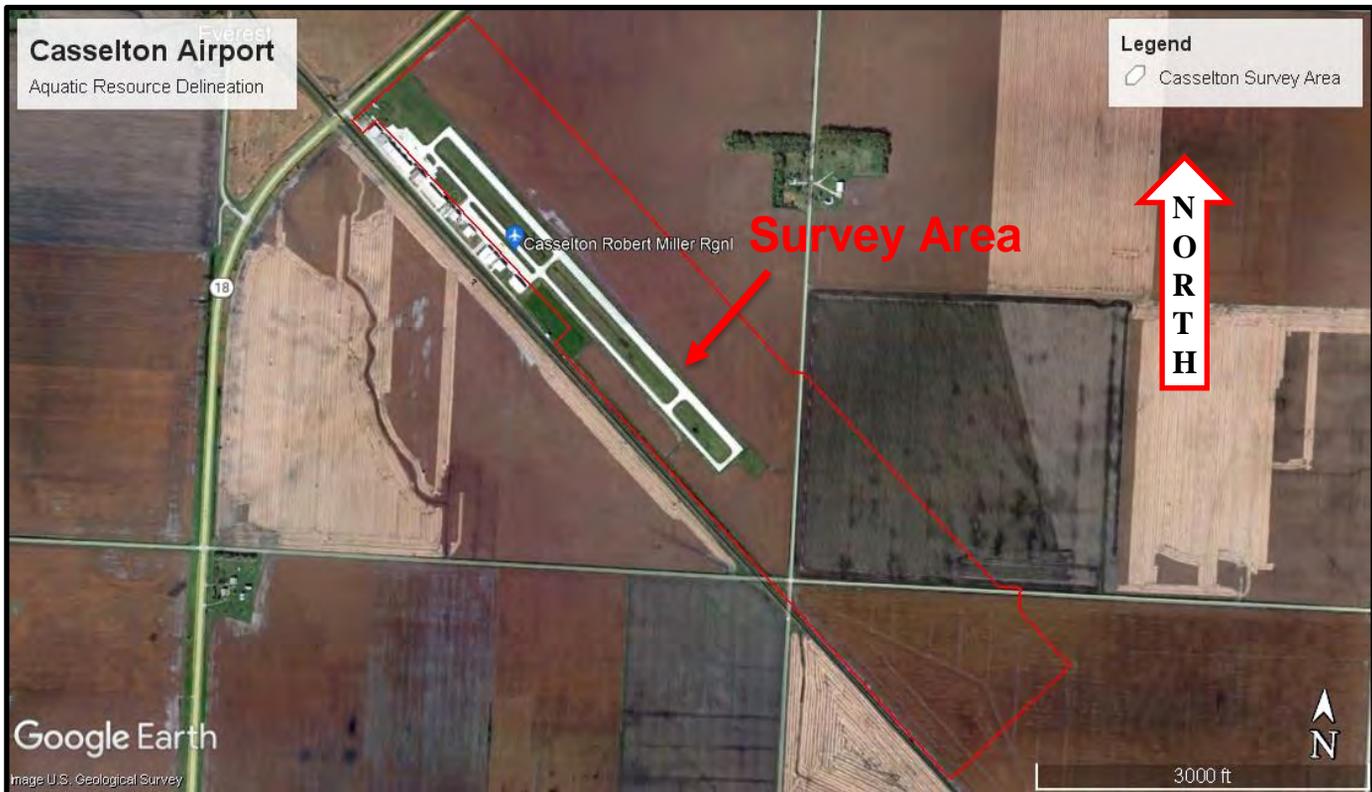
2010

Part of the Survey Area in Section 14 was already developed as the Casselton Airport. The rest of the survey area appears to be used for agricultural purposes.

There were developed roads along the section lines. The area between the runway and taxiway appears to have multiple areas where wetlands may be present.

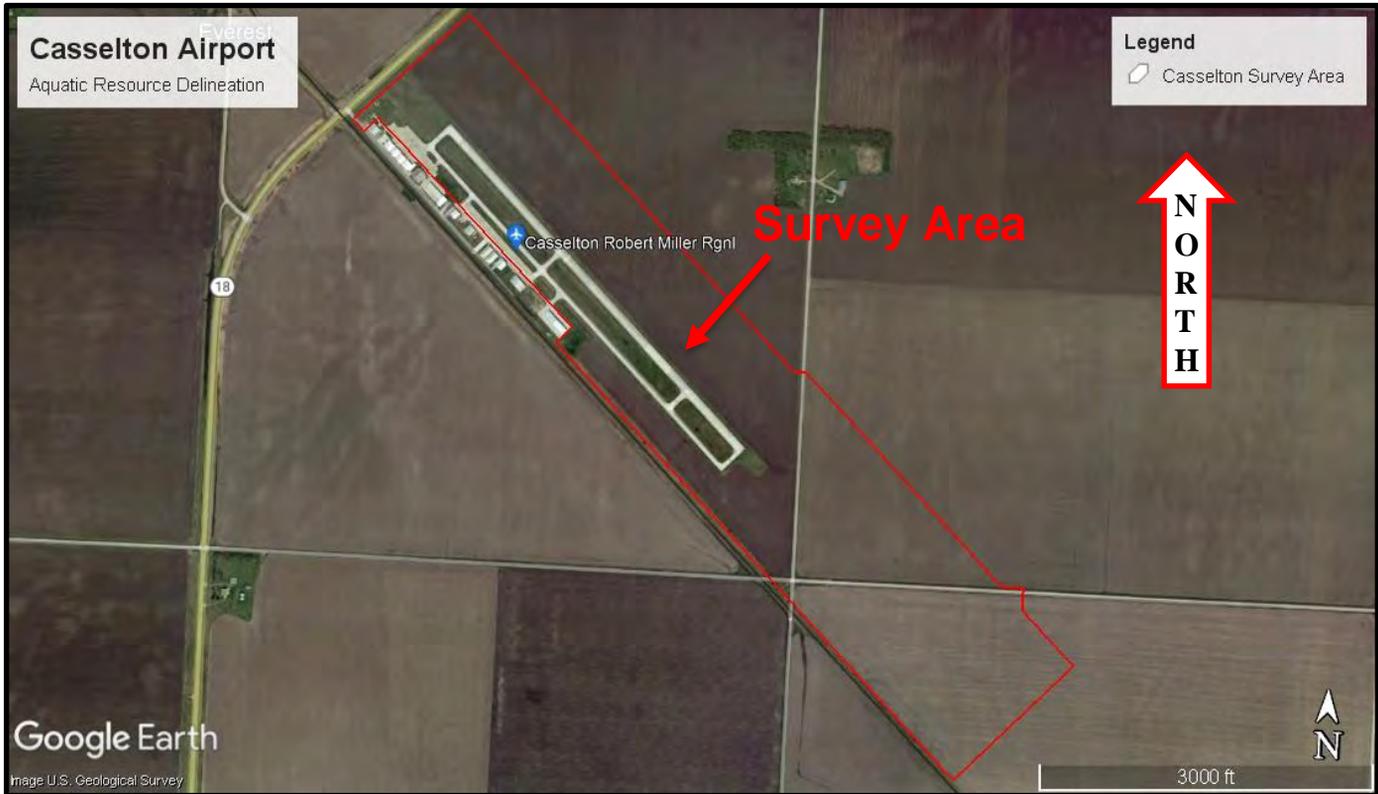
Appendix C. Aerial Photographs 2016

Part of the Survey Area in Section 14 was already developed as the Casselton Airport. The rest of the survey area appears to be used for agricultural purposes.

There were developed roads along the section lines. The area between the runway and taxiway appears to have multiple areas where wetlands may be present, although it was less apparent than the 2010 aerial photograph.

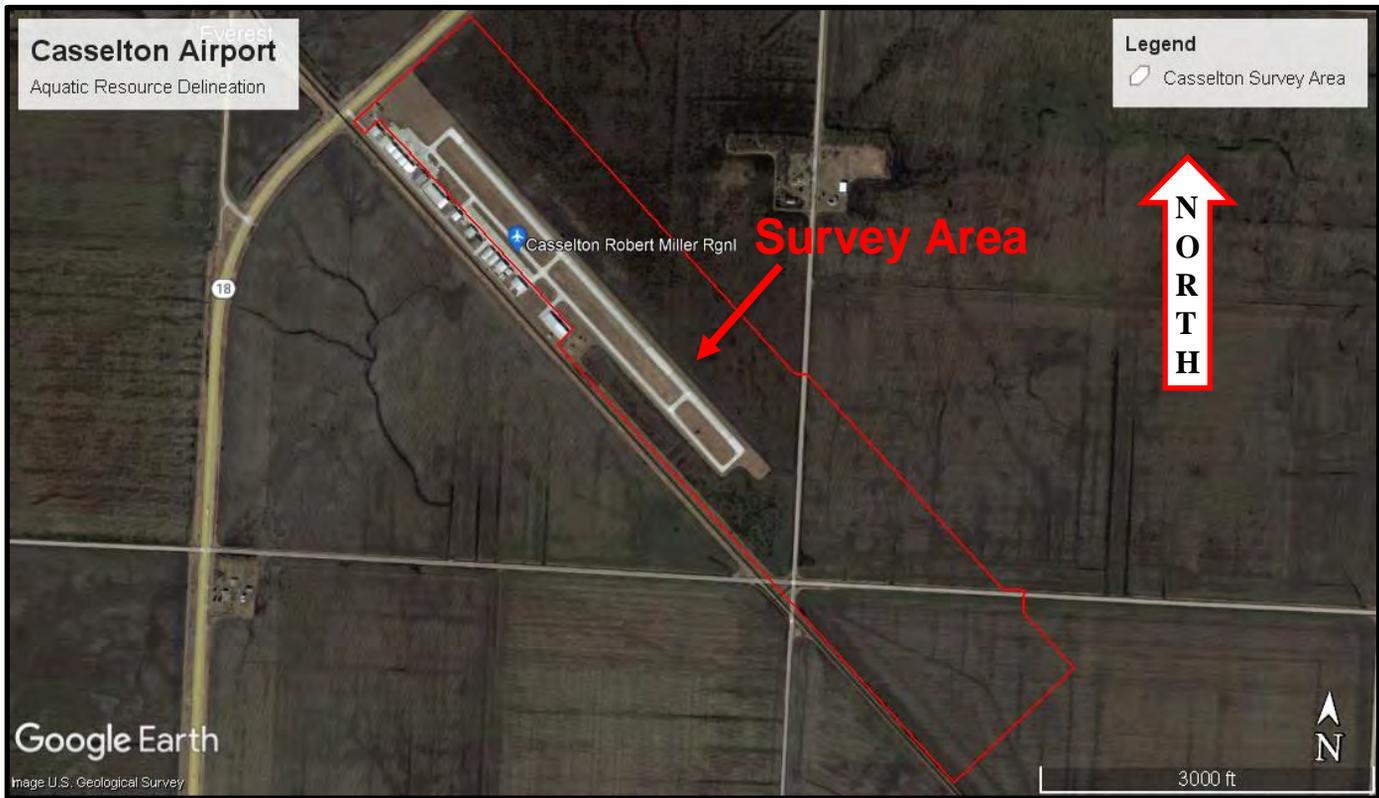
2021

Part of the Survey Area in Section 14 was already developed as the Casselton Airport. The rest of the survey area appears to be used for agricultural purposes. There were developed roads along the section lines. Some small possible wetland areas can be noted between the runway and taxiway of the airport. There also seems to be some possible wetlands at the intersection of the developed roads in the survey area.

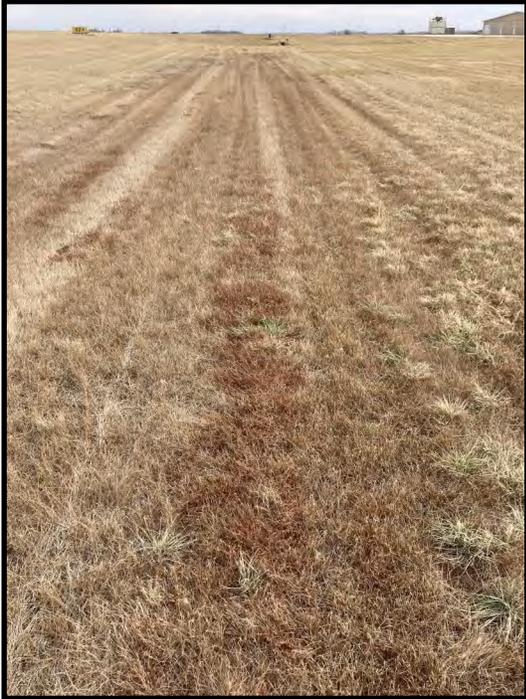
Photo 6 at left. Wetland 2 Point (W-2). View of where the survey point in foreground for Wetland 2 was located. Wetland 2 consisted of Rushes (*Juncus sp.*), Common Knotweed (*Polygonum arenastrum*), and Western Wheatgrass (*Pascopyrum smithii*). Hydric soils were also present indicating the wetland status for this area. November 2, 2022 view southeast.

The airport property where the wetland survey point (W-2) and upland survey point (Upl-2) for this wetland was maintained and mowed. Therefore, the species diversity was limited, and identification was made difficult due to the lack of fruiting structure and the dormant season. However, WPC found the dominant species in the wetland survey area to be Rushes (*Juncus sp.*, FACW) covering 55 percent of the area. Common Knotweed (*Polygonum arenastrum*, FACU) at 35 percent cover and Western Wheatgrass (*Pascopyrum smithii*, FACU) at 10 percent cover. See **Appendix C, Photographs**, Photos #5, 6, 8 for a visual of W-2 and Wetland 2A and B. Plant communities did meet the Prevalence Index for hydrophytic vegetation criteria.

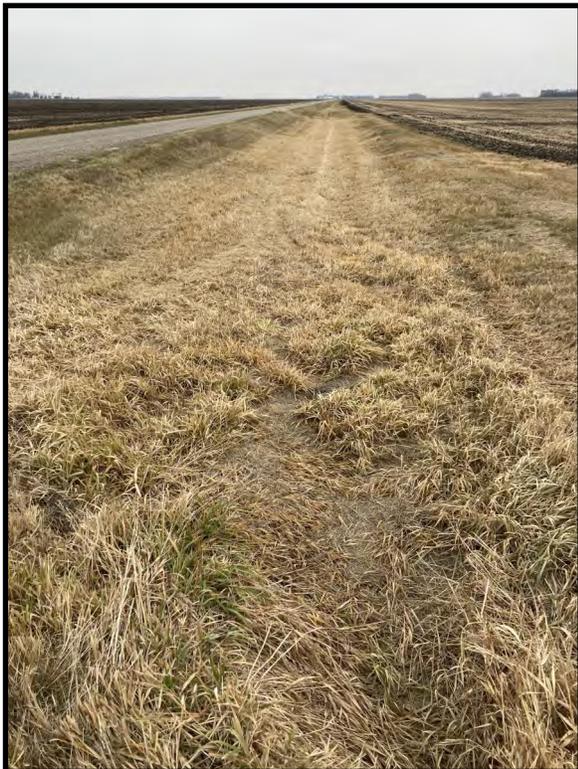
Photo 19 at right. Upland 4 Point (Upl-4) location for the Wetland 4 area. November 3, 2022 view southeast.

Photo 19 at right. Upland 4 Point (Upl-4) location for the Wetland 4 area. November 3, 2022 view southeast.

The wetland survey point (W-4) was within a channel that was near the railroad tracks off-Site. The upland survey point (Upl-4) and additional wetland point (W-4E) for this wetland was maintained and mowed because it was near or in the road ditch. Therefore, the species diversity was limited in Upl-4 and W-4E, and identification was made difficult due to the lack of fruiting structure and the dormant season. However, WPC found the dominant species in the wetland survey area W-4 to be Reed Canary Grass (*Phalaris arundinacea*, FACW) covering 40 percent of the area and Cattails (*Typha sp.*, OBL) covering 30 percent. There was approximately 30 percent of bare ground within the survey point radius. See **Appendix C, Photographs**, Photos #17 and 18 for a visual of the W-4 survey point area. Plant communities did meet the Rapid Test for hydrophytic vegetation criteria.

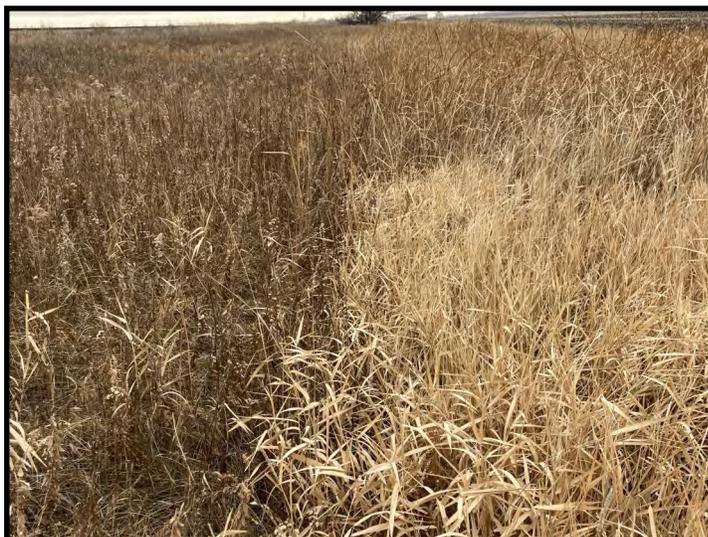
Photo 25 at right. Wetland 4H. A dense stand of Cattails (*Typha sp.*) and Prairie Cordgrass (*Spartina pectinata*) November 3, 2022 view northwest.

Photo 25 at right. Wetland 4H. A dense stand of Cattails (*Typha sp.*) and Prairie Cordgrass (*Spartina pectinata*) November 3, 2022 view northwest.

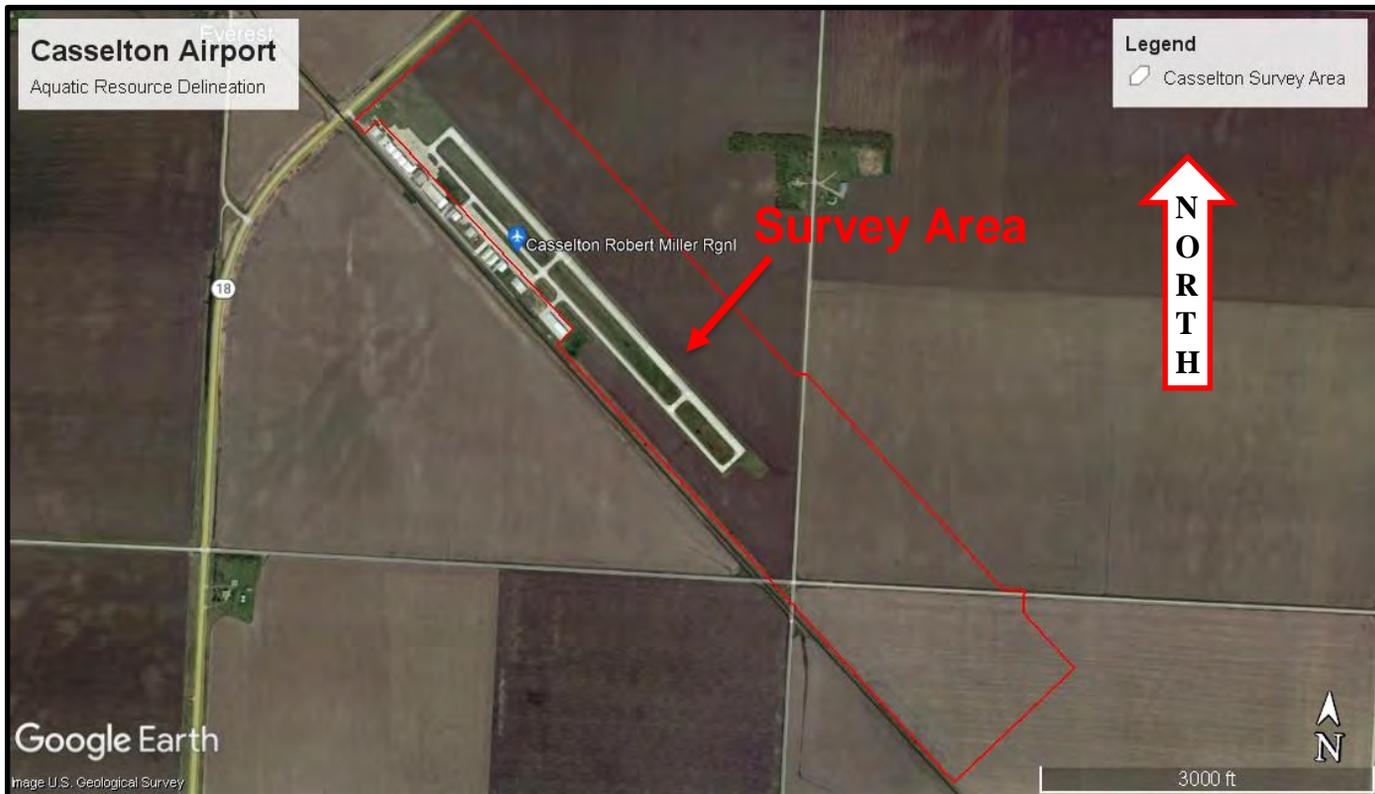
Appendix C. Aerial Photographs 2016

Part of the Survey Area in Section 14 was already developed as the Casselton Airport. The rest of the survey area appears to be used for agricultural purposes.

There were developed roads along the section lines. The area between the runway and taxiway appears to have multiple areas where wetlands may be present, although it was less apparent than the 2010 aerial photograph.

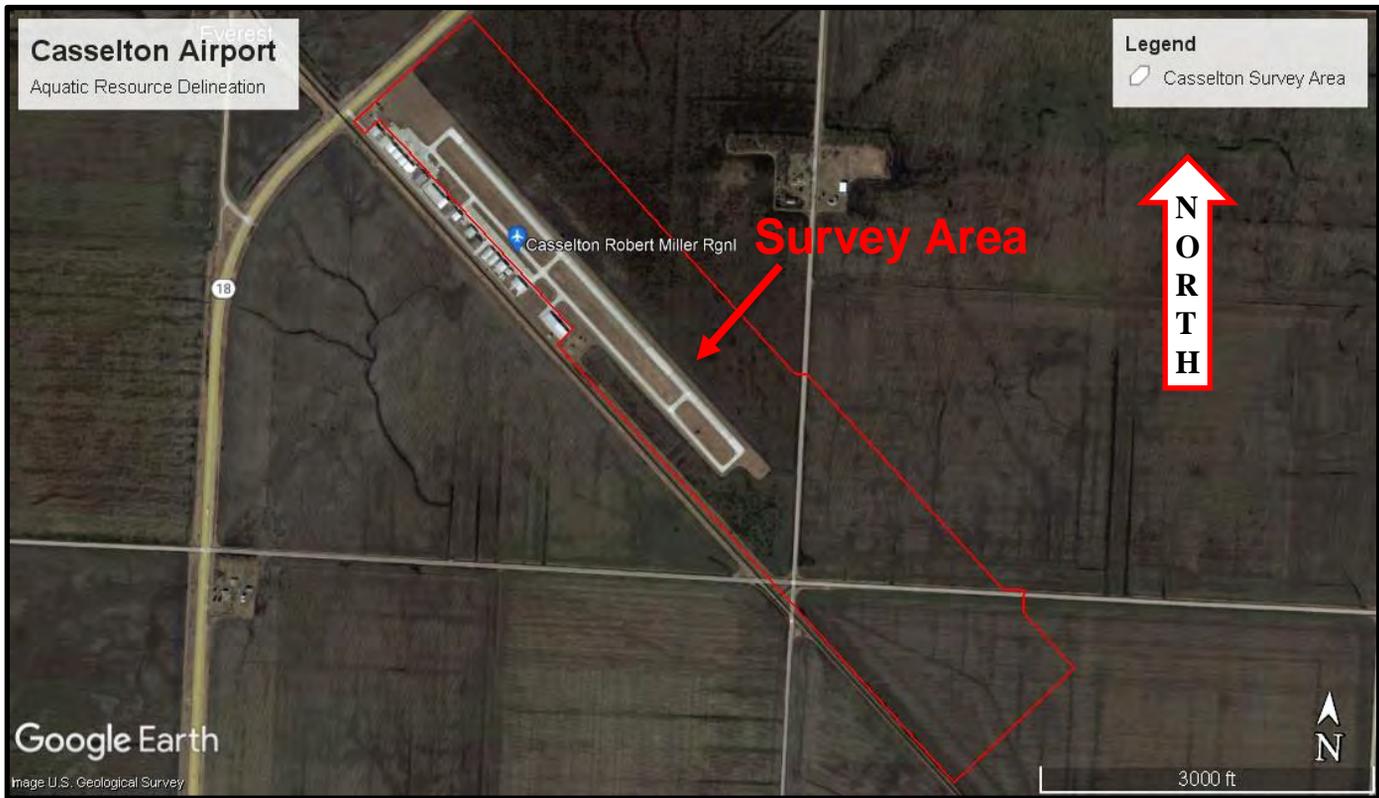
2021

Part of the Survey Area in Section 14 was already developed as the Casselton Airport. The rest of the survey area appears to be used for agricultural purposes. There were developed roads along the section lines. Some small possible wetland areas can be noted between the runway and taxiway of the airport. There also seems to be some possible wetlands at the intersection of the developed roads in the survey area.

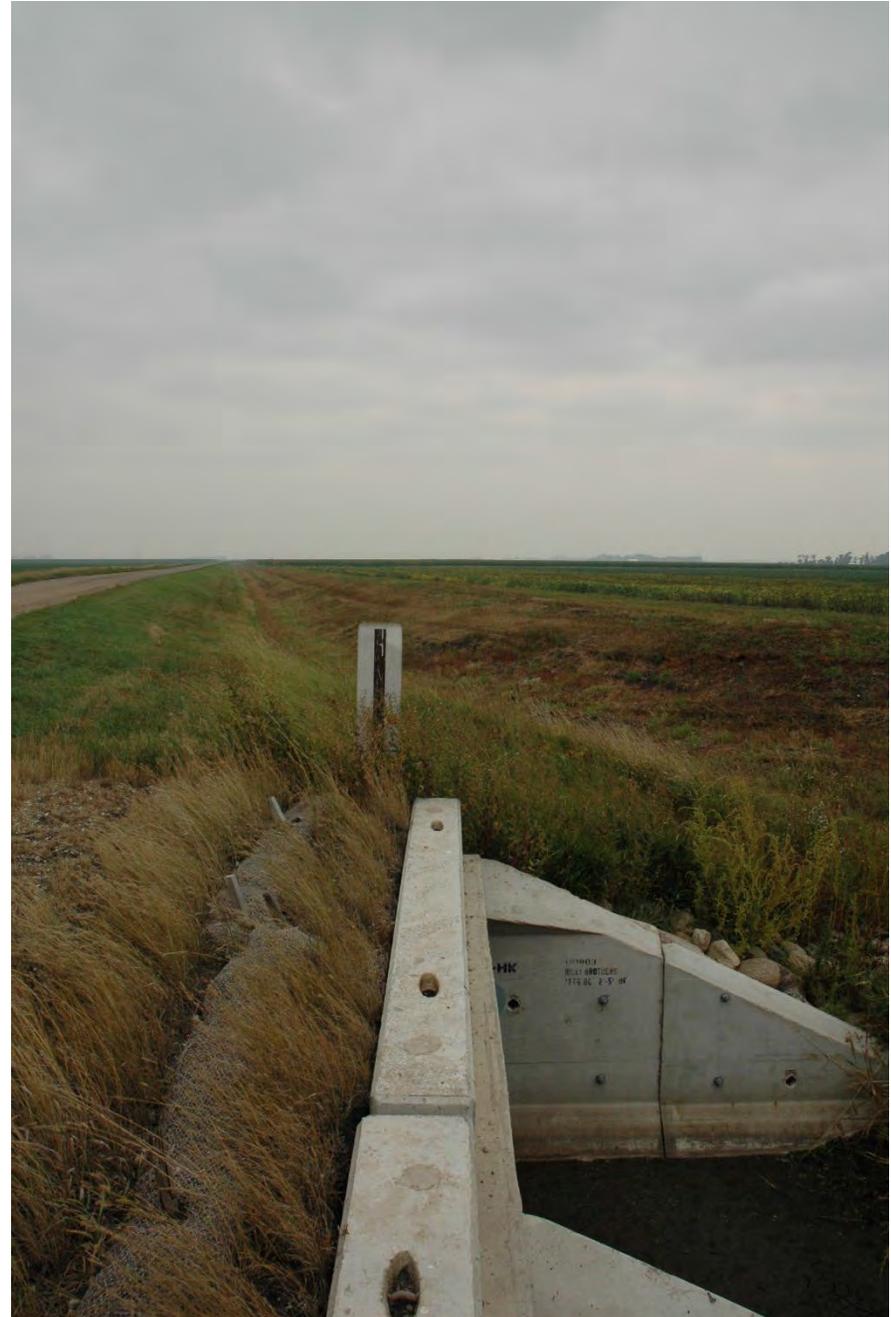
These photograph shows the previously lowered culvert. Again, this culvert goes between Everest and Durbin Township, it was lowered because it's elevation restricted drainage. Both townships and adjacent interested parties were in approval. There was no change in culvert size, it was lowered approximately 8 inches.

This photo was taken $\frac{3}{4}$ of a mile east of the previously lowered culvert where the ditch empties into the Durbin-Everest Channel. This $\frac{3}{4}$ mile ditch was lowered from the culvert east to the Durbin-Everest Channel with a track-hoe by a commercial contractor. This previous work was done with approval from Durbin Township, Everest Township, adjacent farm operators and adjacent landowners.

There was adequate drop from the west side of this section to the Durbin Everest Channel to allow for these changes. Water volume was not impacted as culvert size was not changed.

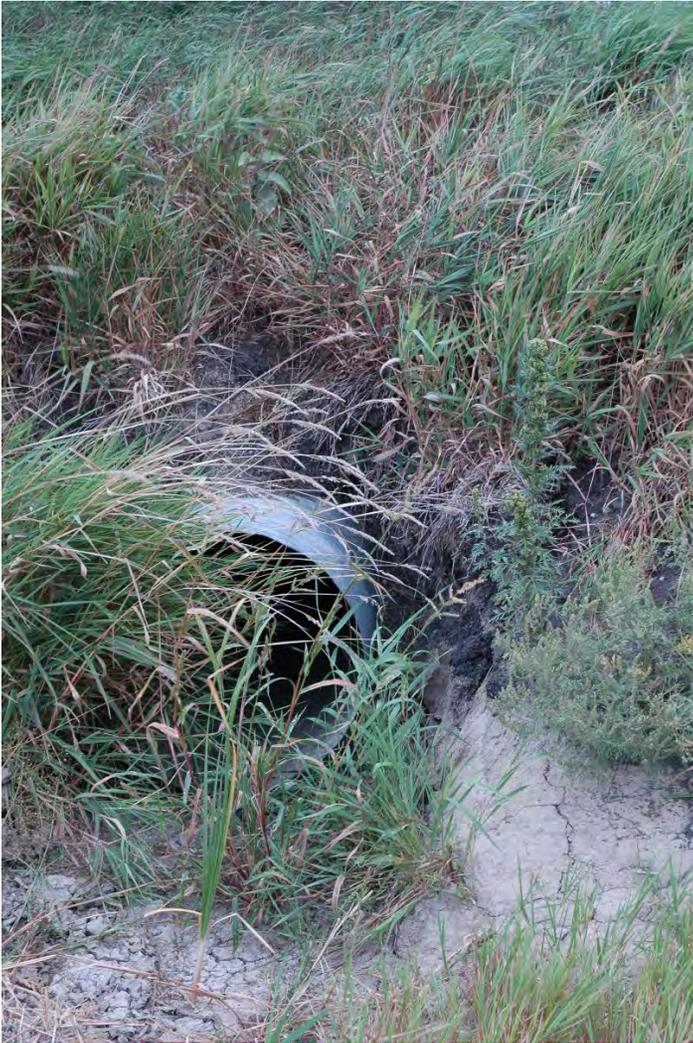
These photos show the ditches west of the culvert and to the north of the culvert. These are the ditches that need to be lowered. We will not change the ditch slope on the road side of the ditches. The bottom of the ditch will be shifted a slight amount away from the road and the field side of the ditch will be reshaped to accommodate this change. Below shows the west ditch viewed from the culvert. We have cleaned the wash soil out of the bottom of the ditch and began reshaping the field side of the ditch. While cleaning the wash soil and surveying it is estimated that maximum depth change will be 6 inches and some areas needing very little soil removed. The east end of this ditch will have the bulk of the soil to be removed. This will get us closer to a 0.04% grade and should prevent standing water in the ditch.

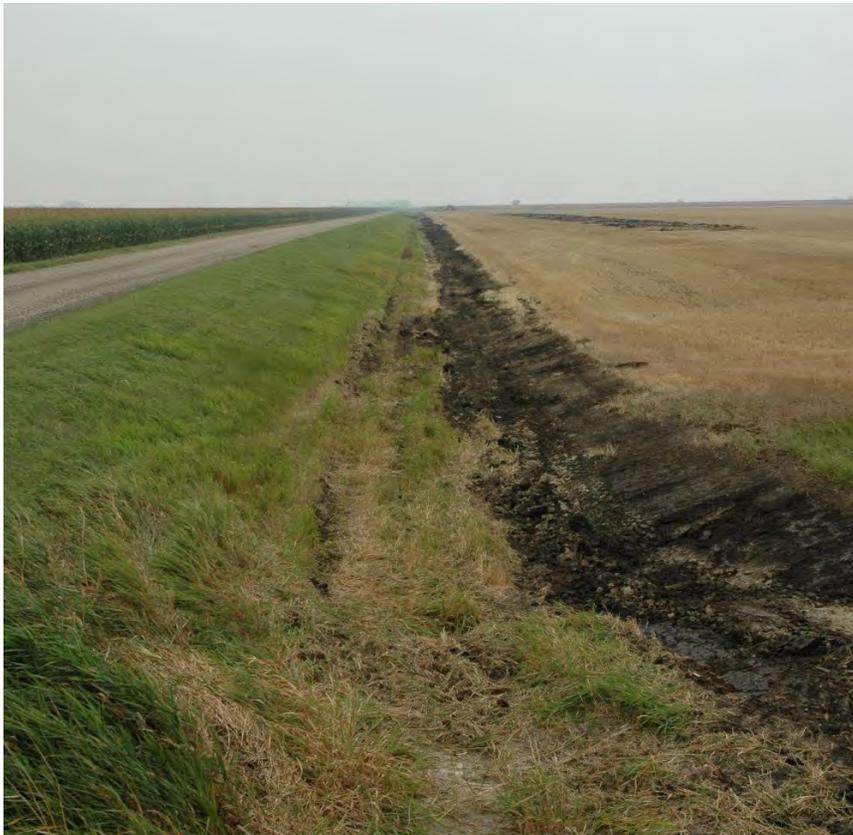
The photo below shows the ditch going north from culvert. This ditch is lower and does not need as much dirt removed. The intent would be to re-survey and take out high spots and prevent water from sitting in the ditch. While it may need to be lowered, the amount is less than 3-4 inches.

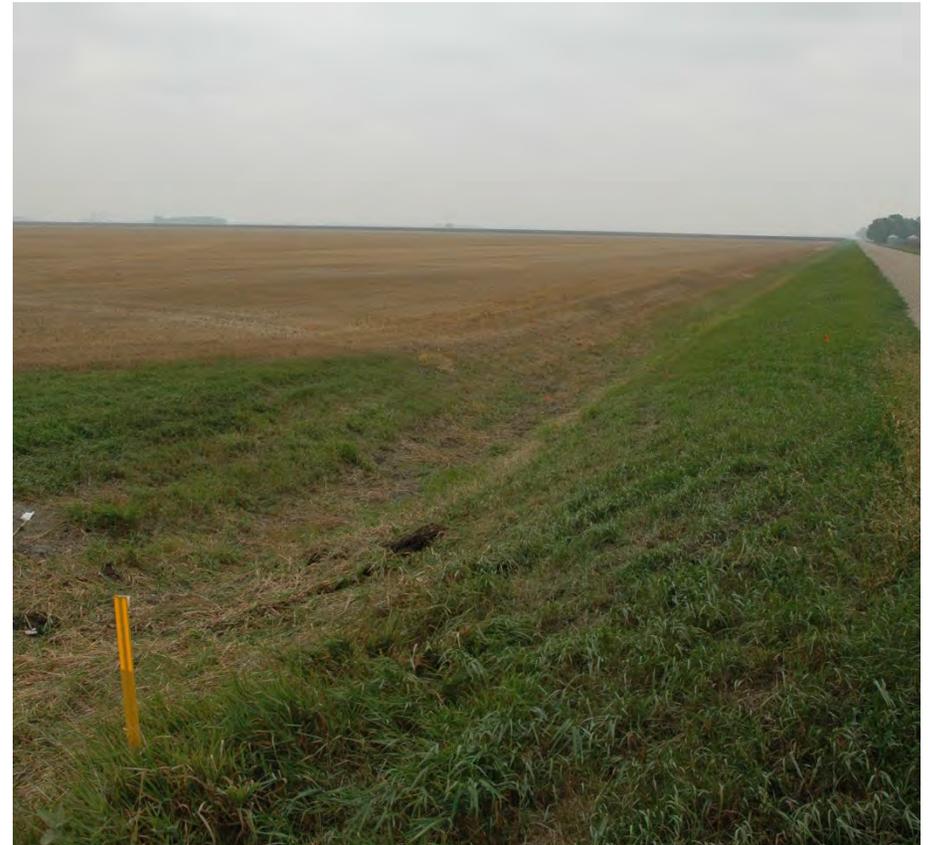
*green, cleaned/lowared 2 years ago *yellow = culvert + lowered 2 years ago

Blue = Durbin-Everest Channel

Pink = Project area

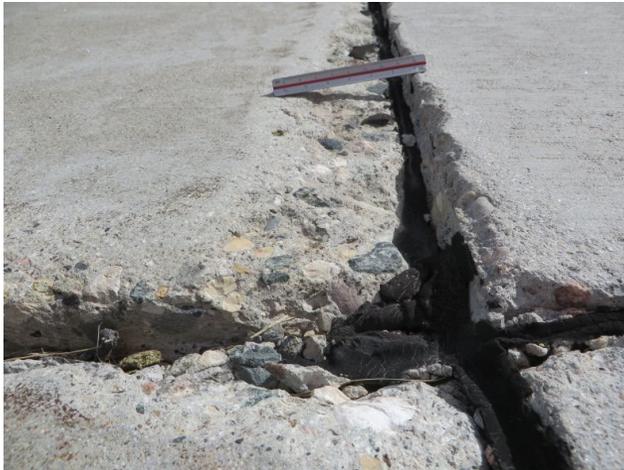
Faulting on Taxiway Connector

Because reconstruction of the runway and parallel taxiway is necessary, improvements should be designed to meet standards for existing and projected users.

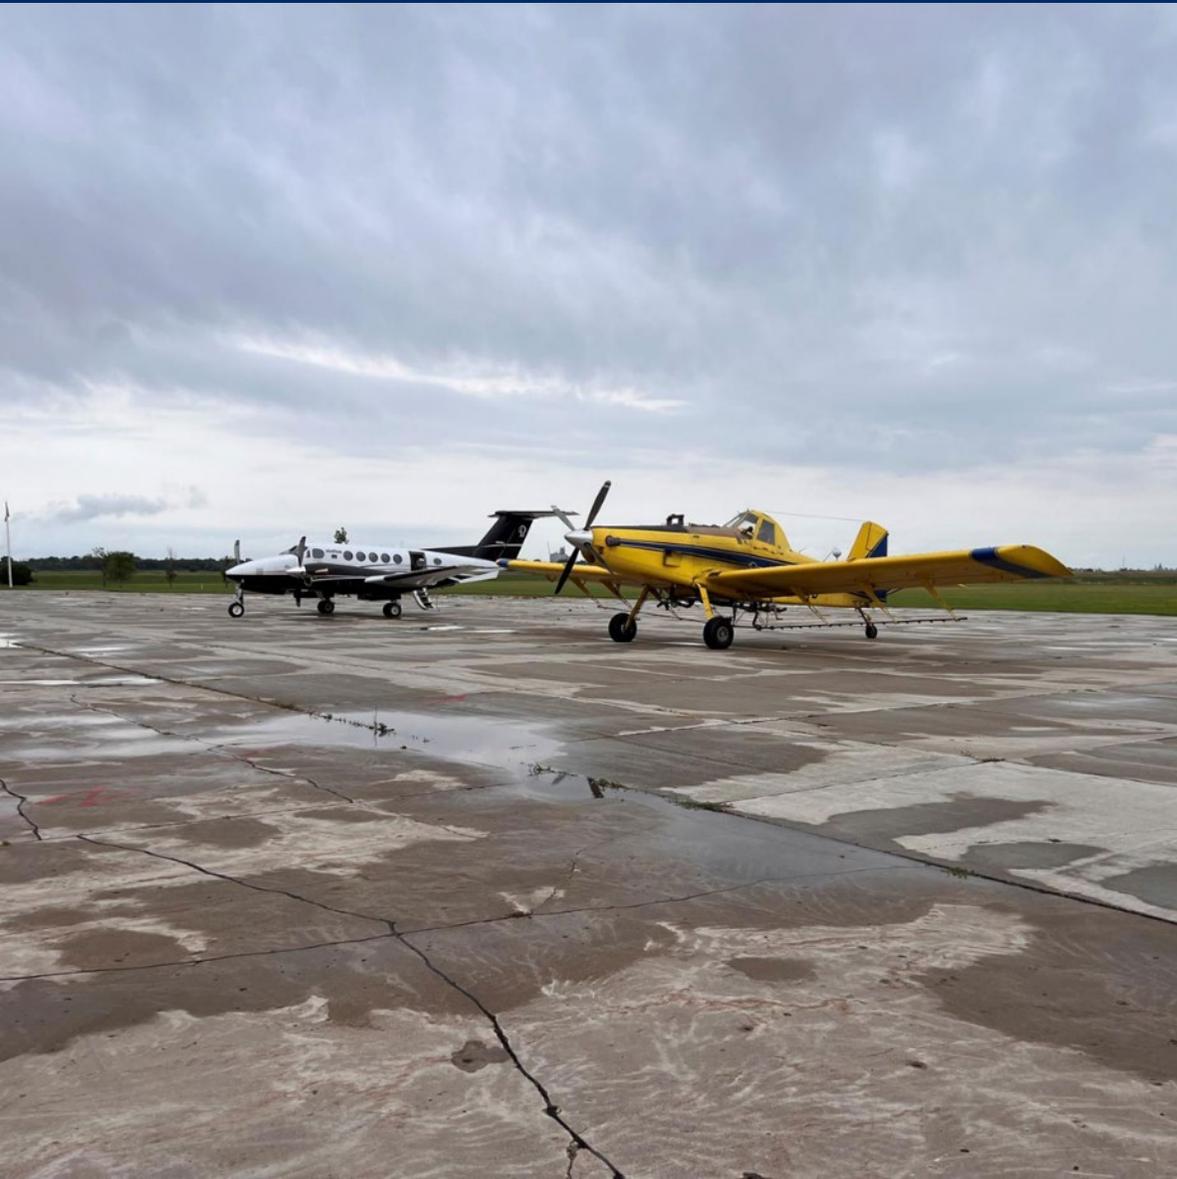
2021 PCI Map of Airport Pavements

- The majority of Airport pavement is over 30 years old
- Although multiple rehabilitation projects have occurred since construction, pavement throughout the Airport is now in poor condition and nearing the end of its service life.
- A runway rehabilitation done in 2023 will maintain the surface in usable condition until the runway project

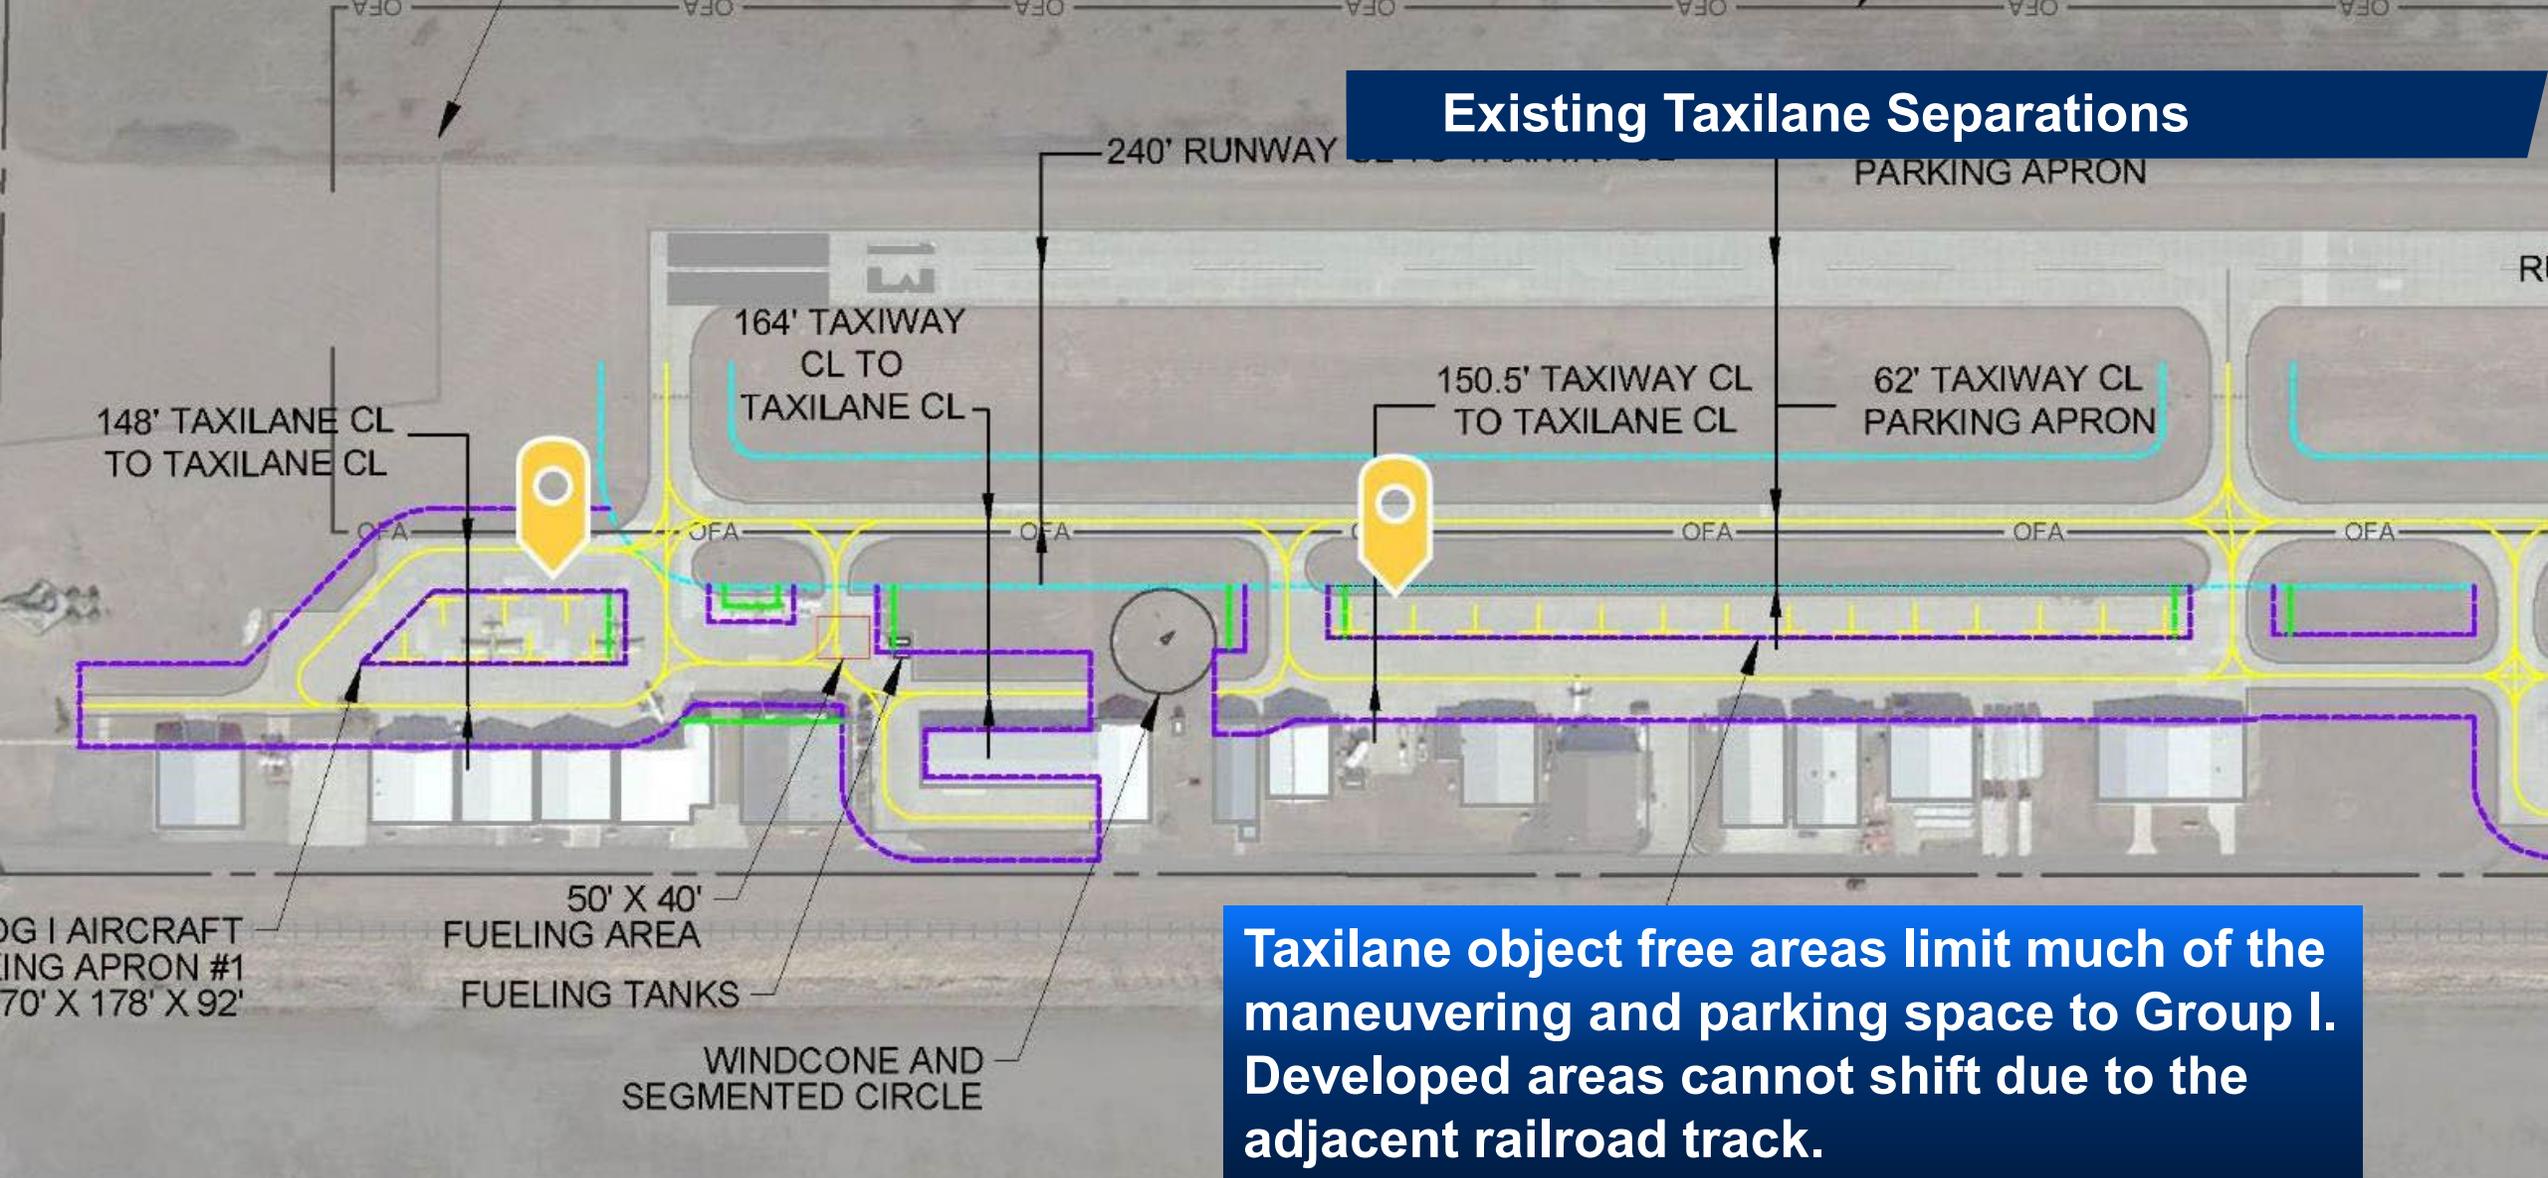
Existing Taxilane Separations

Taxilane object free areas limit much of the maneuvering and parking space to Group I. Developed areas cannot shift due to the adjacent railroad track.

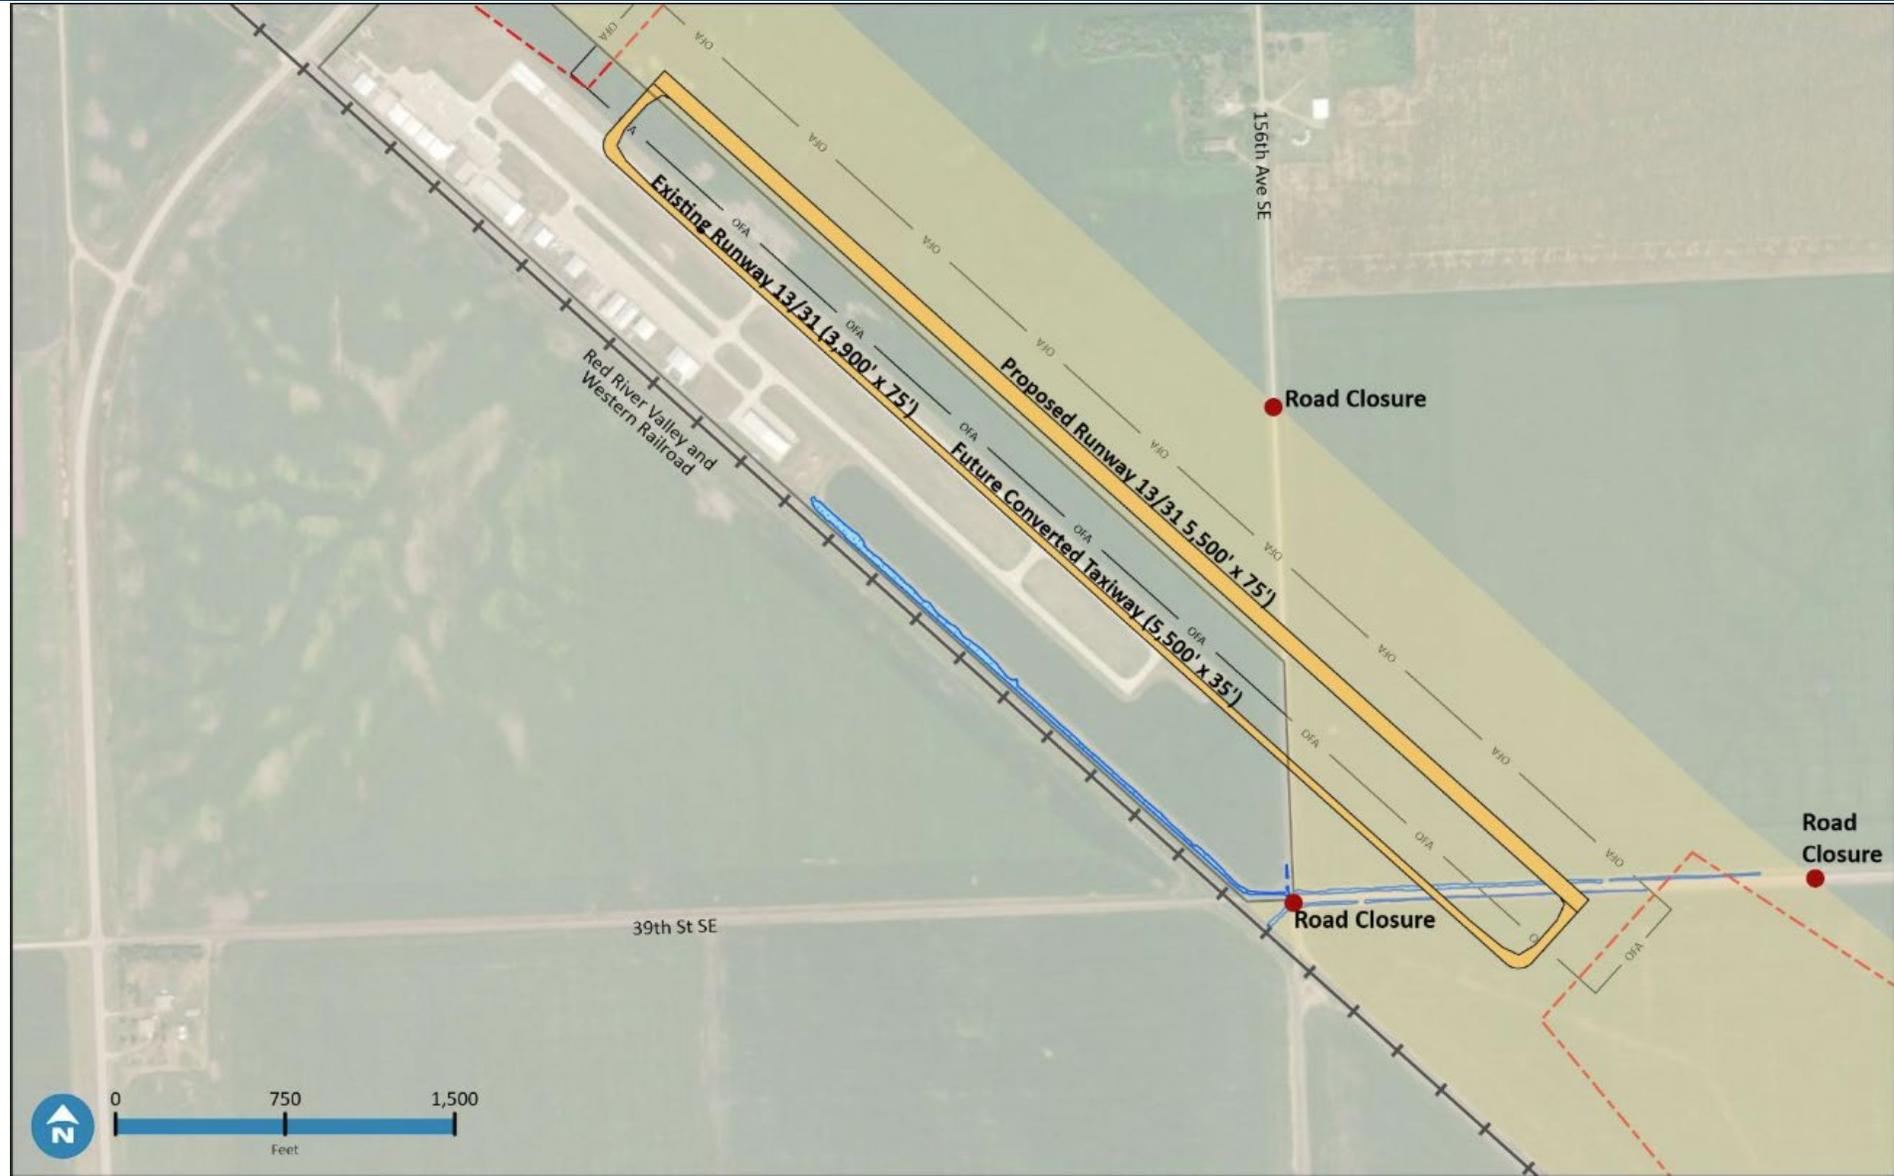
Alternative 2 – Improve 39th Street SE

Benefits

- Moderate cost: ~\$500,000
- Preserves controlled access to most farmland
- Improves farm access in wet conditions
- Minimizes wetland/drainage disruption

Drawbacks

- Interrupts N-S and E-W connection
- Reduces overall road miles in Everest Township ~1mi

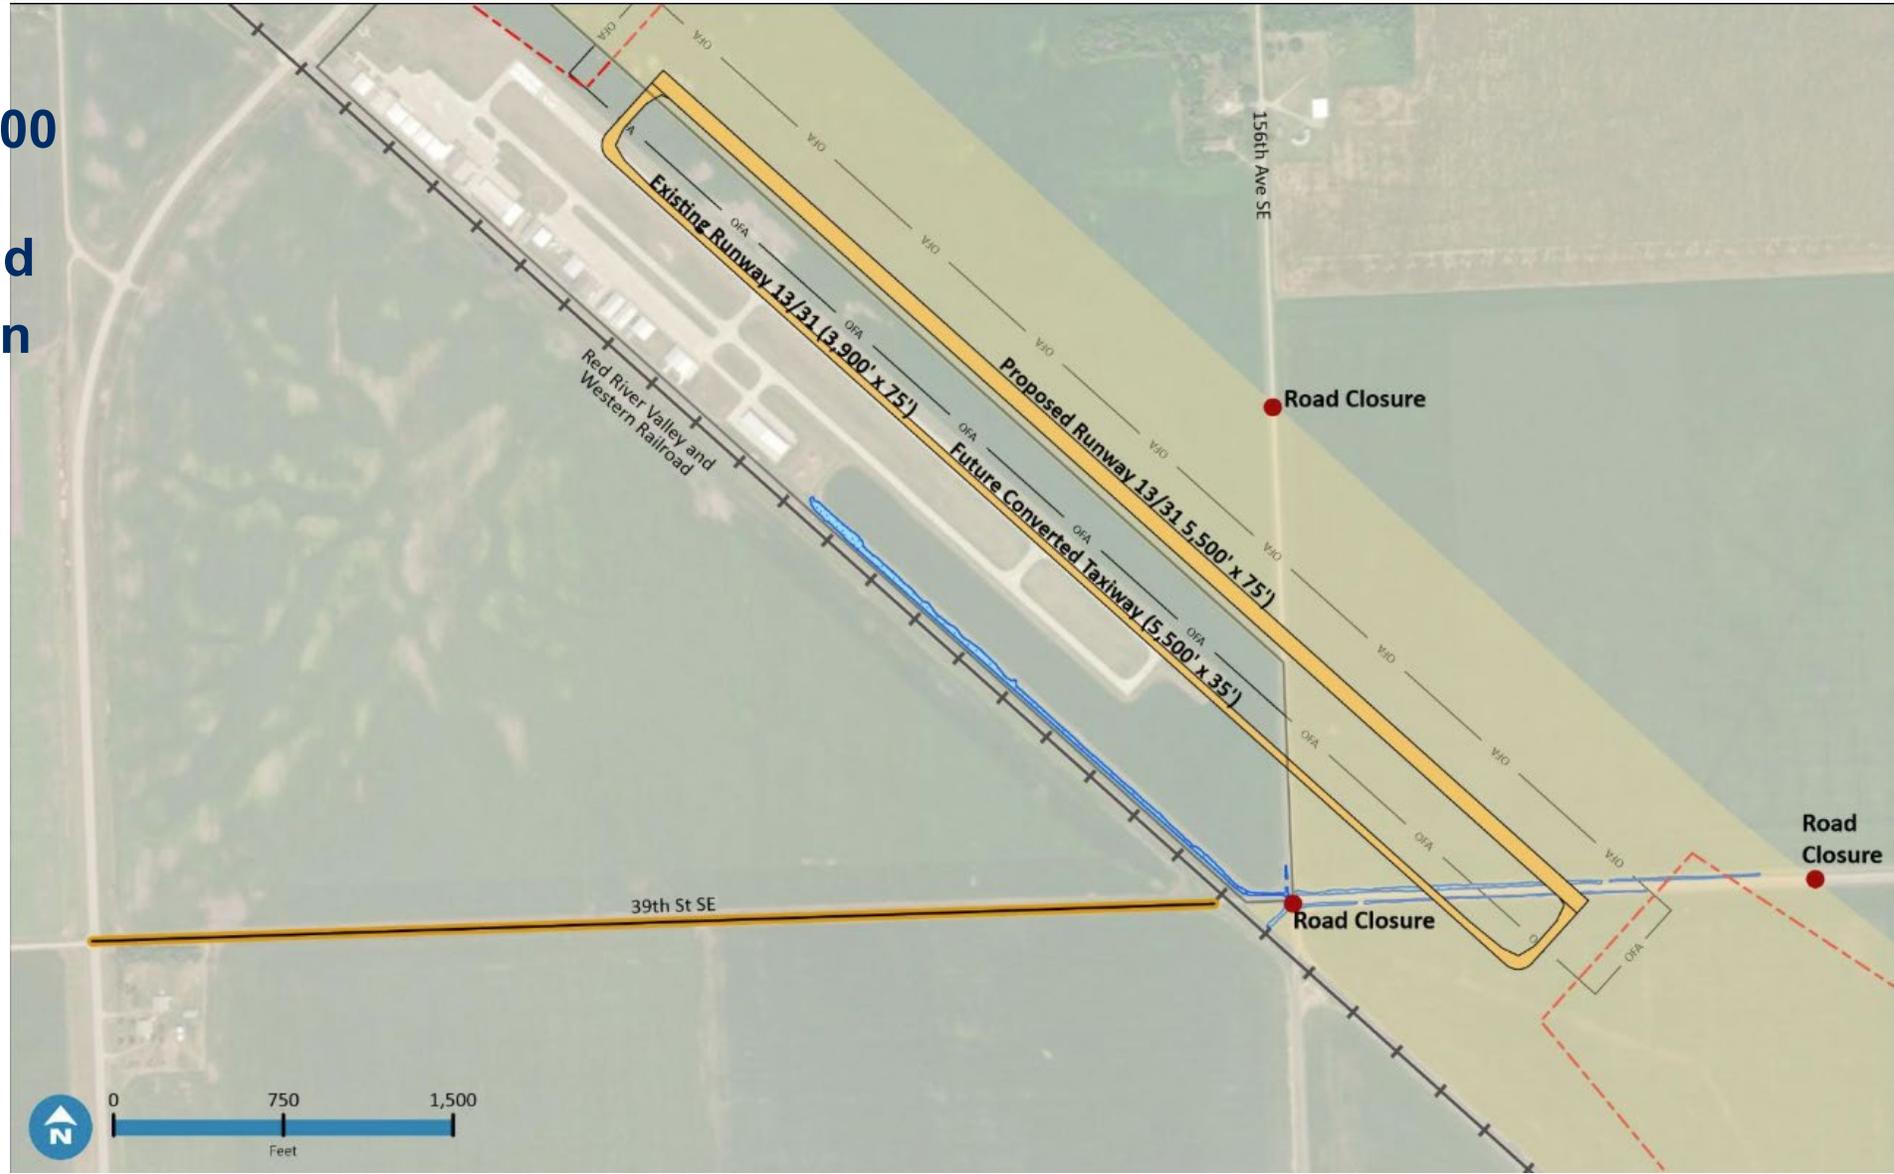
Alternative 3 – Improve and Relocate 39th Street SE

Benefits

- Preserves access to most farmland
- Improves access in wet conditions
- Maintains E-W connection

Drawbacks

- Potential drainage / wetland impacts
- Interrupts N-S connection
- Requires coordination with FAA, may not be approved
- May constrain future runway performance
