Appendix A: Threatened and Endangered Species

Project Code: 2024-0132672

Project Name: Casselton Robert Miller Regional Airport Runway Relocation

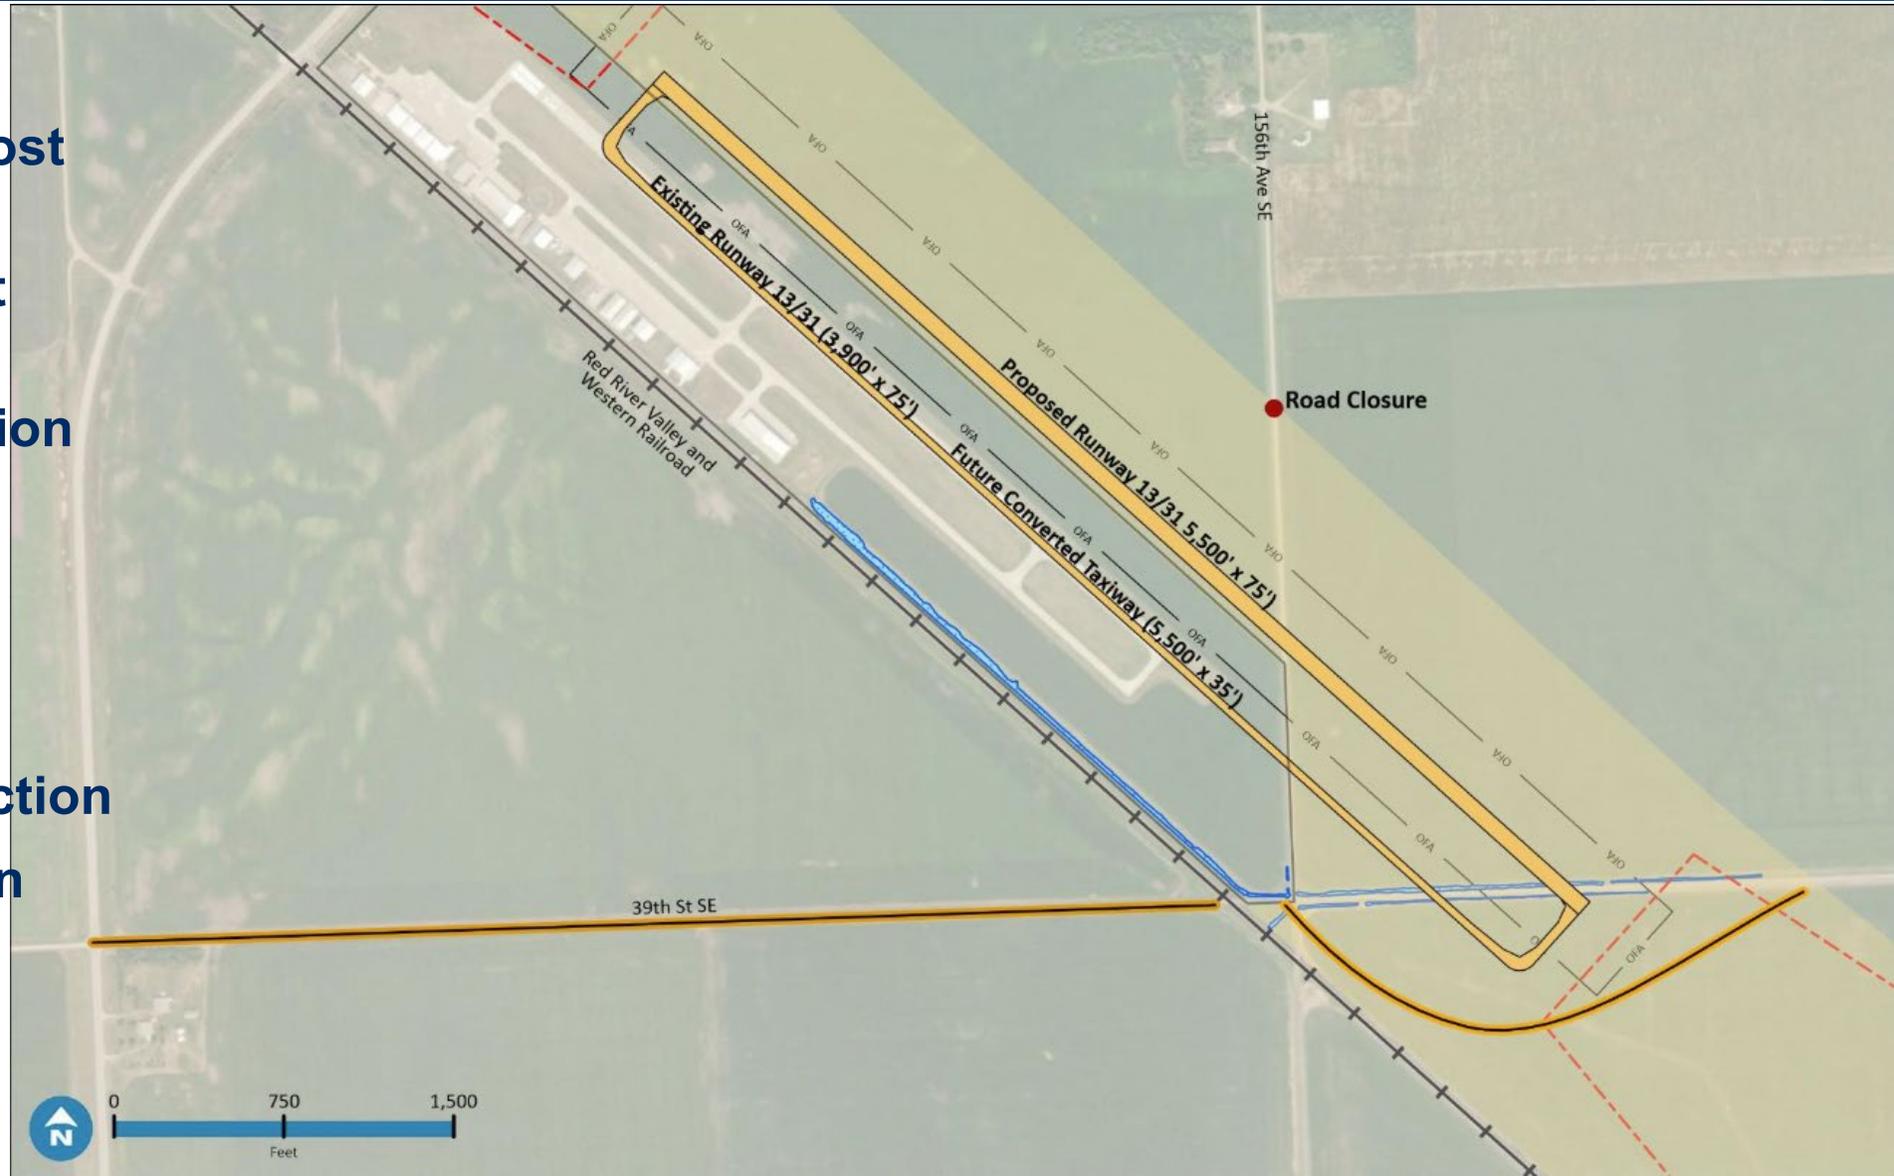
Alternative 3A – Improve and Relocate 39th Street SE

Benefits

- Preserves access to most farmland
- Improves access in wet conditions
- Maintains E-W connection
- Accounts for future Approach Category C Runway Safety Area if needed in future

Drawbacks

- Potential drainage / wetland impacts
- Interrupts N-S connection
- Requires coordination with FAA, may not be approved

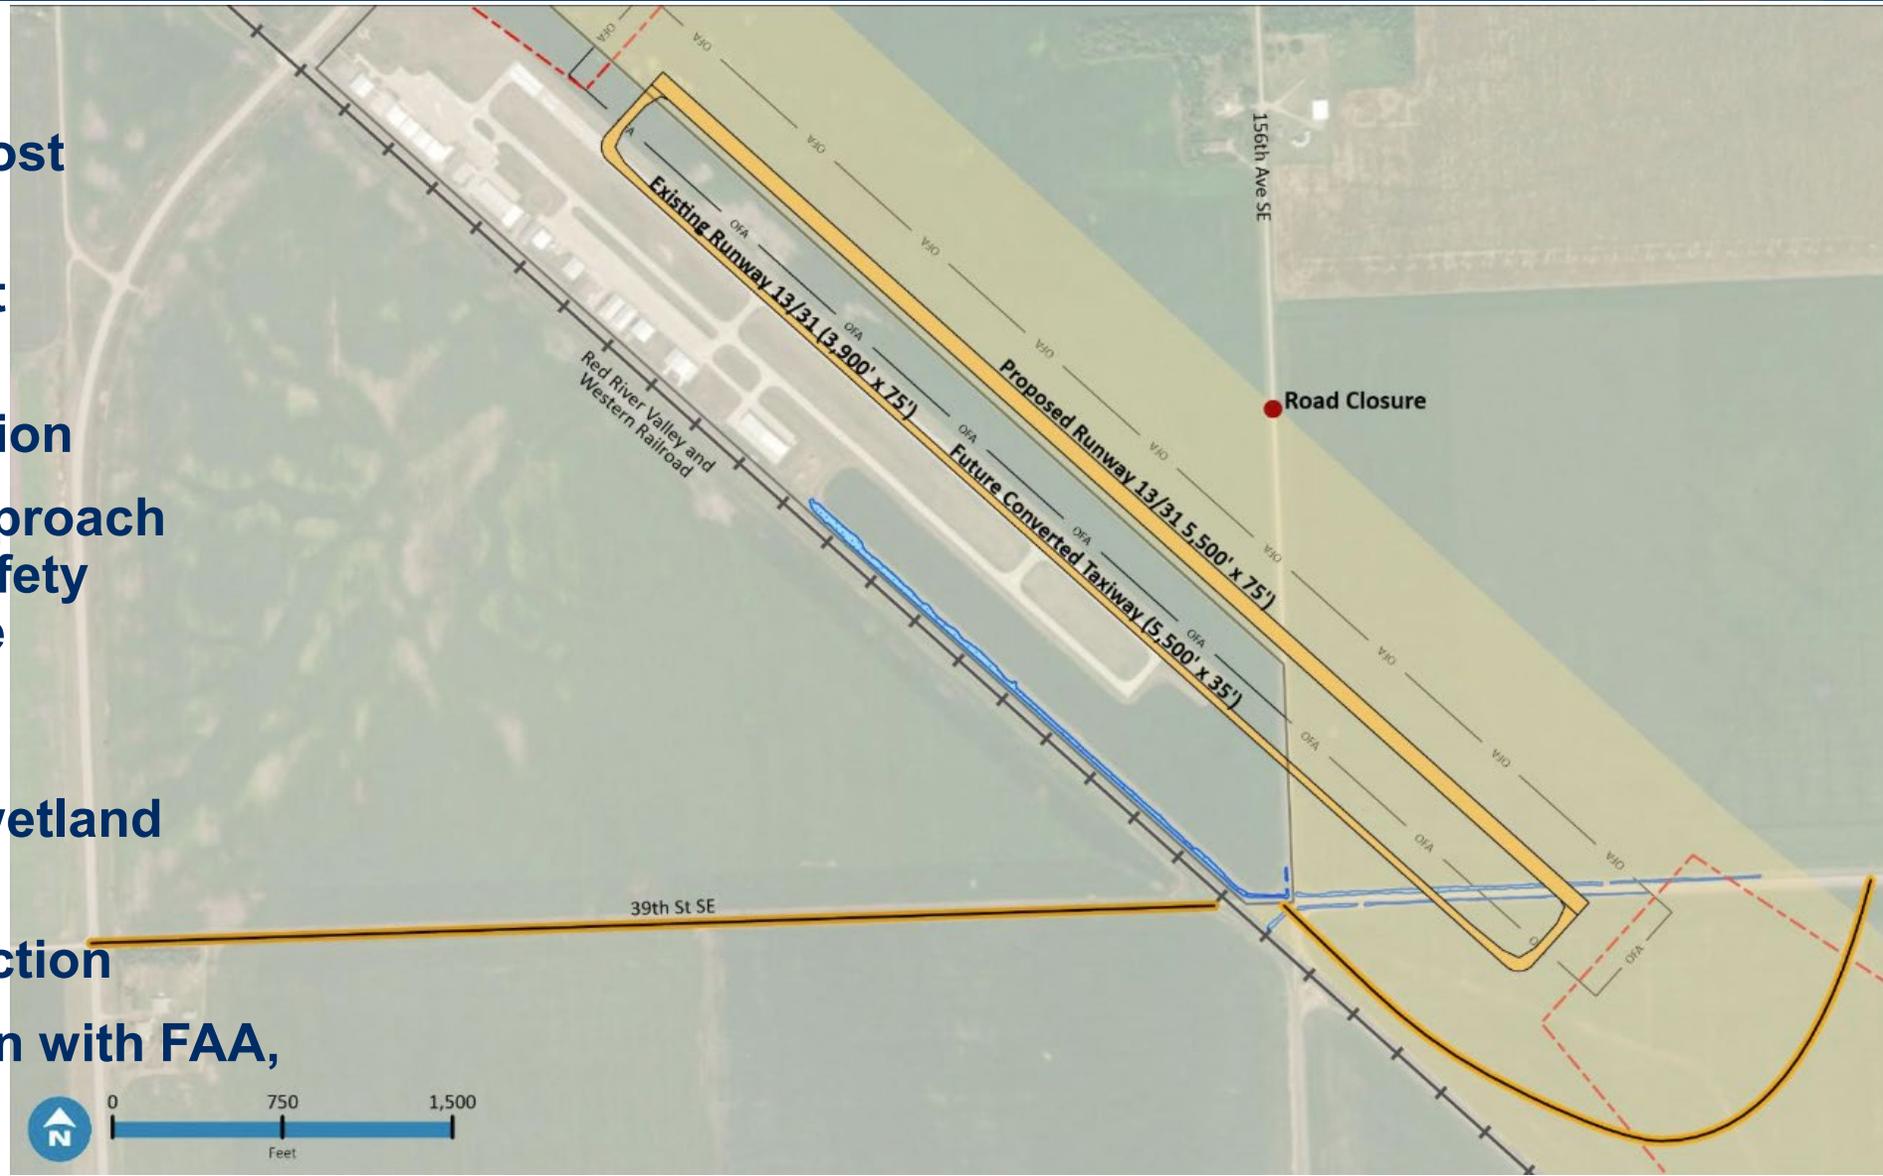
Alternative 4 – Full Road Relocation

Drawbacks

- Most costly: ~\$3.5 million
- Potential drainage impacts
- Breaks up farm fields
- Adds travel time

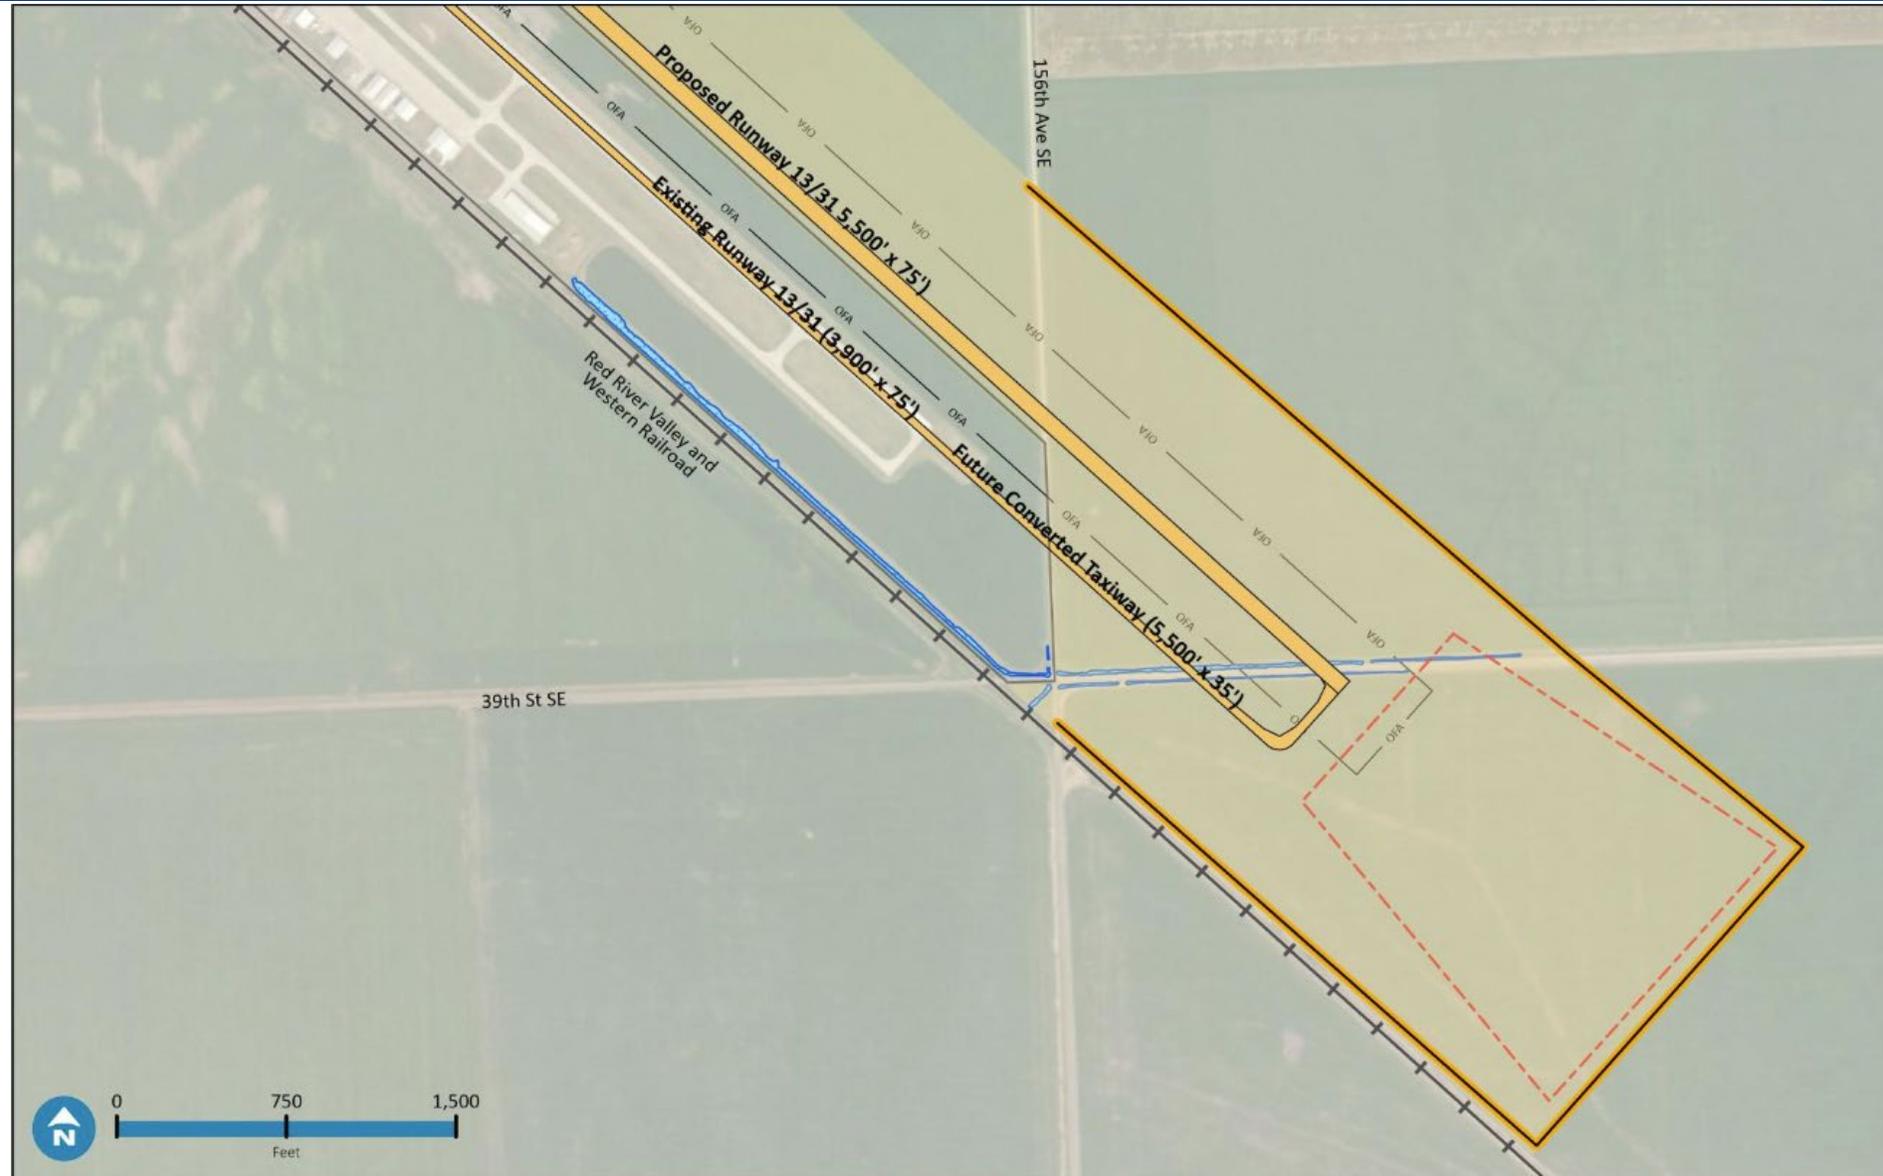
Alternative 5 – On-Airport Access Road

Benefits

- Moderate cost: ~ \$1.5 million
- Allows farm access in wet conditions

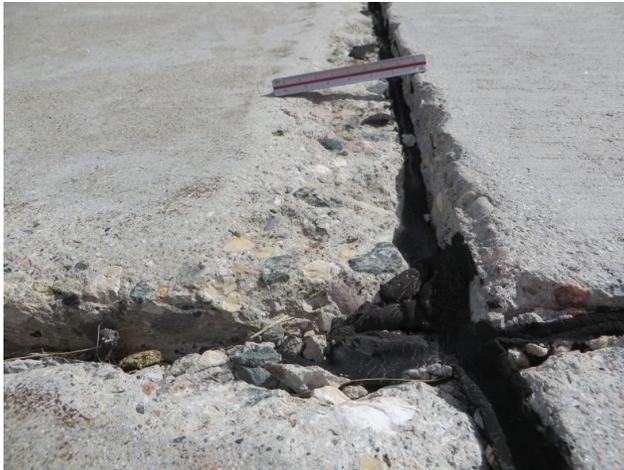
Faulting on Taxiway Connector

Because reconstruction of the runway and parallel taxiway is necessary, improvements should be designed to meet standards for existing and projected users.

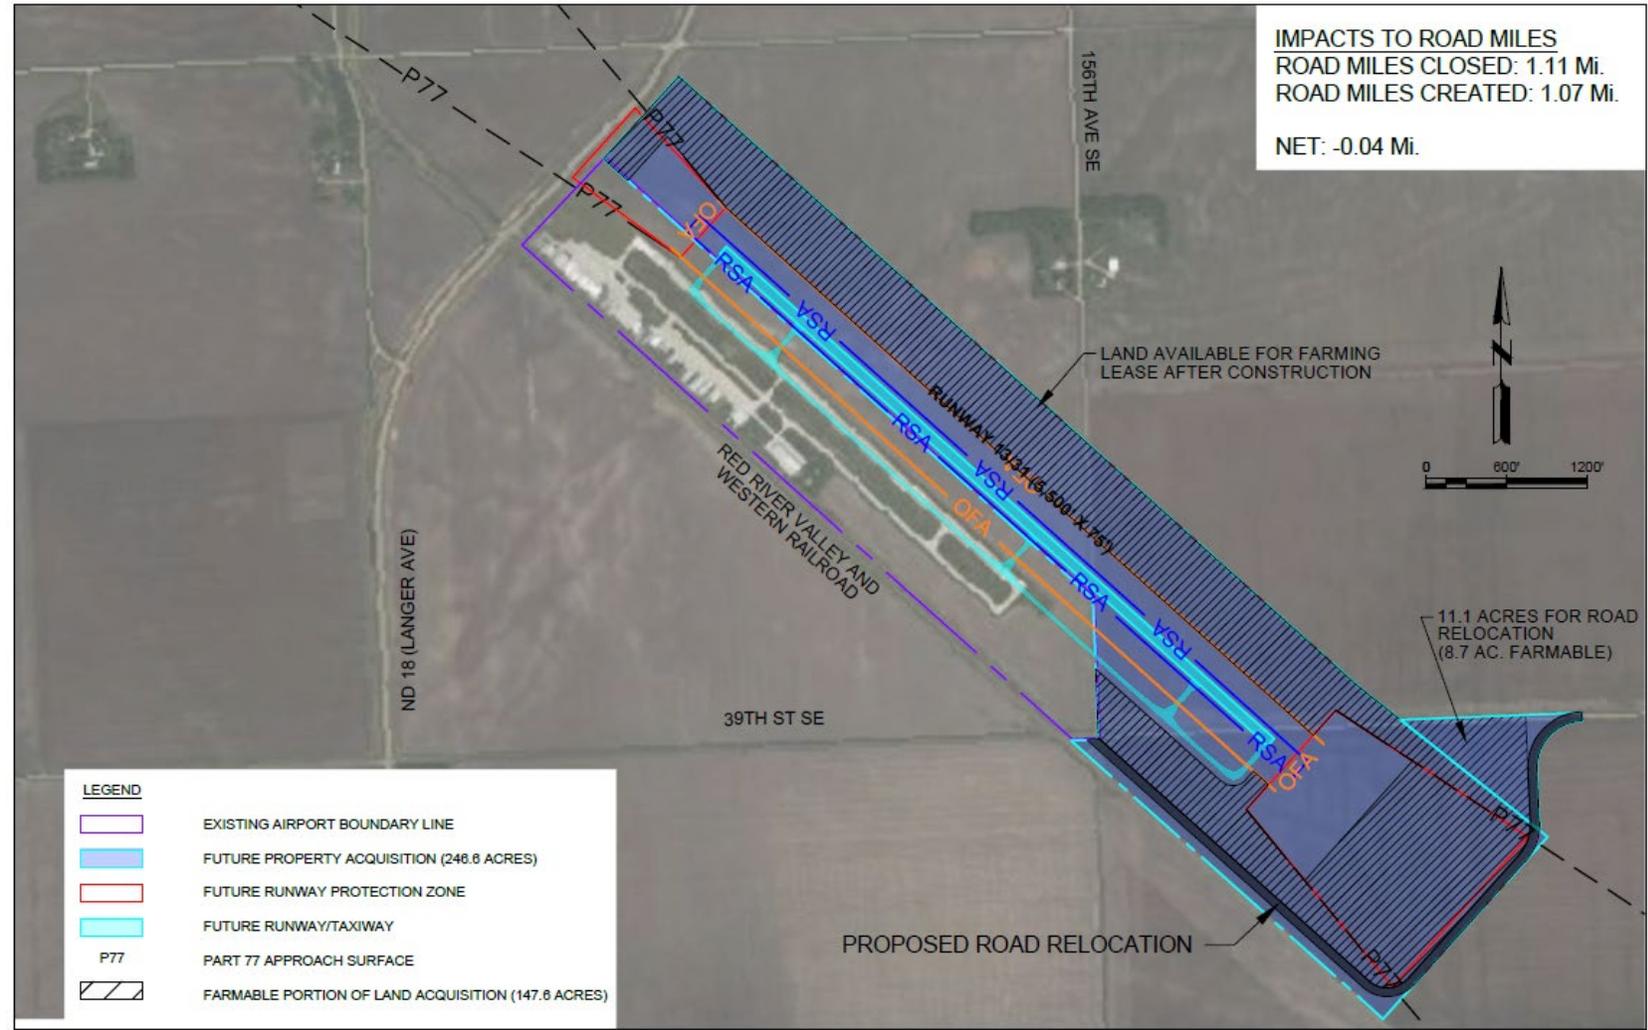
- Meets Group II design standards
- Meets length guidance for long-term future users
- Property acquisition: 246.6 acres
- Allows agricultural lease of 148 acres
- Road miles reduced: 0.04 miles

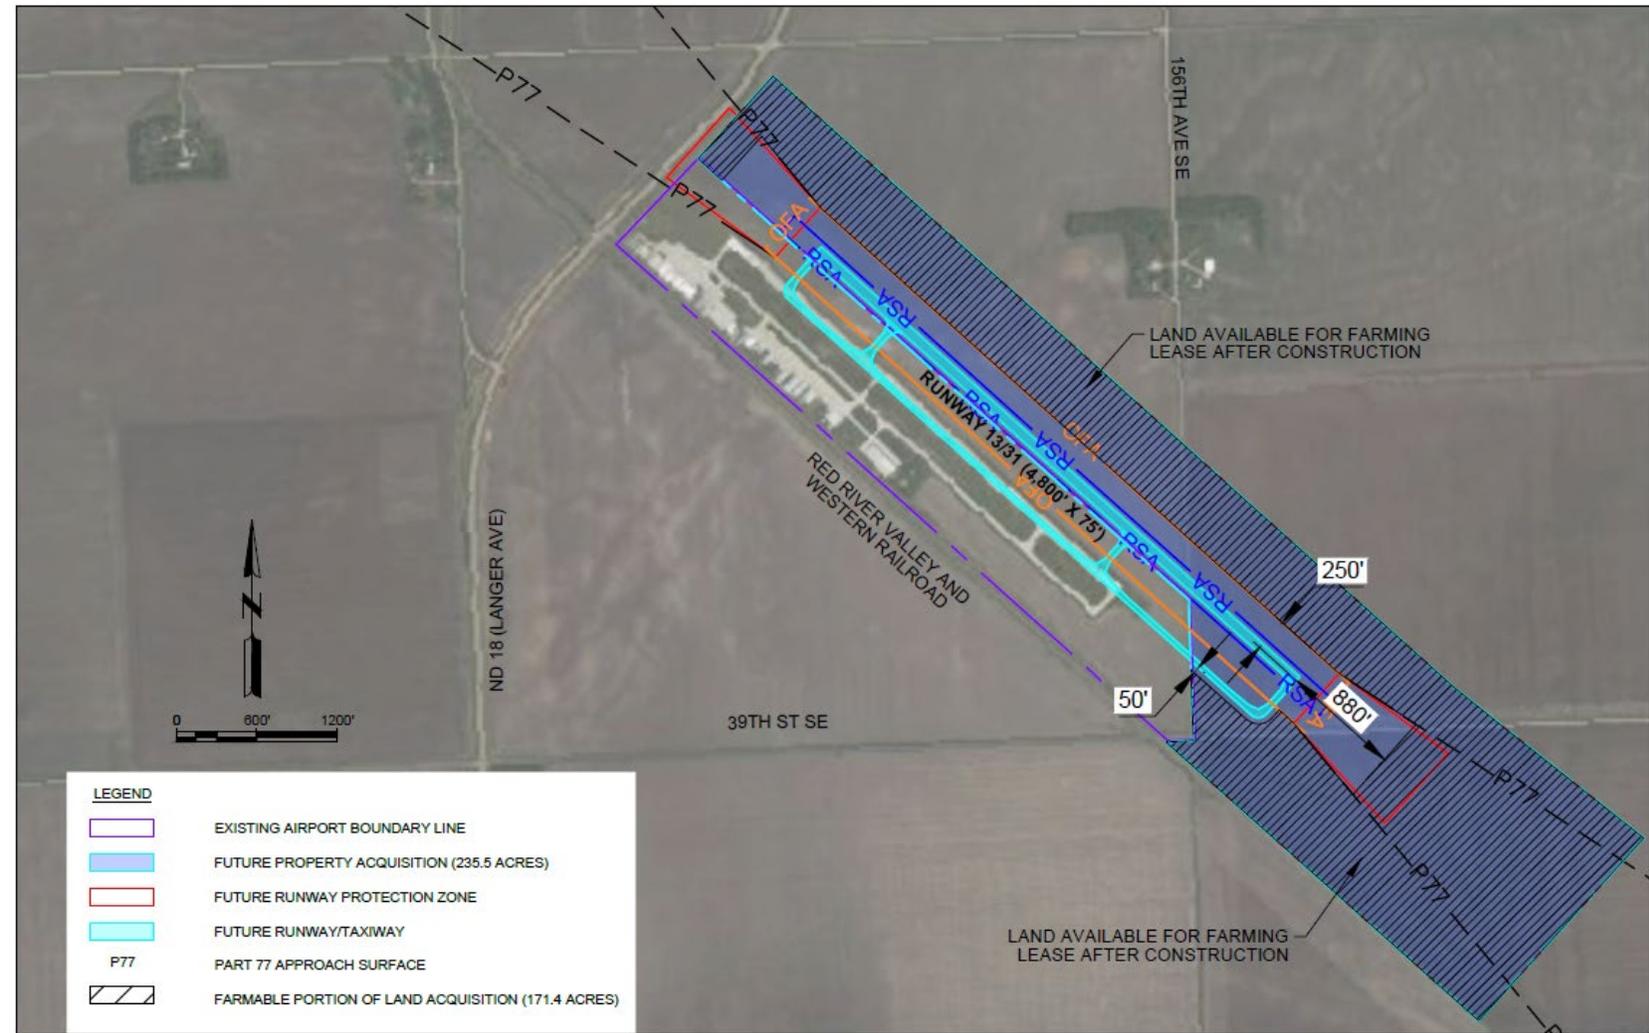
Project Alternatives: Interim 4,800-foot Runway

- Meets Group II design standards
- Meets length guidance for long-term future users in dry conditions
- Property acquisition: 235.5 acres (reserves for future 5,500-foot runway)
- Allows agricultural lease of 171 acres
- Road miles reduced: ~1 mile

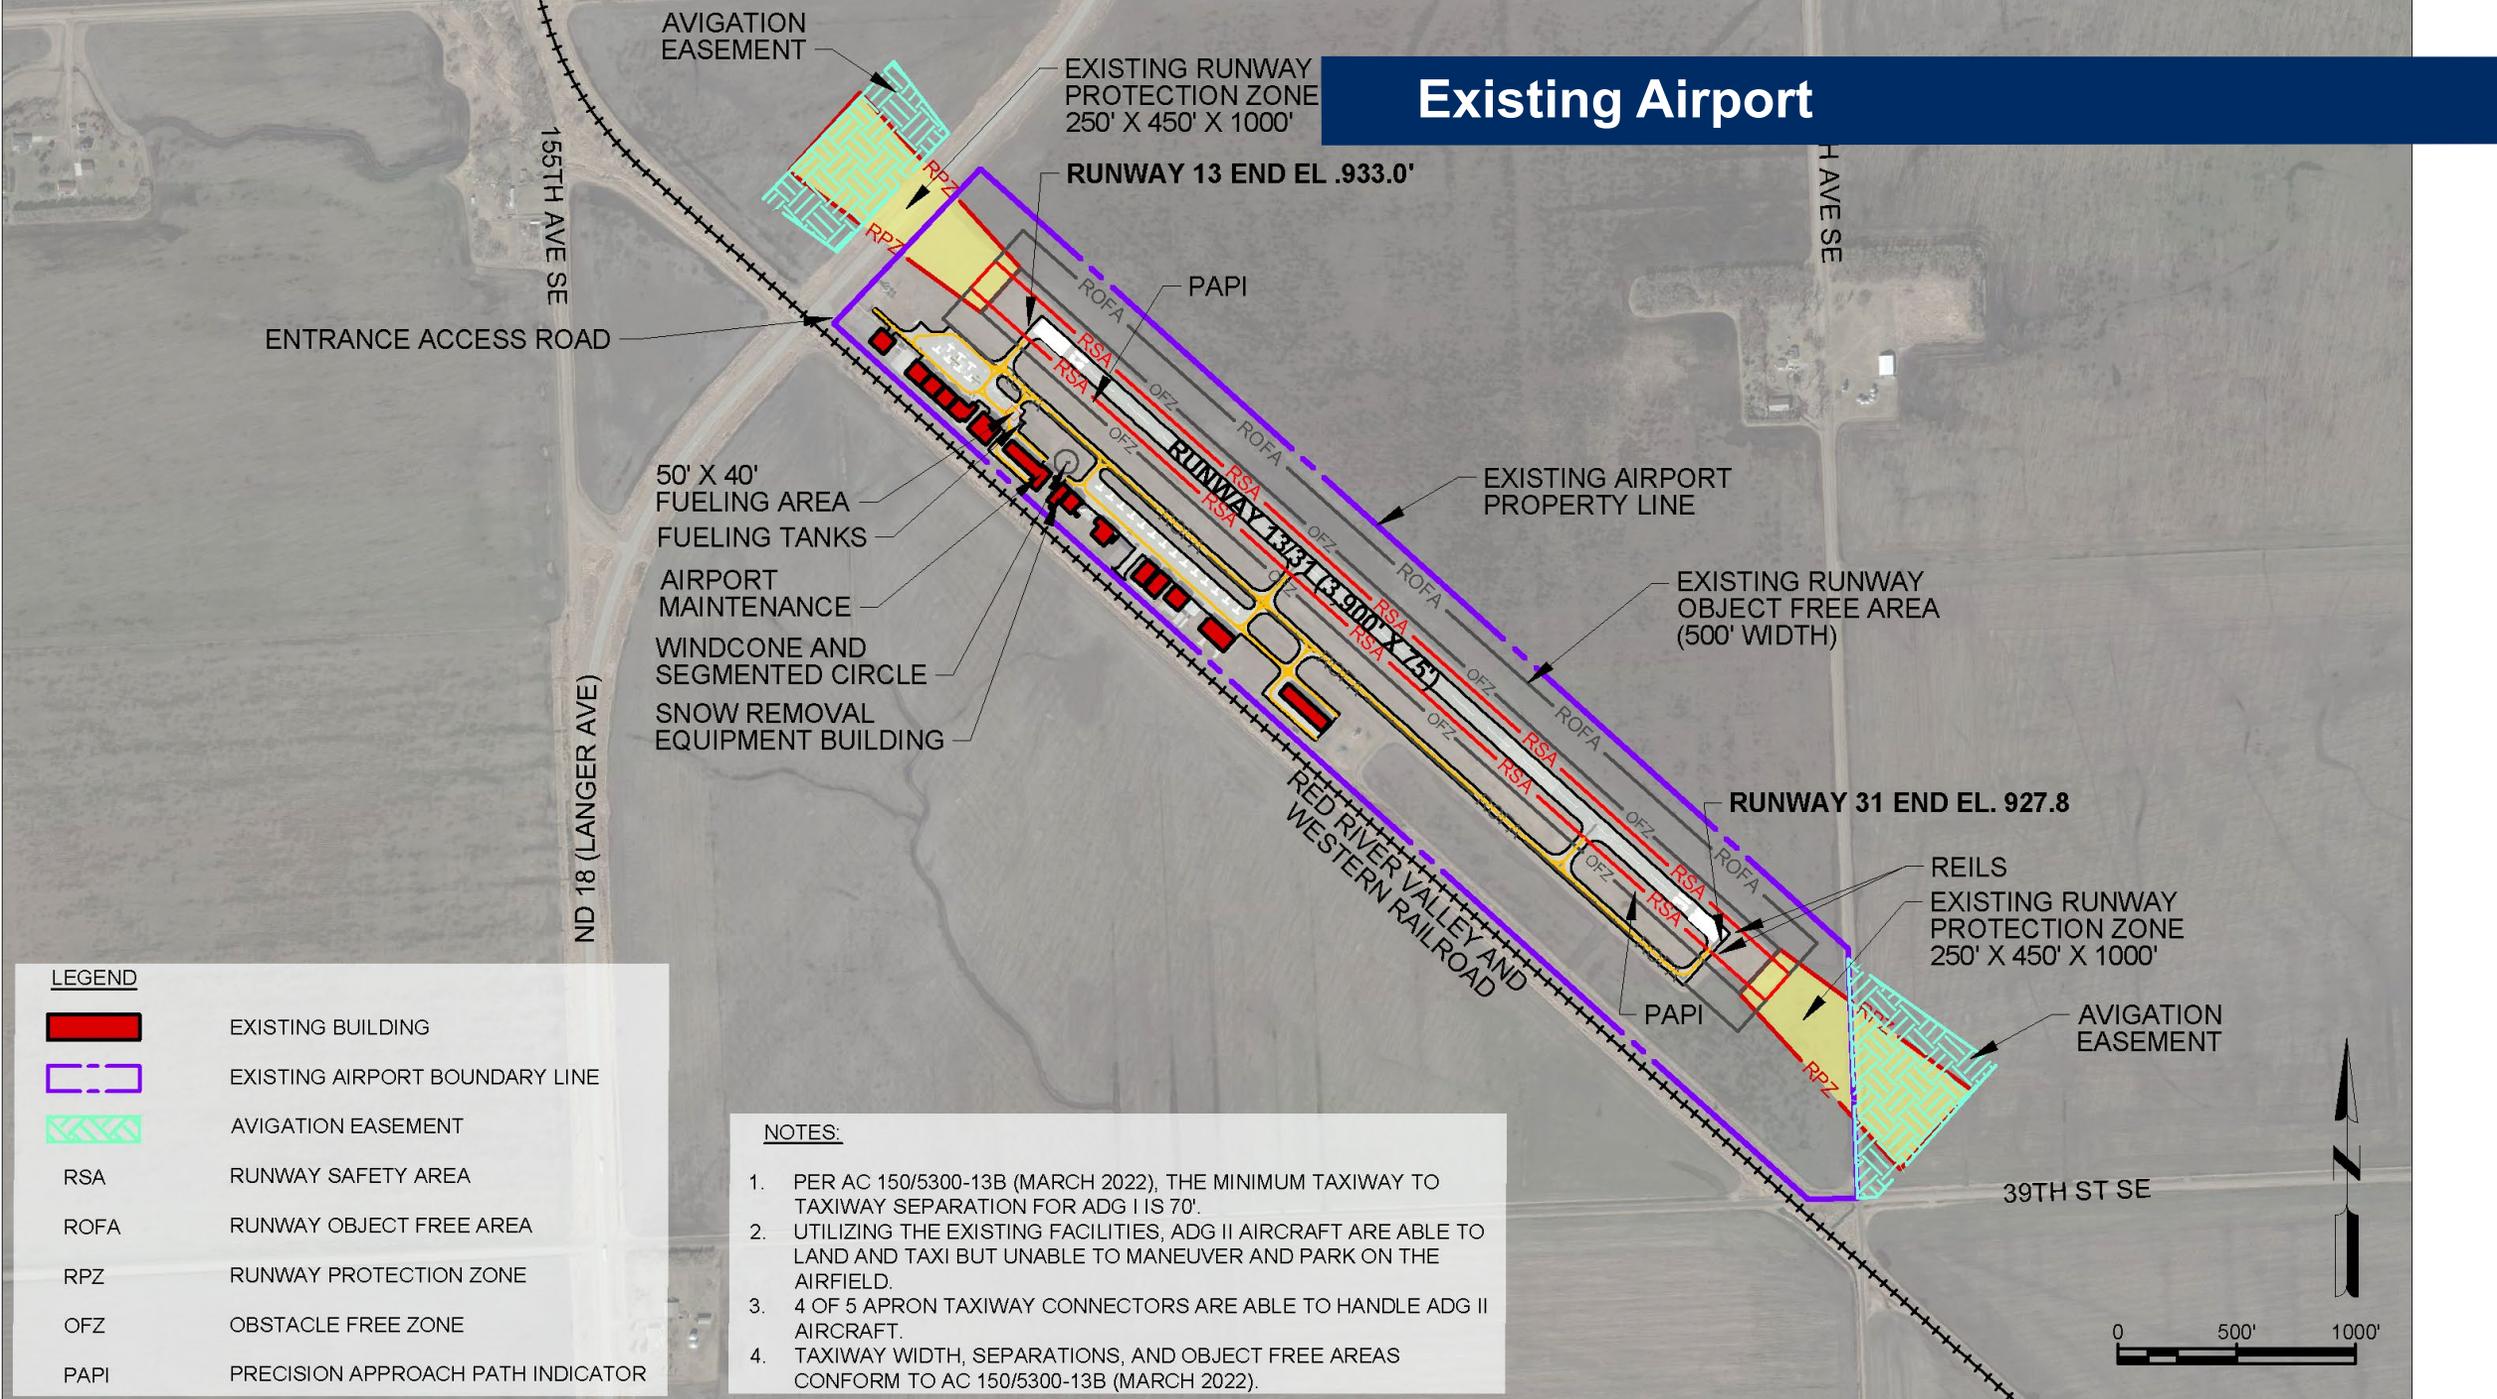
Existing Airport

AVIGATION EASEMENT

EXISTING RUNWAY PROTECTION ZONE 250' X 450' X 1000'

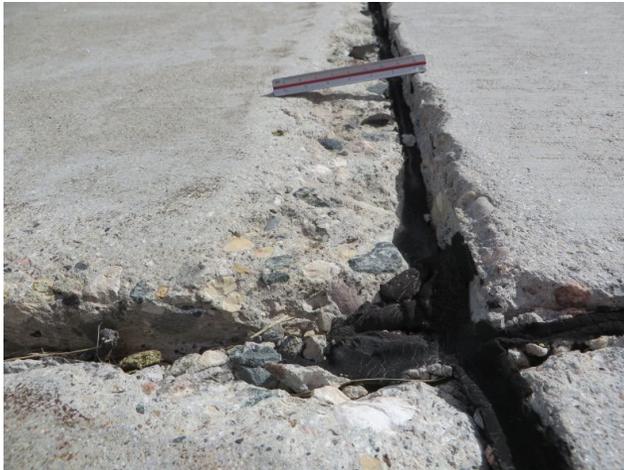
Faulting on Taxiway Connector

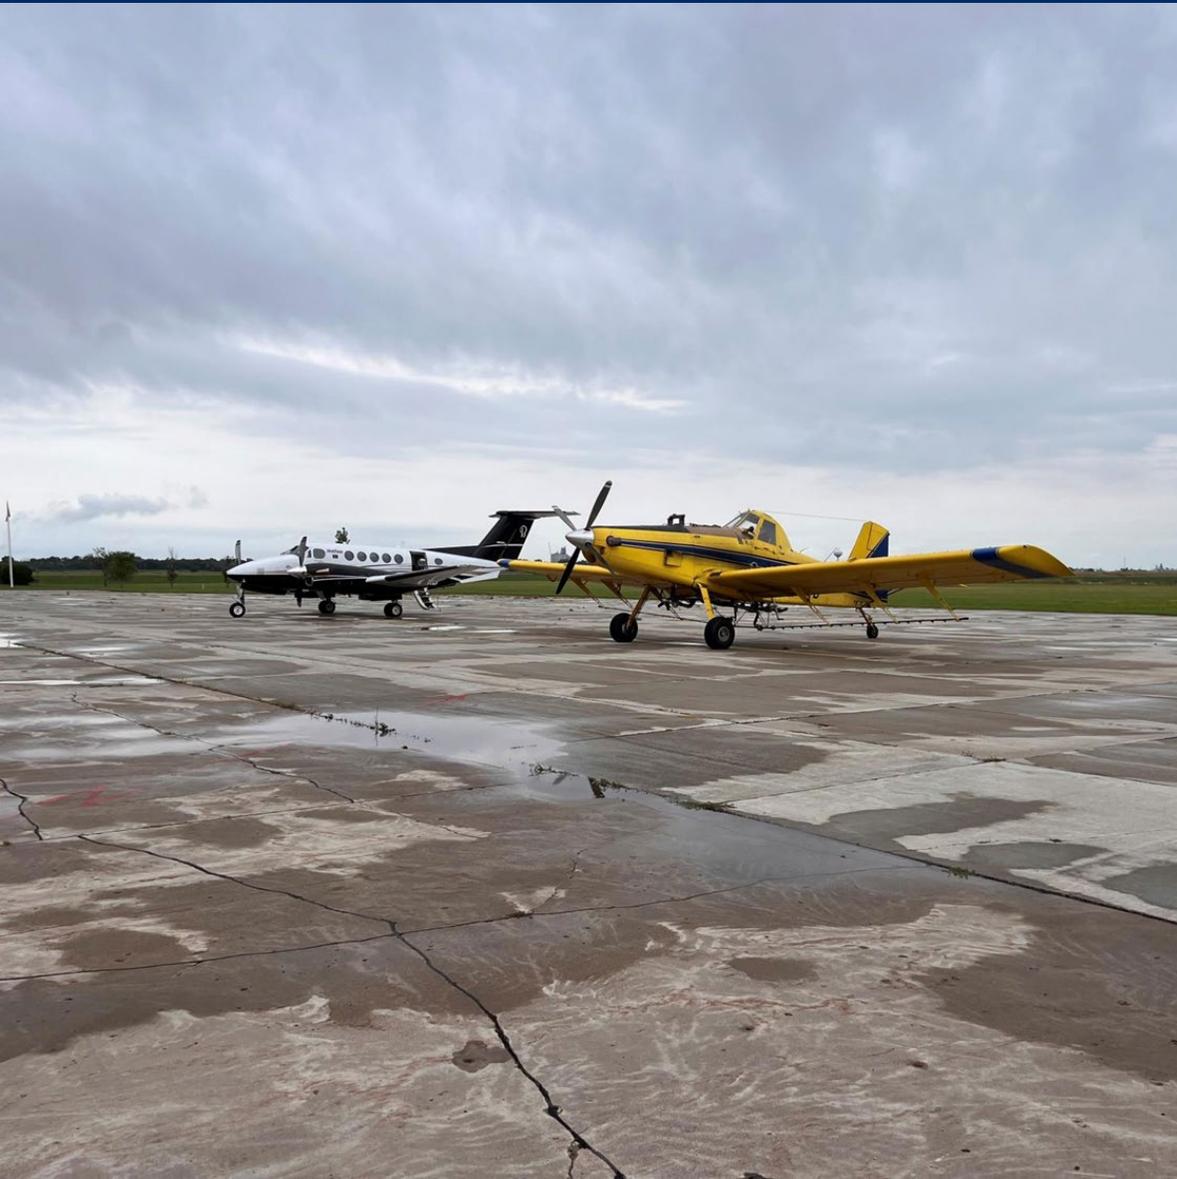
2021 PCI Map of Airport Pavements

- The majority of Airport pavement is over 30 years old
- Although multiple rehabilitation projects have occurred since construction, pavement throughout the Airport is now in poor condition and nearing the end of its service life.
- A runway rehabilitation done in 2023 will maintain the surface in usable condition until the runway project

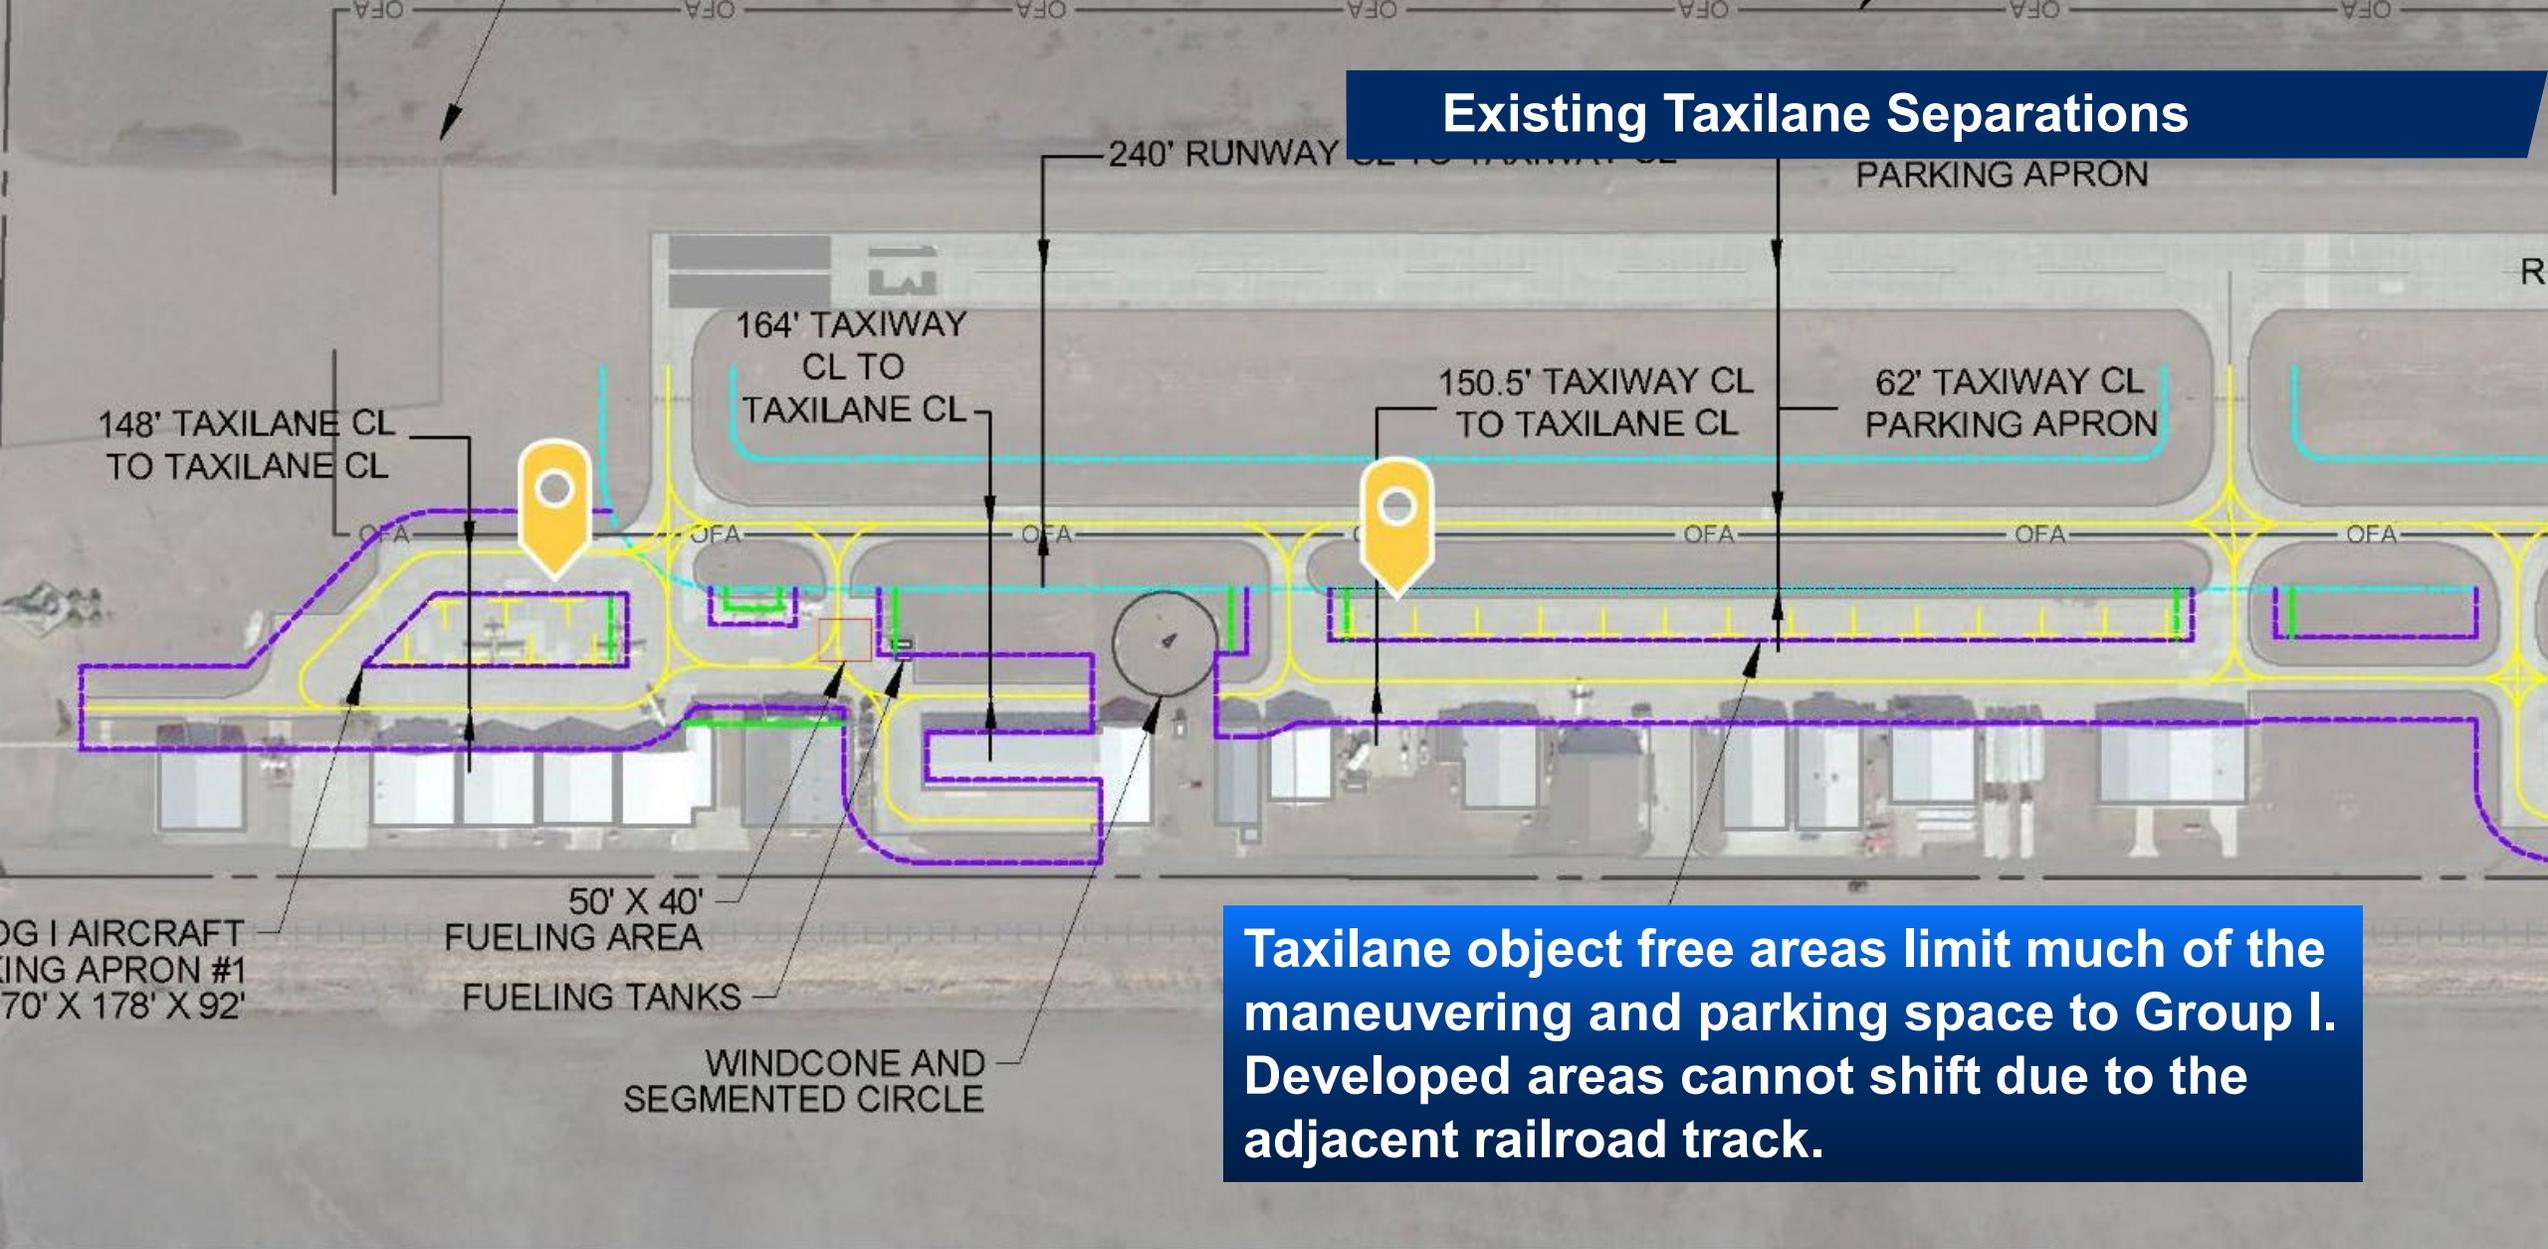
Existing Taxilane Separations

Taxilane object free areas limit much of the maneuvering and parking space to Group I. Developed areas cannot shift due to the adjacent railroad track.
