GoDURHAM TRANSIT VEHICLE MAINTENANCE AUDIT

CONDUCTED
DECEMBER 13 – 17, 2021

PHOTOS OF DEFECTS FOUND

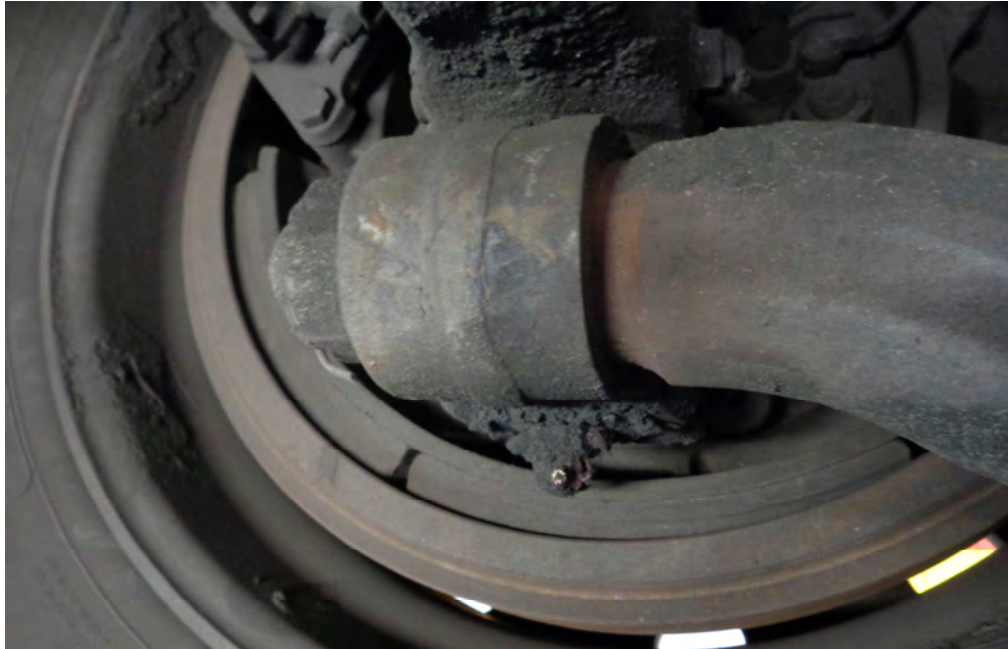
Bus 1003: Loose Steering Arm

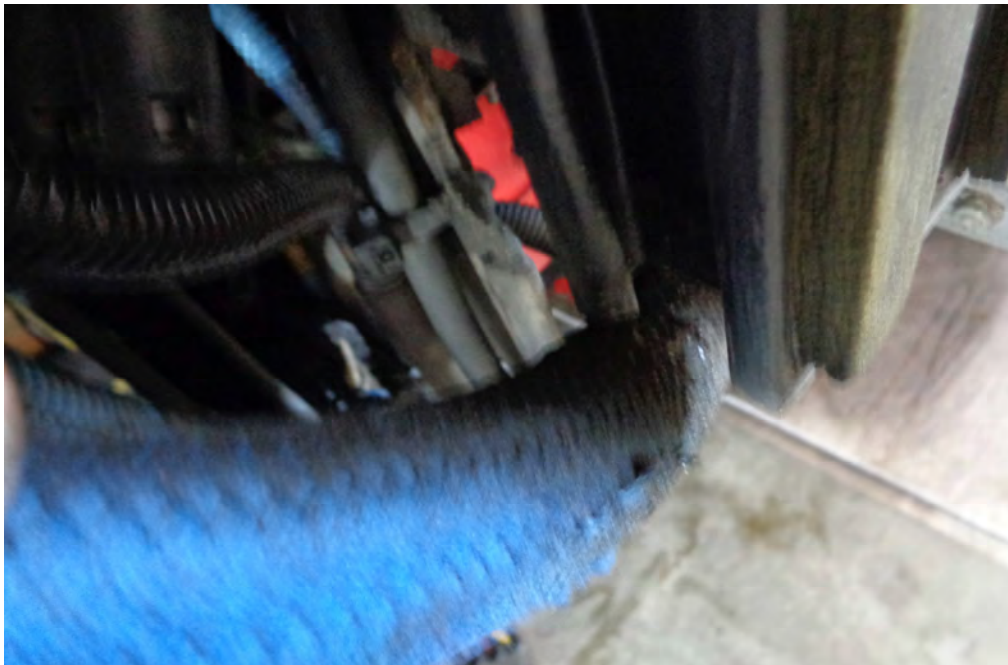
Bus 1005: Hole in Fire Suppression Hose

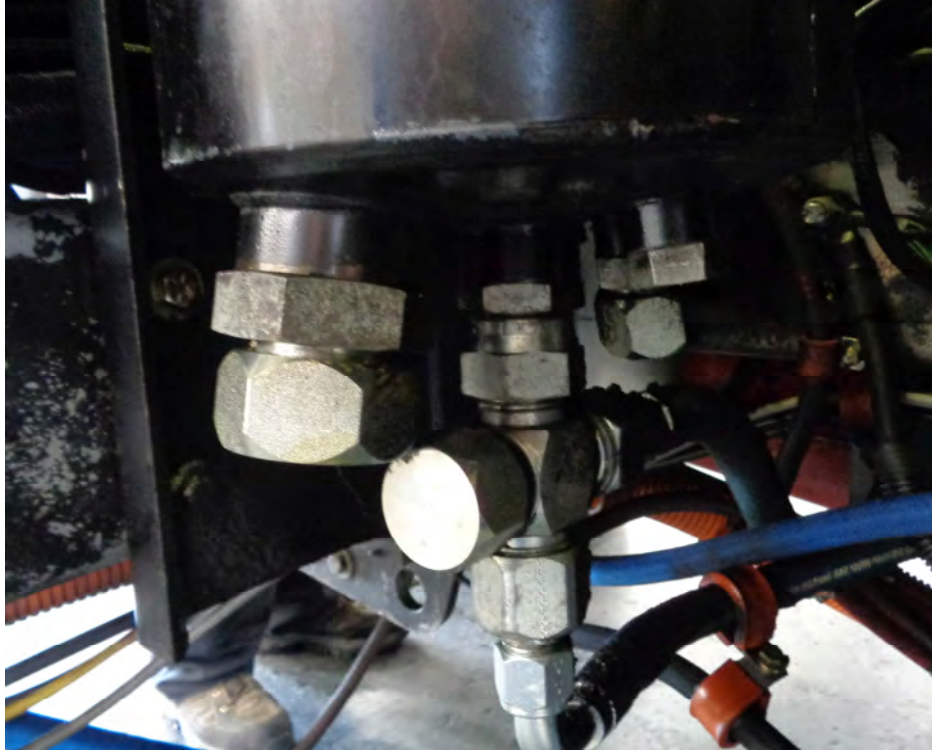
Bus 1005: Hose Leak at Hydraulic Reservoir

17	2010	12/17/2021	Exterior	Replace LR wheelhouse molding	
18	2010	12/17/2021	Brakes	Brake hose frayed badly on RR chamber	Yes
19	2010	12/17/2021	Engine	Hydraulic reservoir leaking badly	Yes
Bus #1007					
1	2010	12/15/2021	Driver's Controls	Driver's light lense missing	
2	2010	12/15/2021	Driver's Controls	Play in steering column lock	
3	2010	12/15/2021	Driver's Controls	Driver's seat cushion torn	
4	2010	12/15/2021	Doors	Bottom rear door bearings loose	
5	2010	12/15/2021	Exterior	Curb side wiper arm needs adjustment	
6	2010	12/15/2021	Driver's Controls	Dash lights inoperative	
7	2010	12/15/2021	Doors	Front door panels need adjustment in open adjustment	
8	2010	12/15/2021	Chassis	Both front hub grease fills leaking	
9	2010	12/15/2021	Exterior	Front curb side turn signal lense cracked	
10	2010	12/15/2021	Brakes	Line from ping tank to air dryer kinked	
11	2010	12/15/2021	Electrical	Top center brake light out

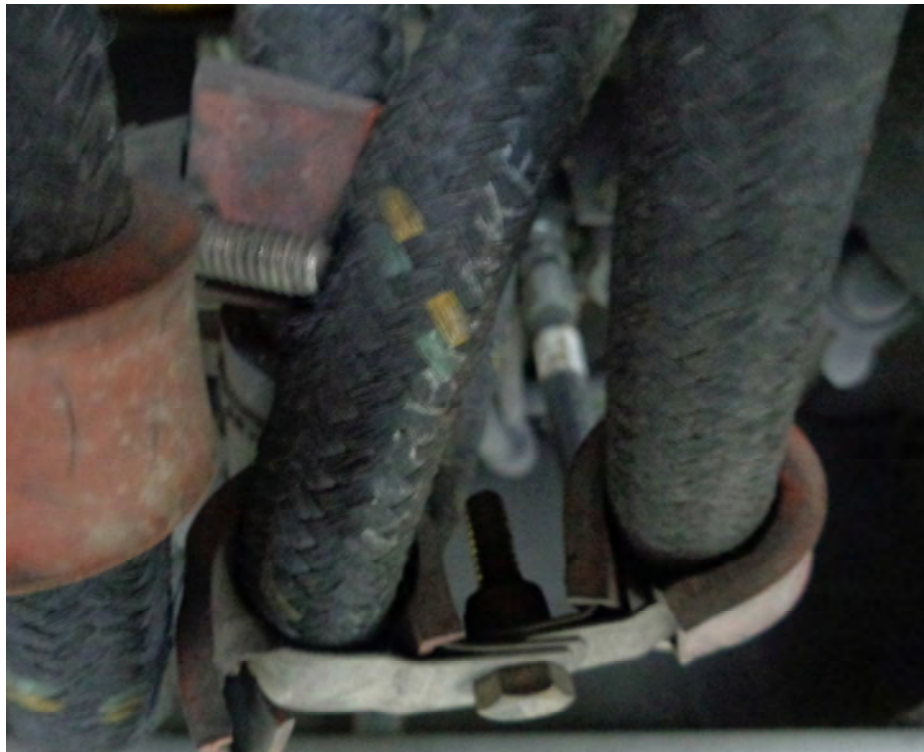
Bus 1205: Bolt Rubbing Hole in Brake Hose

18	2010	12/16/2021	Brakes	Bolt rubbing through hose to curb side brake chamber	Yes
19	2010	12/16/2021	Chassis	Pinion seal leaking	
Bus #1205					
1	2012	12/16/2021	Exterior	Replace curbside wiper blades	
2	2012	12/16/2021	Tires	Bolt in RRO tire	Yes
3	2012	12/16/2021	Electrical	Main harness bundle above ping tank needs re-routing	
4	2012	12/16/2021	Electrical	Top of plate holding main junction box loose at firewall	Yes
5	2012	12/16/2021	Exterior	Curb side engine compartment door broken at top	
6	2012	12/16/2021	Electrical	Broken P-clamp on top at alternator bracket	
7	2012	12/16/2021	Engine	Radiator brace rod loose	
8	2012	12/16/2021	Exterior	Street side tail light fixture on engine door broken	
9	2012	12/16/2021	Exterior	Rear front door light broken	
10	2012	12/16/2021	Doors	Front door panels need adjustment when closed	
11	2012	12/16/2021	Exterior	Top drivers side mirror does not adjust remotely	
12	2012	12/16/2021	Doors	Replace heim joints on both front door arms

As part of this training technicians should be shown how to properly route the hoses on the rear brake chambers to prevent hose damage. RVBA is also recommending that GoDurham retrain all technicians how to properly adjust the front and rear door panels. Proper inspection and lubrication of the door bearings should be part of this training. RVBA is also suggesting that GoDurham perform a campaign of all buses in the fleet to make sure that the wheelchair ramp stow latches are adjusted properly.

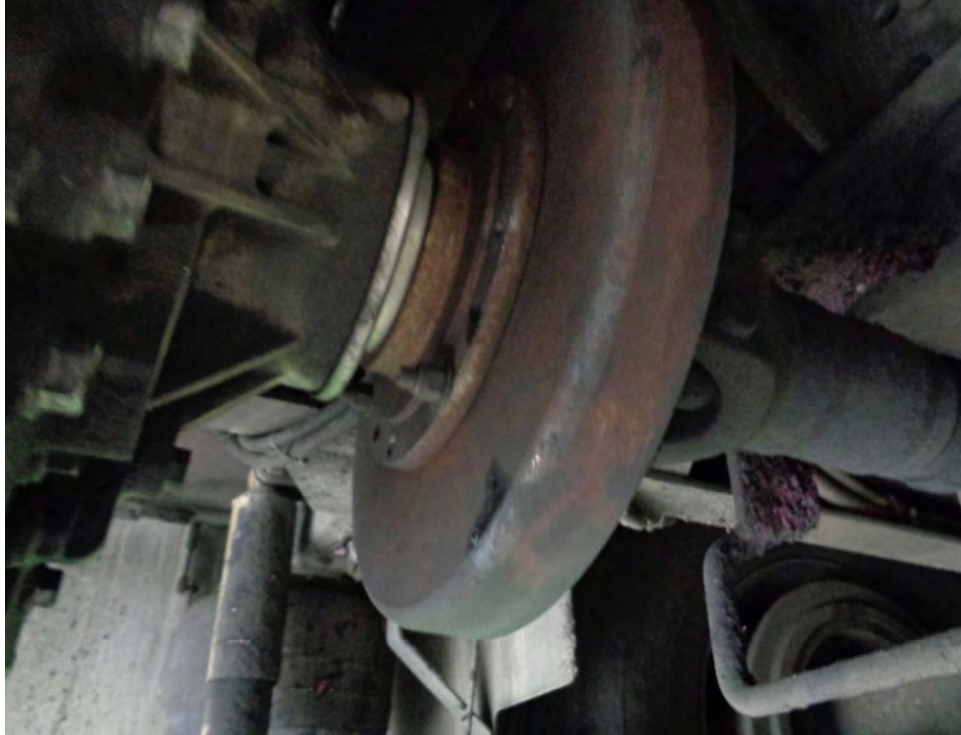
Bus 1205: Six Bolts Missing in Driveshaft Flange

13	2012	12/16/2021	Electrical	Damaged wire in curbside wheel well	
14	2012	12/16/2021	Brakes	Hoses on both brake chambers fraying	Yes
15	2012	12/16/2021	Chassis	Differential housing gasket leaks	
16	2012	12/16/2021	Engine	Allison unit leaking from breather	
17	2012	12/16/2021	Engine	Power steering line leaking	
18	2012	12/16/2021	Engine	Main DPM line leaking at Allison unit	
19	2012	12/16/2021	Chassis	Six bolts missing in driveshaft flange	Yes

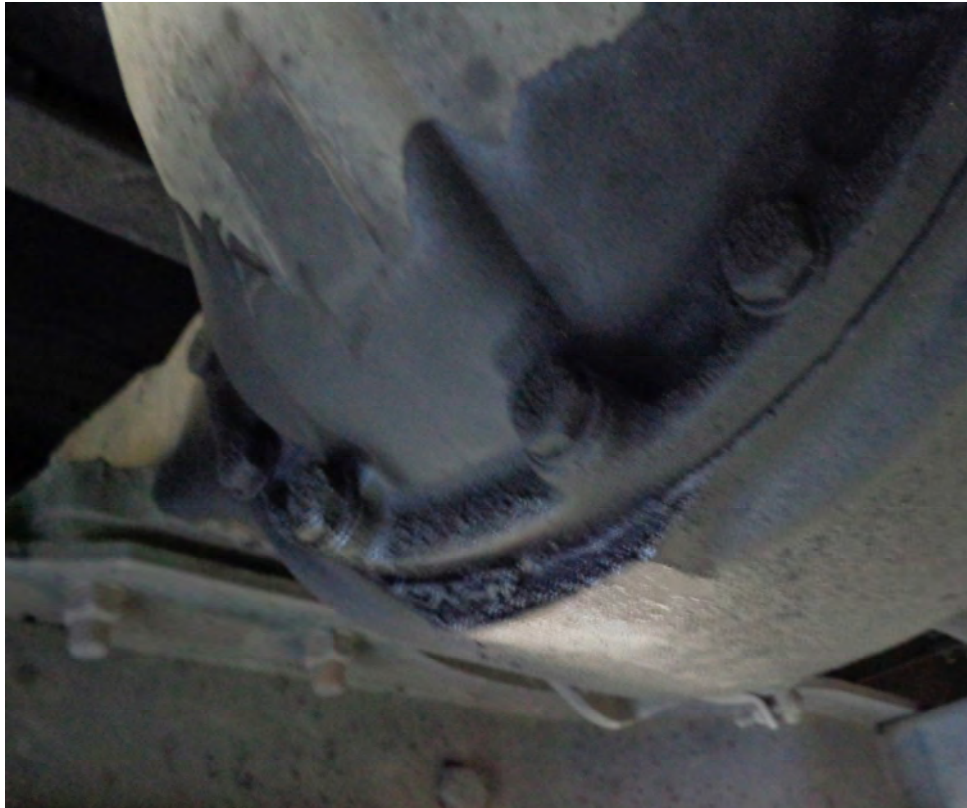
Bus 1205: Differential Gasket Leaking
