### Aquatic Resources Delineation Report Stanley Municipal Airport

July 2023

Moore Project No. 22710E

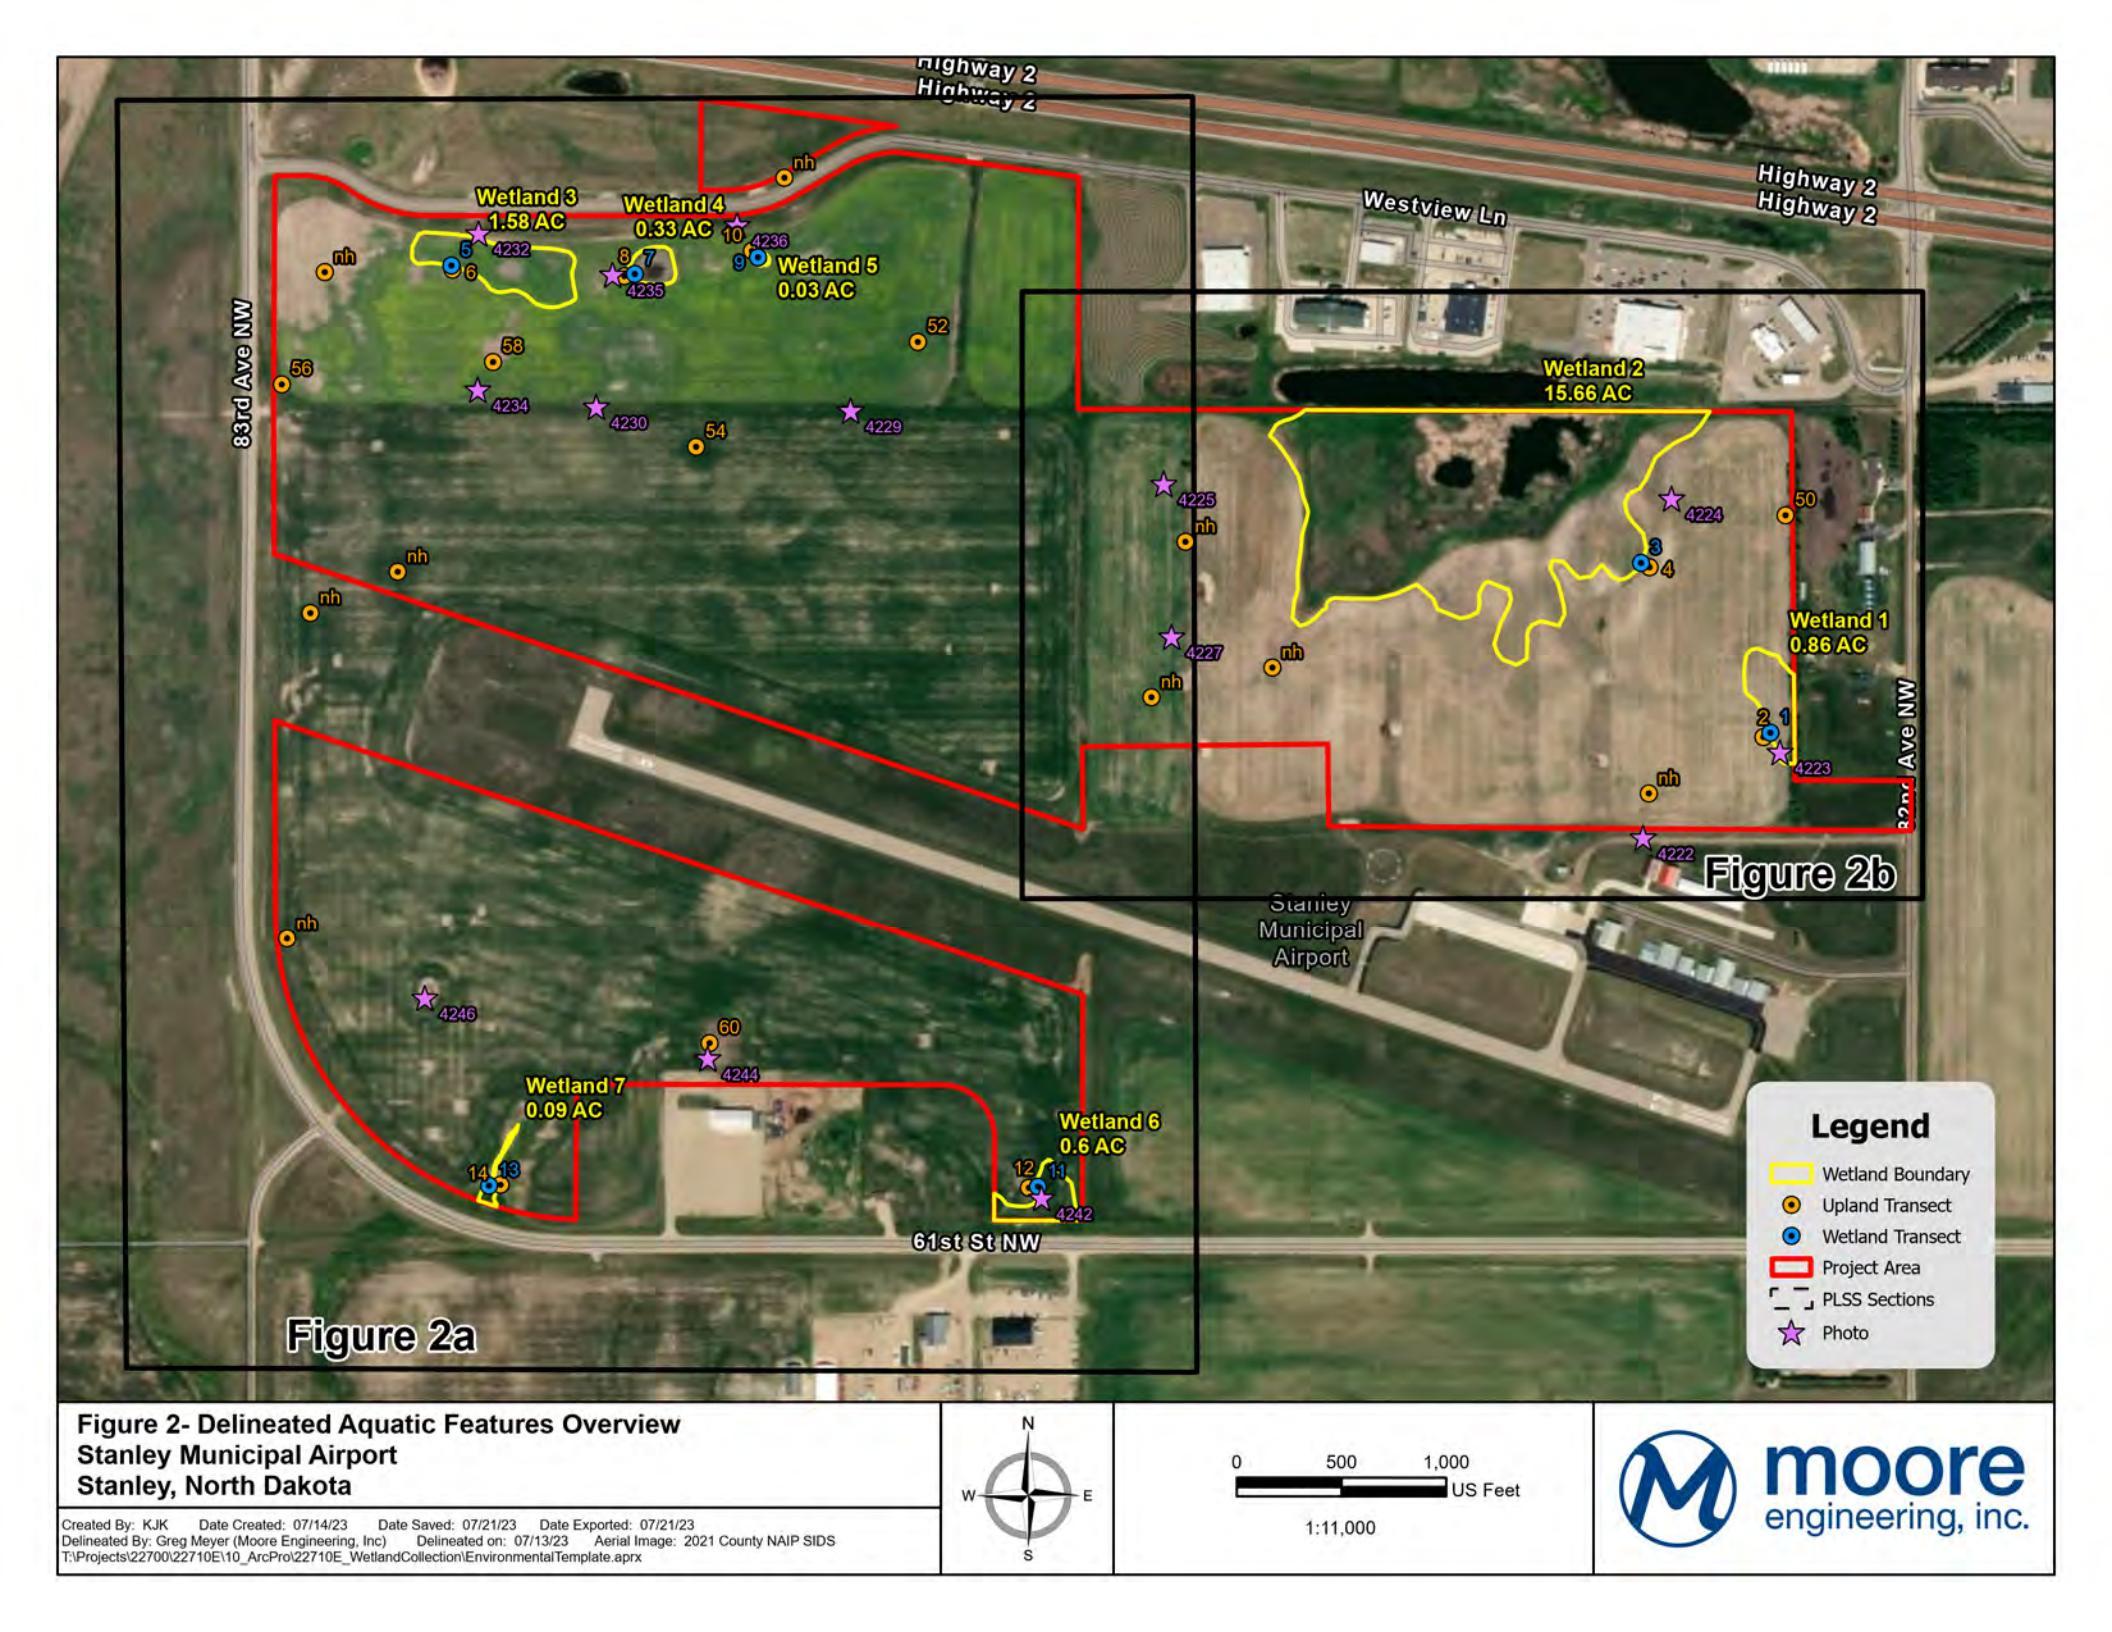
The field aquatic resource delineation for the proposed project was completed by Greg Meyer (Environmental Scientist) of Moore Engineering, Inc., and Hal Weiser (Professional Soil Classifier) on July 13, 2023. Numerous aquatic resources are located in the project area including several wetlands scattered throughout along the edge of the project area. Cumulatively the wetlands comprise approximately 19.12 acres. The project area comprises approximately 210 acres. Please refer to Figure 2, Delineated Aquatic Features.
